Underwood Playground

Belmont, Massachusetts

Recreational Feasibility Report and Preliminary Design

April 2, 2013

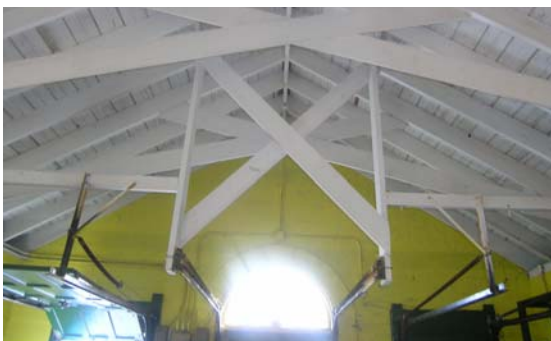
- Walls constructed in this era will have little or no reinforcing.
- The roof structure is consists of 2 by 8 framing at 16 inches on center with wood plank sheathing. The framing is undersized based on current code requirements. Roof loading for unheated structures is higher than heated buildings since snow will accumulate at higher levels on colder surfaces.
- The roof structure is tied to the top of the masonry wall.
- A renovation of the building would not be a change in use; therefore no seismic upgrades would be required. However, the extent of a renovation may trigger significant structural improvements.

Roof Framing at Lobby

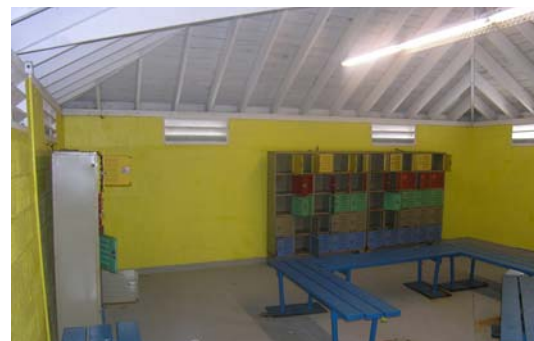
Typical Roof Framing at Changing Areas

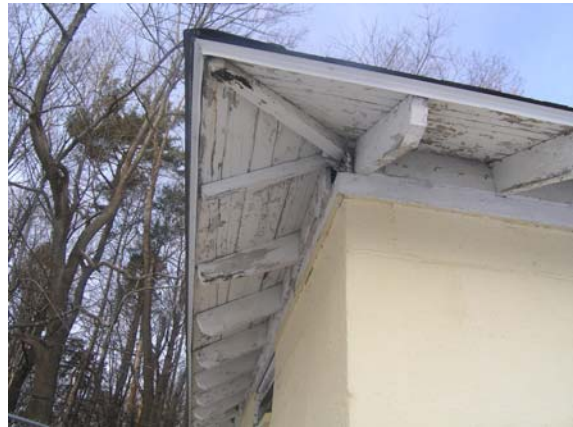
The exterior eave framing and trim are painted wood. The wood is in poor condition. Minor splits/cracks are visible at joints and wood ends; scraping, sealing and repainting required. Areas of trim need replacement; repairs required at some framing members.

Eave Framing and Trim at southeast corner

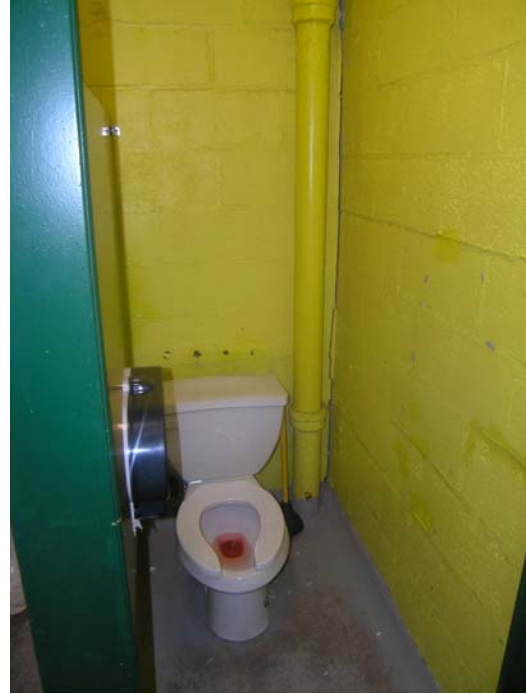
The quantity of toilet room fixtures is inadequate for the number of bathers. The fixtures do not provide provisions of individuals with disabilities.

Typical Toilet Stall

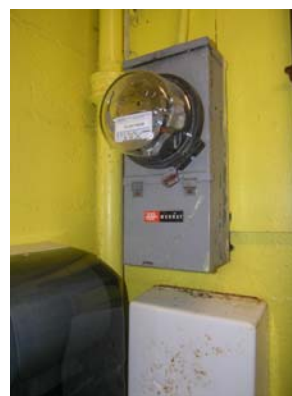
- The panels and conduit are older; corrosion is visible on devices. Older plug fuses are still used on certain panels.
- Light fixtures are caged fluorescent strip fixtures; the fixtures are not lensed which is required by code in a bathhouse building.
- There is no emergency lighting or exit signs that are required by code. The building is not equipped with a fire detection or alarm system.

Service Entrance

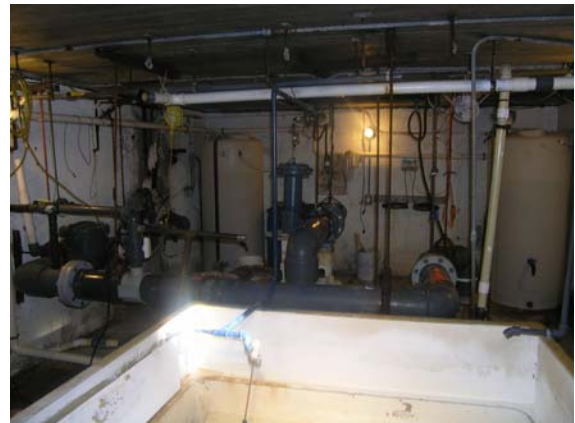
- The filter room is constantly wet from ground water and must be pumped. The room has been flooded in the past.
- The building is considered a confined space and should have two means of egress.
- The lighting and electrical components are showing signs of corrosion. Light fixtures are not guarded.
- Working clearances between equipment and switches are minimal and not ideal for service.

View of space over filter.

The filter equipment must be moved above grade to avoid the continual leaks and periodic flooding experienced at the existing structure. Modern filtration equipment can be housed in a simple structure that will provide easy and safe access to Town personnel maintaining the pool.

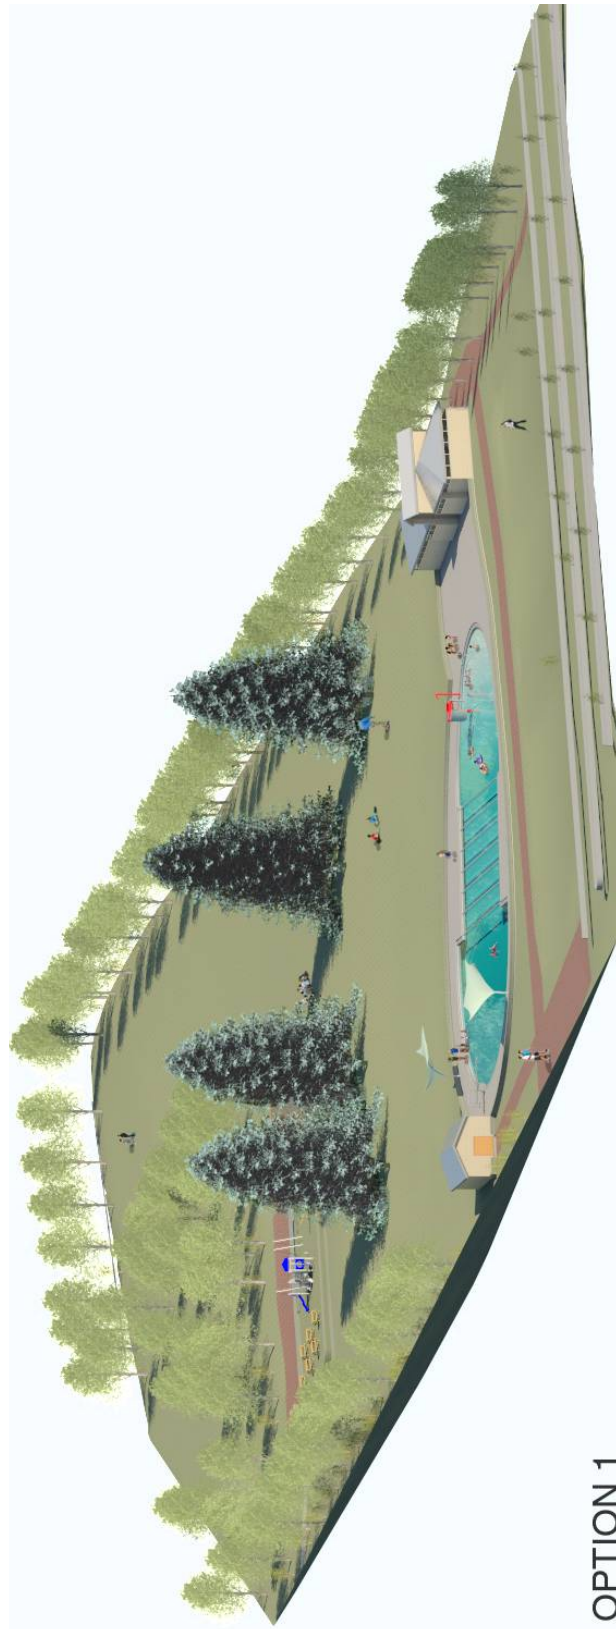
OPTION 1

BH+A prepared design options and reviewed with Town Staff. Based on comments and feedback. Option 1 explores the replacement of the existing pool in the location of the existing swimming pool.

5. New wood framed bathhouse-building including spaces noted above.
6. 8 -Foot high, vinyl coated chain link security fence at perimeter of pool enclosure.

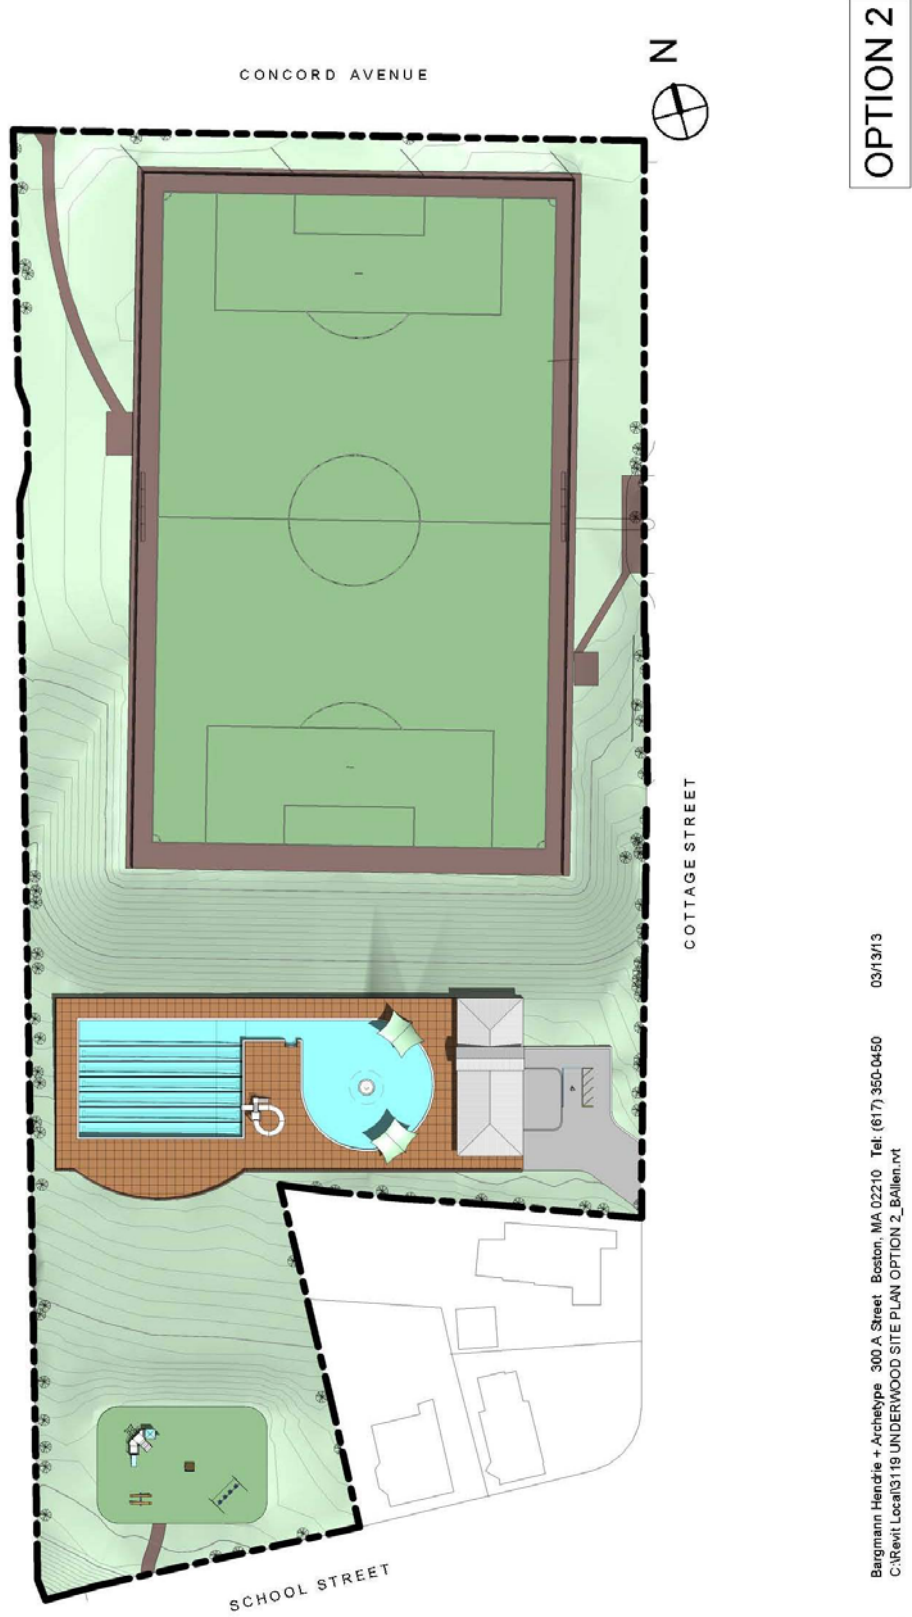
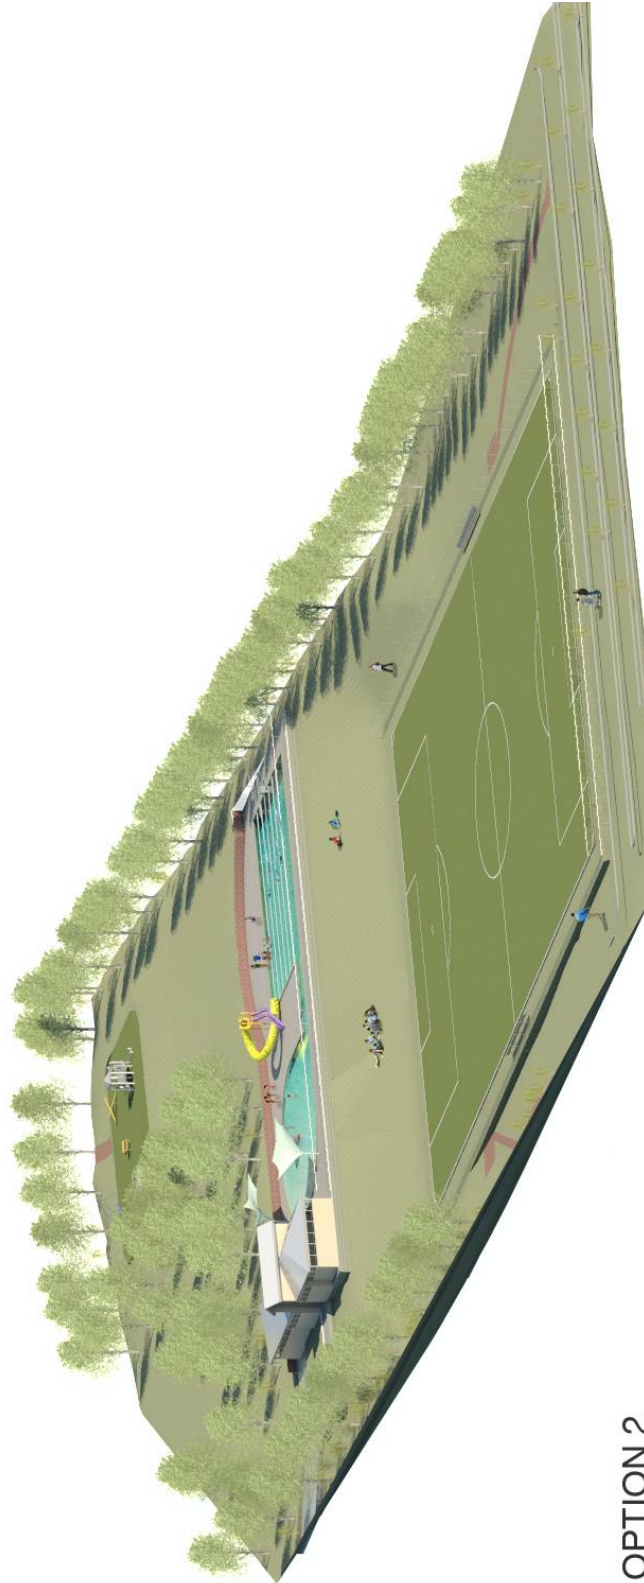
OPTION 2

- New multi-purpose field along Concord Avenue
- The pool complex utilizes all of the available buildable space above the multi-purpose field.
- Brings diving back to the pool.

- 4. Backfill site with gravel borrow to bring grade of new field up to elevation 18.00 (18 inches above culvert)
- 5. New wood framed bathhouse-building including spaces noted above.

- 6. 8 -Foot high, vinyl coated chain link security fence at perimeter of pool enclosure.
- 7. New dry-mix shotcrete "Gunite" swimming pool with painted finish. Although located up the hill, it is recommended that the pool still be built with an underdrain/dewatering system comprised of the following:

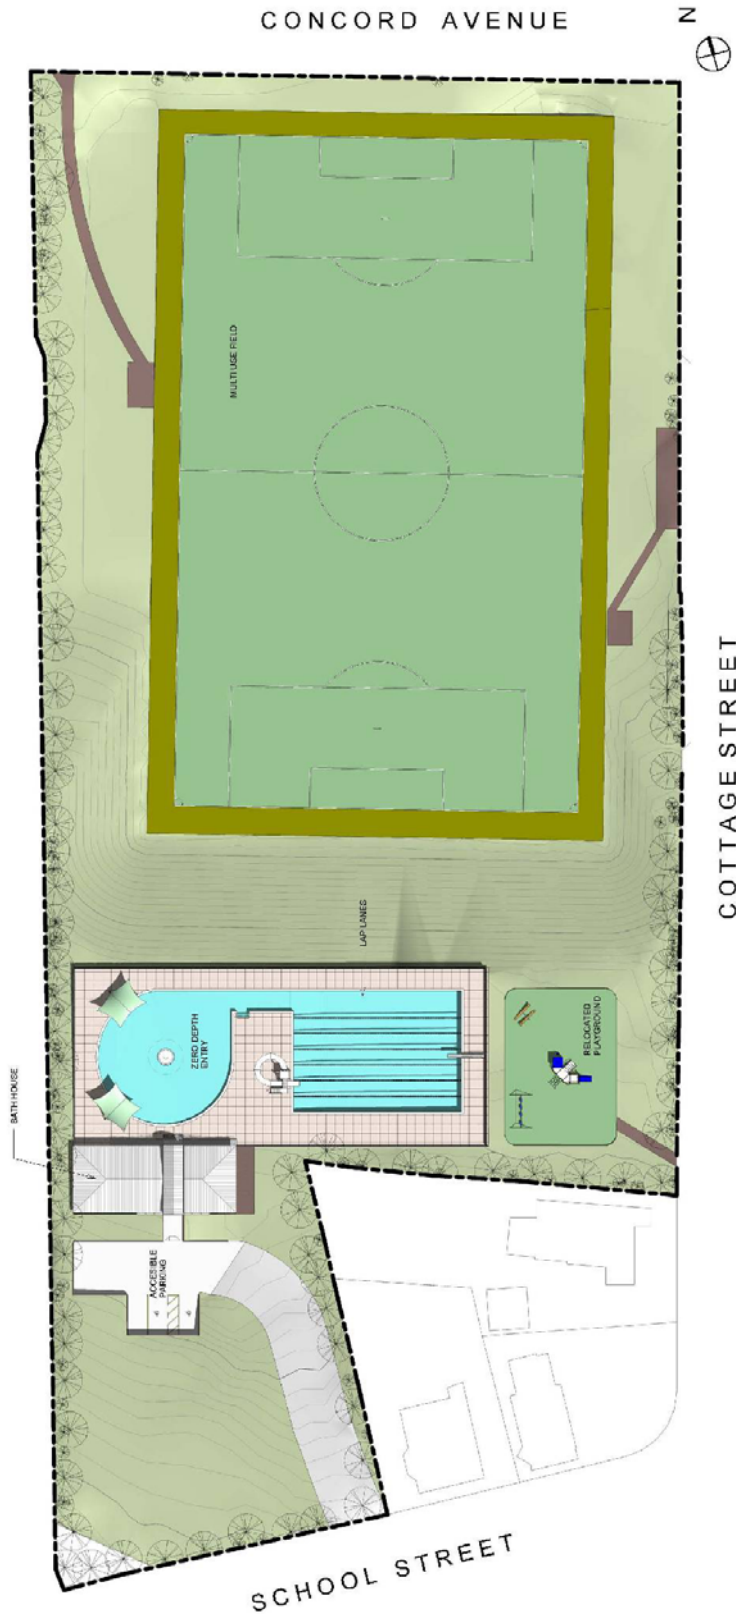
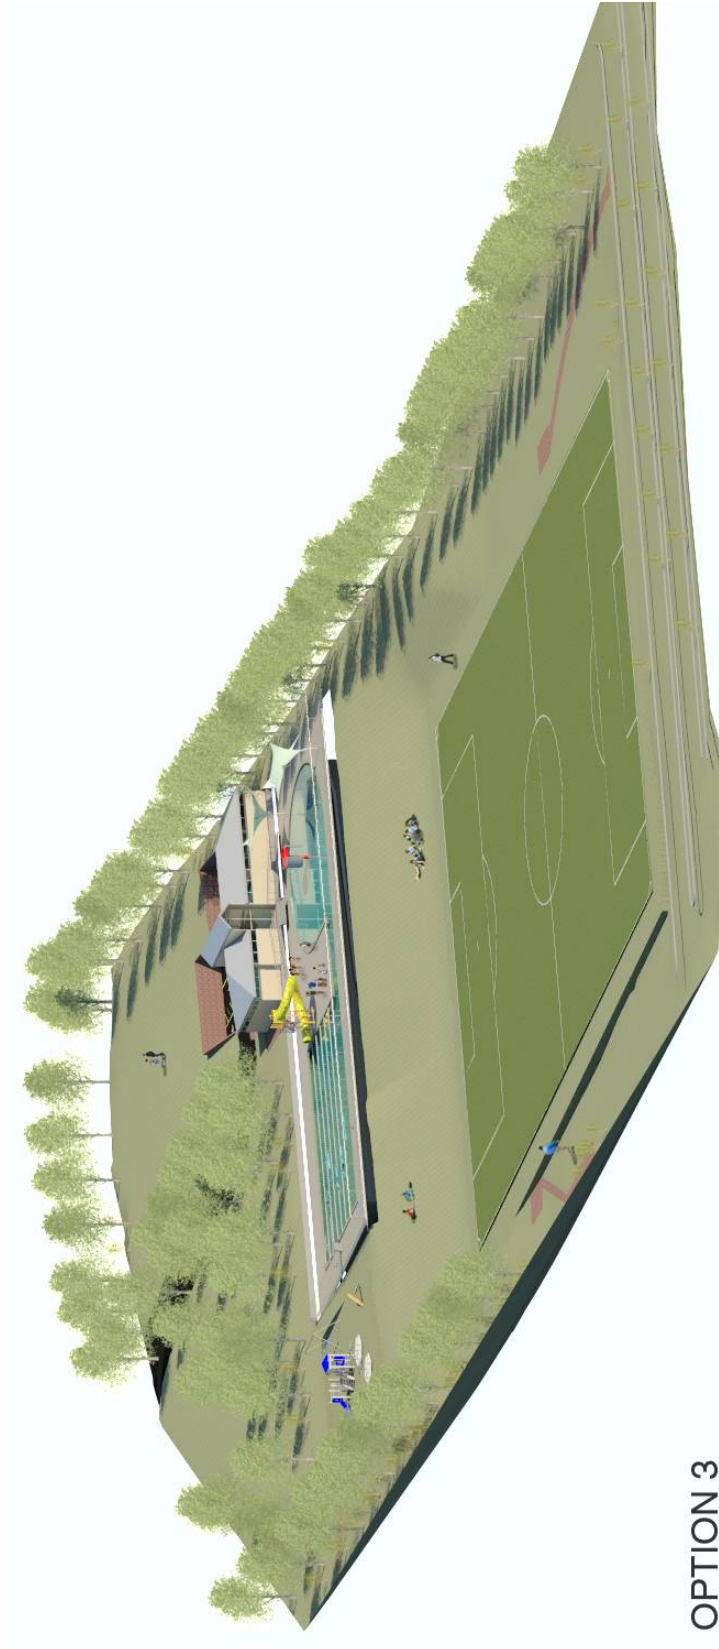
OPTION 3

- New multi-purpose field along Concord Avenue
- Pool is sized to meet current and future public demands. The pool complex utilizes all of the available buildable space above the multi-purpose field.
- Brings diving back to the pool.

- 4. Backfill site with gravel borrow to bring grade of new field up to elevation 18.00 (18 inches above culvert)
- 5. New wood framed bathhouse-building including spaces noted above.

- 6. 8 -Foot high, vinyl coated chain link security fence at perimeter of pool enclosure.
- 7. New dry-mix shotcrete "Gunite" swimming pool with painted finish. Although located up the hill, it is recommended that the pool still be built with an underdrain/dewatering system comprised of the following:

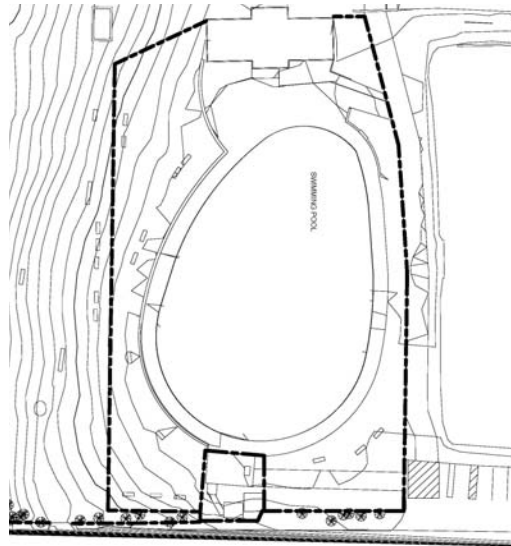
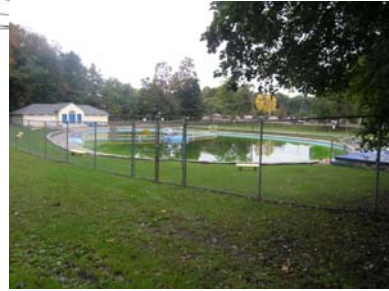
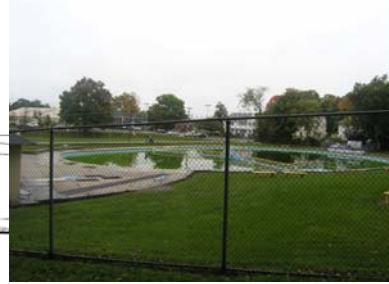
Existing Pool Complex

- Not Compliant with MAAB/ADA
- Does Not Provide Code Required Plumbing Fixture Count
- No Secure Staff/First Aid Areas
- Structural Repairs Required at Roof Walls and Foundations
- Mechanical Ventilation Required
- Plumbing and Electrical Systems Have Exceeded Useful Service Life

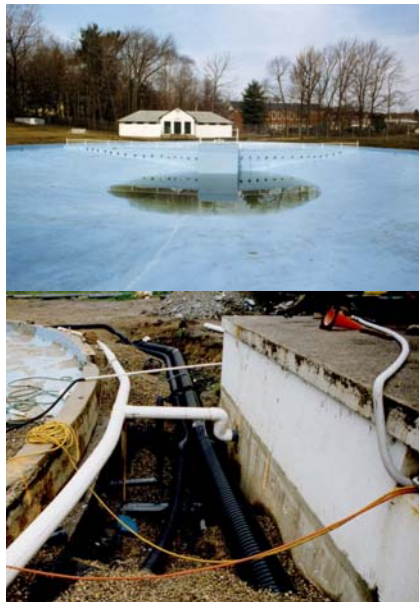
- 15,500 SF of Surface Area
- 425,000 Gallons
- Calculated Bather Load: 900 Bathers
- No Existing Surface Skimming
- Pool Profile Not Compliant with Pool
- Standards for Depth, Slope, and Segregation of Shallow and Deep Areas
- Pool Surface Is Difficult to Maintain
