# 3.1.4 EVALUATION OF EXISTING CONDITIONS

# 3.1.4 - EVALUATION OF EXISTING CONDITIONS

**RE: Historic Status, Belmont High School**

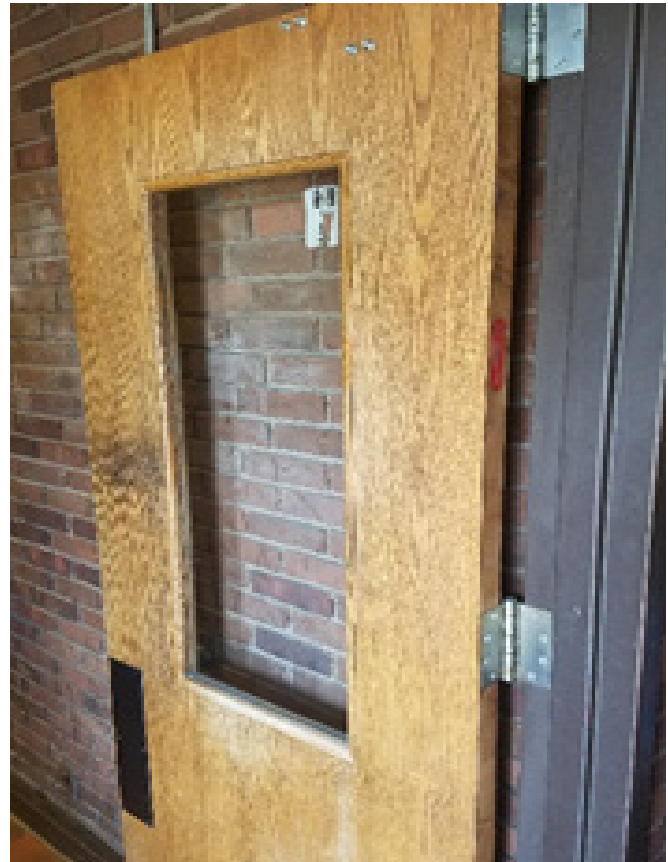
The existing exit stair enclosures consist of substantial construction with 90-minute doors containing wired glass. Over time the glass was damaged in many of the doors, and was replaced with non-wired/non-rated glass. Furthermore, several exit enclosure doors have broken latches. Regardless of the scope of work, all exit enclosures are required to be protected in accordance with one of the following:

Figure 3: Rated Stair Door with no Latch and Non-rated Glazing

- Where exiting doors remain with their original wired glass, functional latches, and are in good condition they are permitted to remain;
- Where exiting doors have broken, missing, or non-functioning latches, the latches are required to be repaired/replaced;
- Where existing doors no longer have wired glass, they are required to be replaced with 90-hour rated & labeled doors; or
- Omit the rating on the stair on the basis that there are only two interconnected levels (780 CMR 712.1.12 & 1019.3(1)). The implication of this approach is that where such stairs are unenclosed, the travel distance measurement is required to be taken down the stairs measured diagonally along the nosings until reaching an exit.

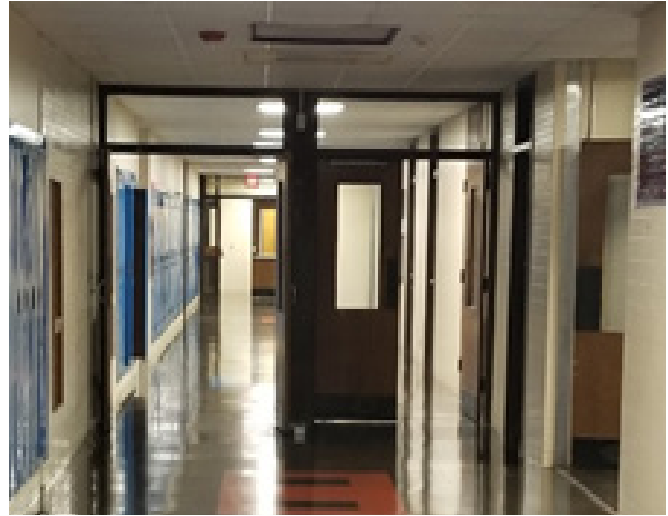
A majority of the existing cross corridor doors were measured to be 29-30" in clear width. In addition, multiple stair enclosure doors were measured to have clear widths of 29.5" – 31.5". All doors that are replaced or provided new as part of the project are required to comply with the following requirements:

Figure 5: 29.5" Wide Cross Corridor Doors

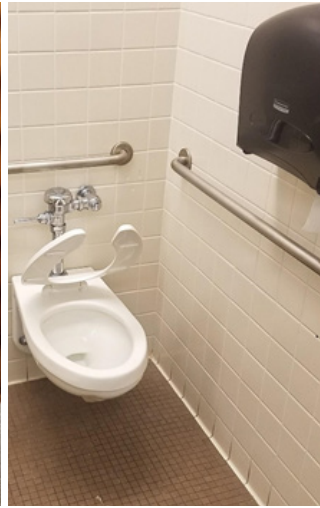
Figure 12: Toilet Paper Dispenser above Grab Bar

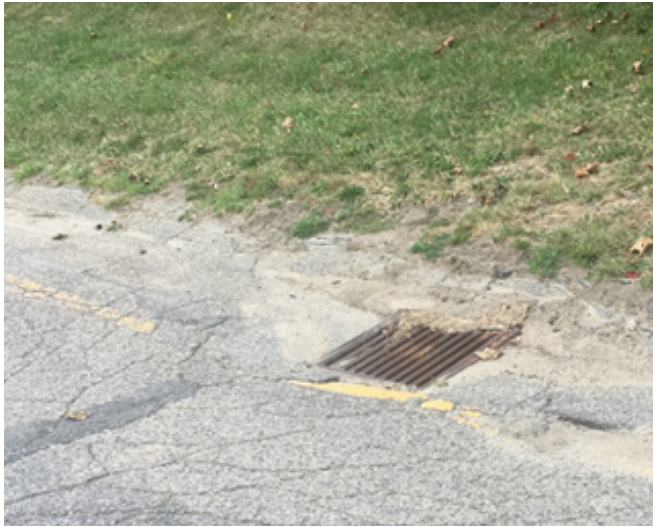
Figure 1: Catch Basin along the north of the School

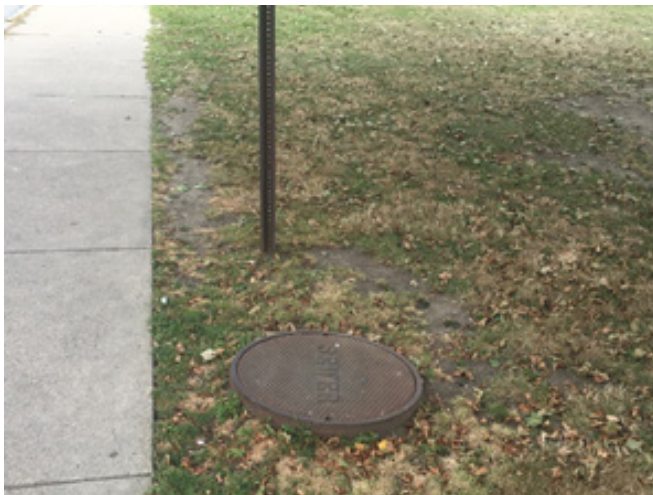
Figure 2: Sewer Manhole along the south of the School

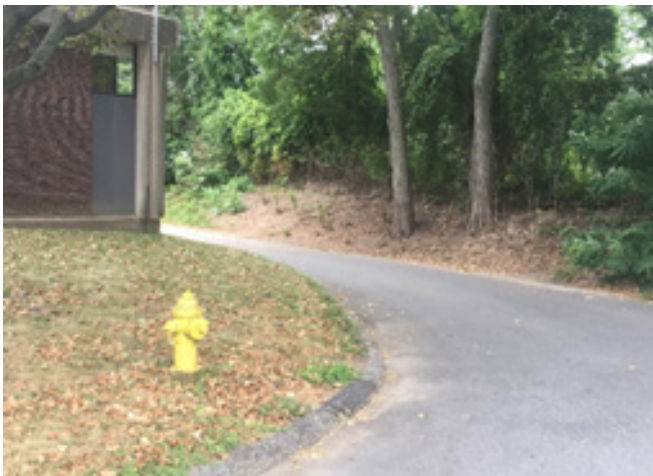
Figure 3: Fire Hydrant along the north of the School

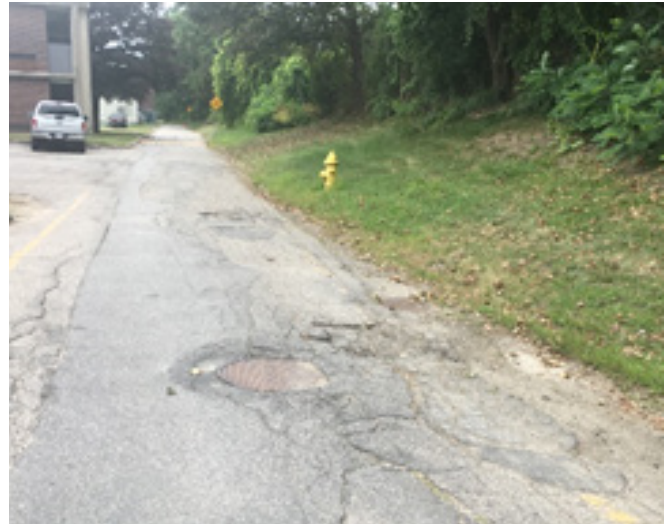
Figure 4: Fire Hydrant along the west of the School

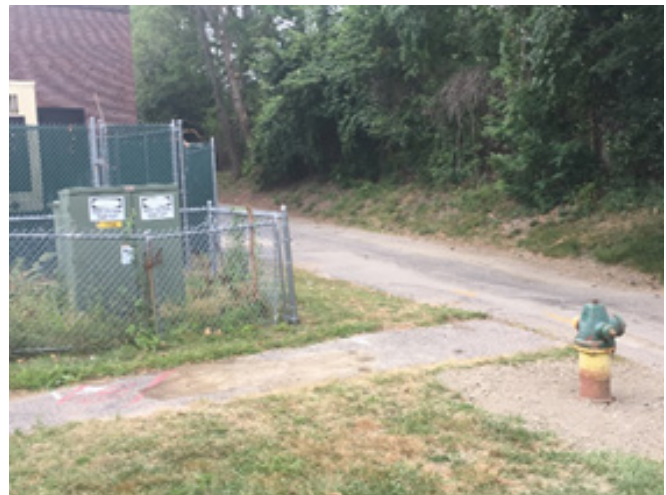
Figure 5: Fire Hydrant along the north of the School

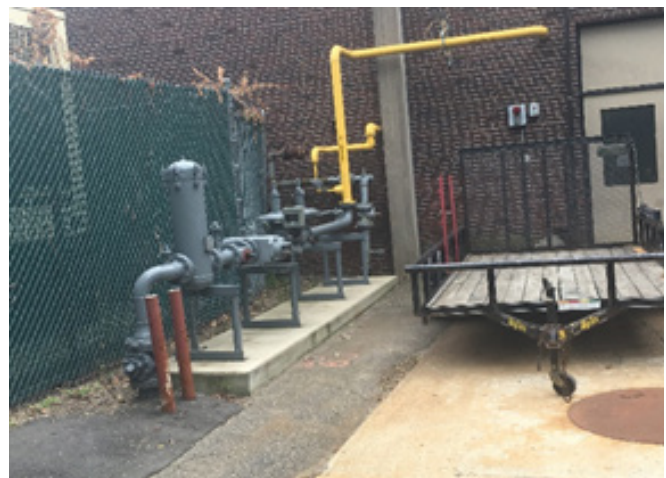
Figure 6: Gas meter along the north of the School

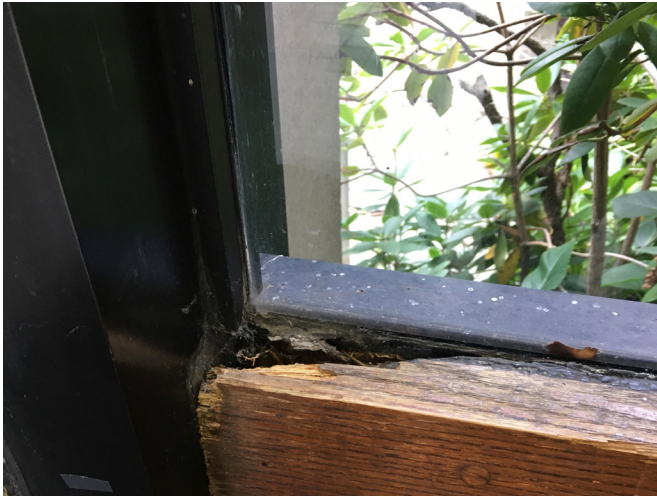
*Water damage at window*

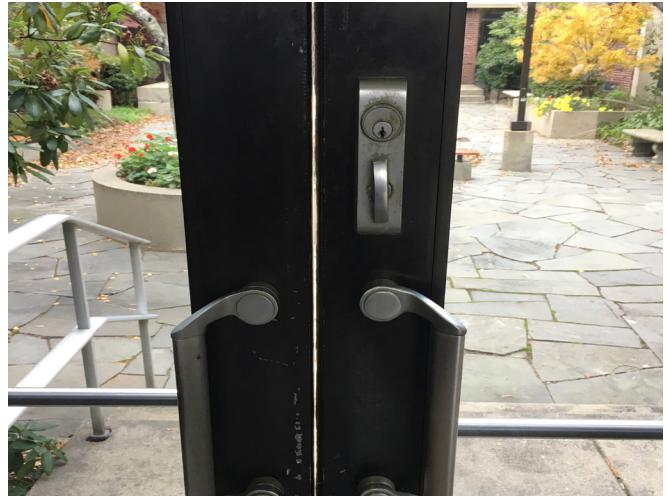
*No thermal barrier between doors*

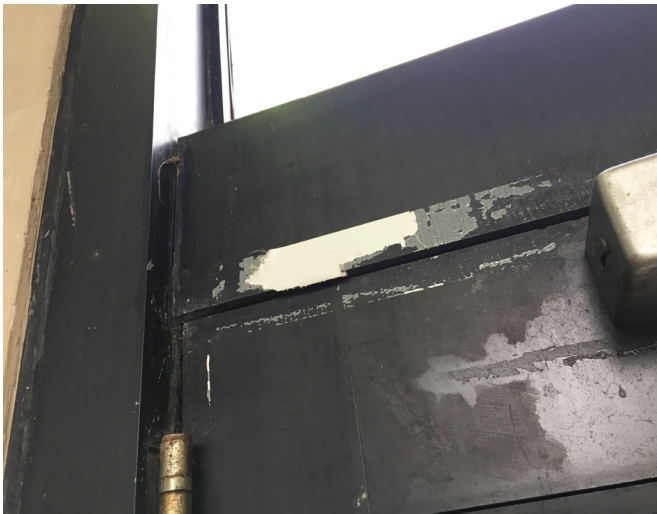
*Paint damage at the door*

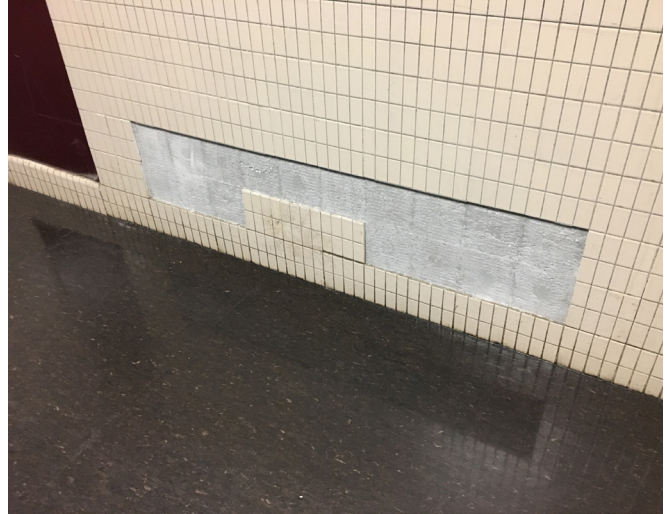
*Tiles falling off the wall*

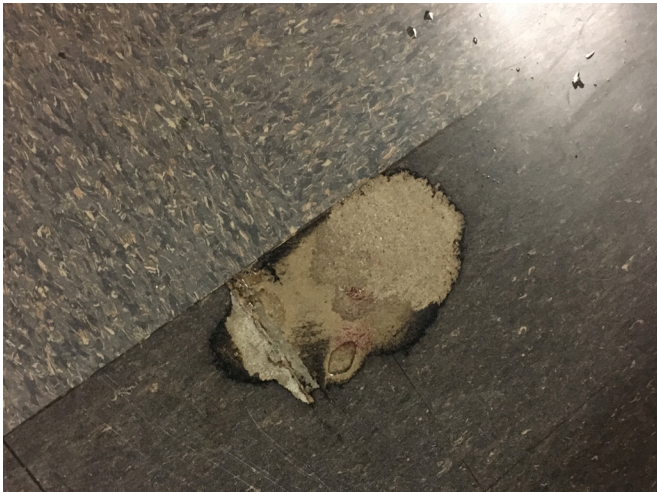
*Flooring worn out at door locations*

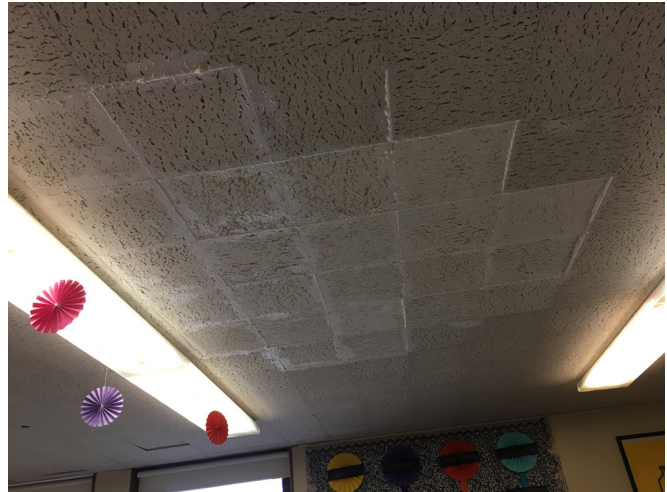
*Ceiling modification due to water damage*

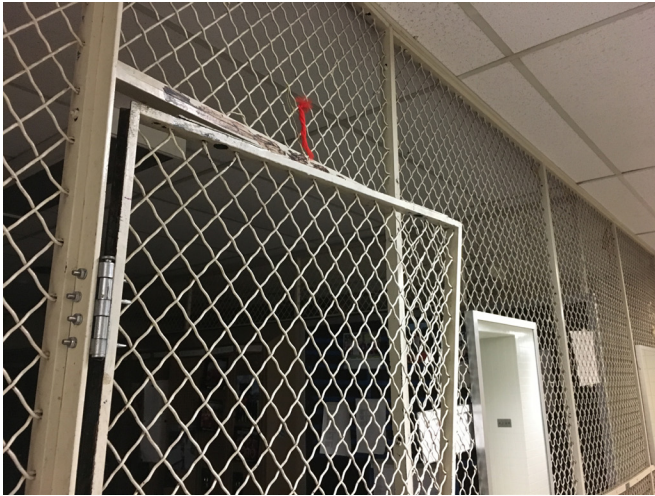
*Damaged locker room door*

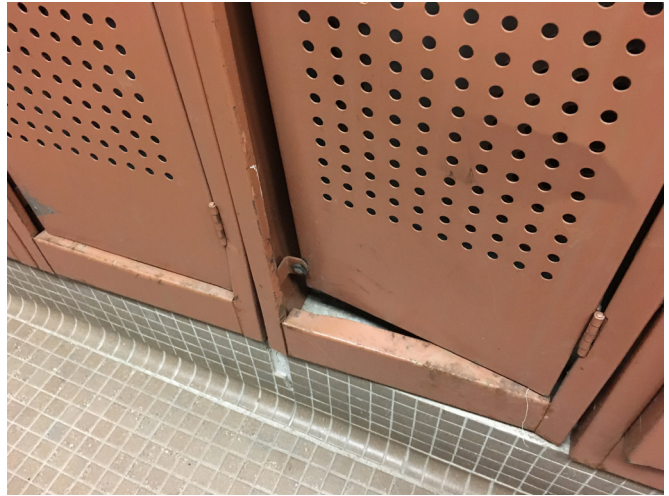
*Deformed locker door*

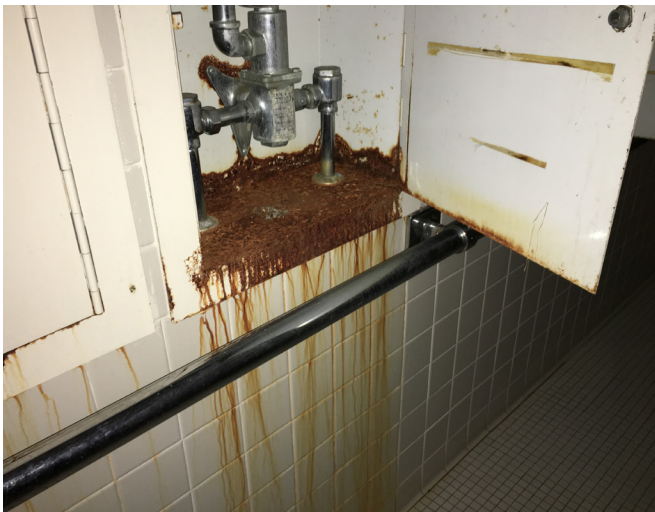
*Corroded piping and wall*

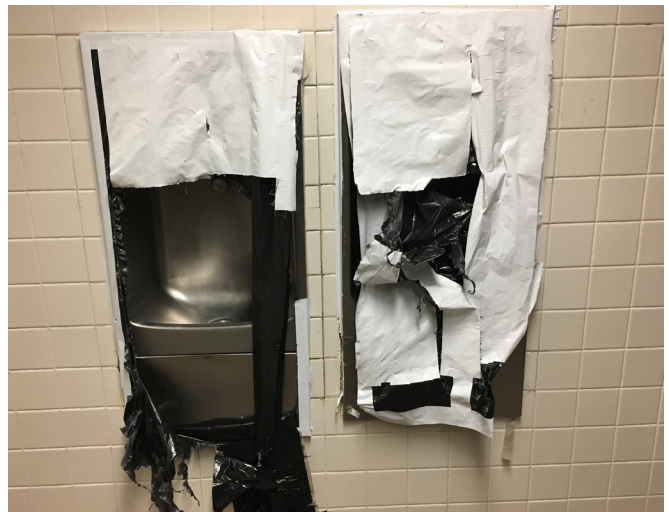
*Water faucets inoperable*

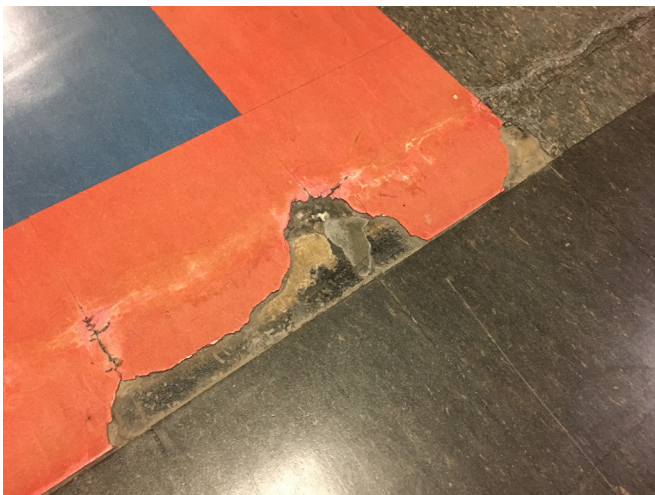
*Severe cracking of floor tile*

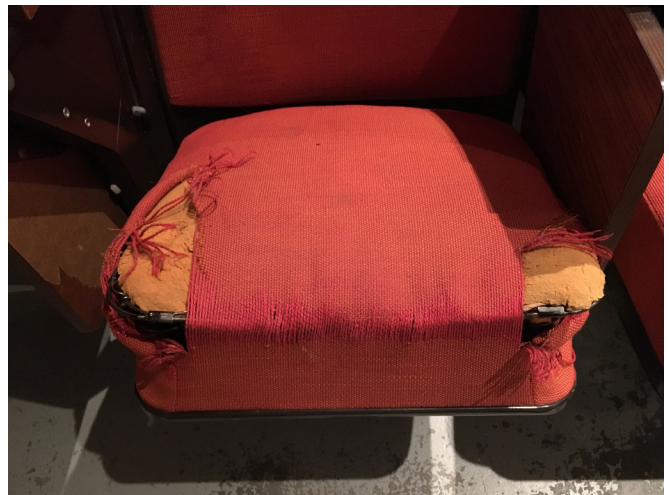
Coil Wall Partitions are broken and inoperable in most spaces. The Auditorium and Cafeteria folding partition is not usable - damaged and falling off its track. Auditorium seating shows signs of excessive use and fabric/cushion is falling apart in vast majority of seating. Numerous permeant Seats in small instructional rooms (wellness room) have been removed for handicap access and collaboration areas. Holes from removed seat hardware remain in flooring.

*Excessive damage to auditorium seat*

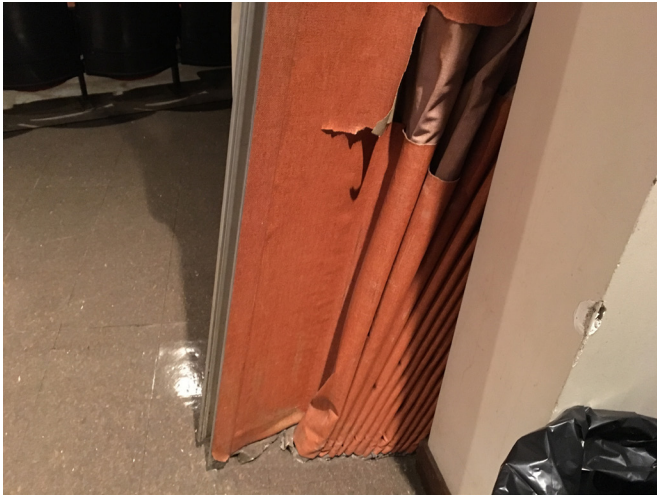
*Damaged coil Wall partitions in auditorium*

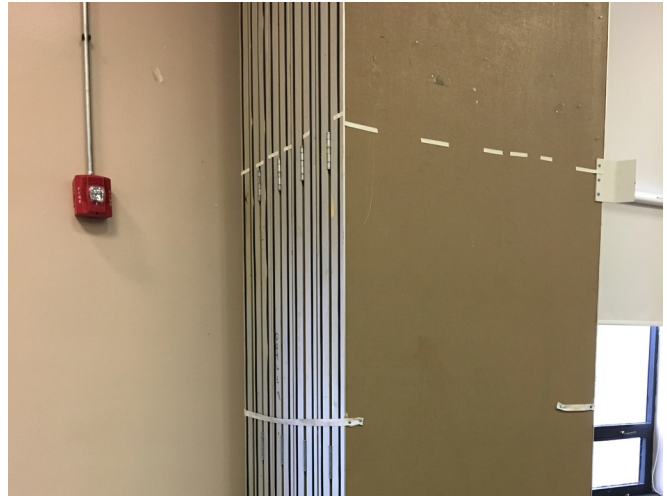
*Damaged coil Wall partitions in cafeteria*

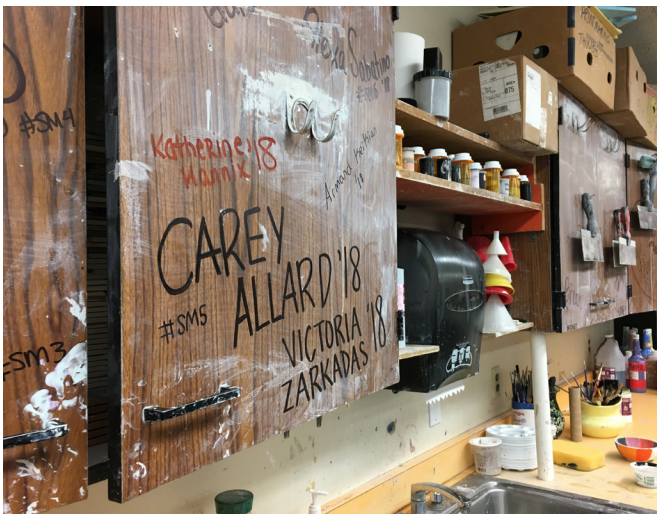
*Cabinet and shelves in deteriorated condition*

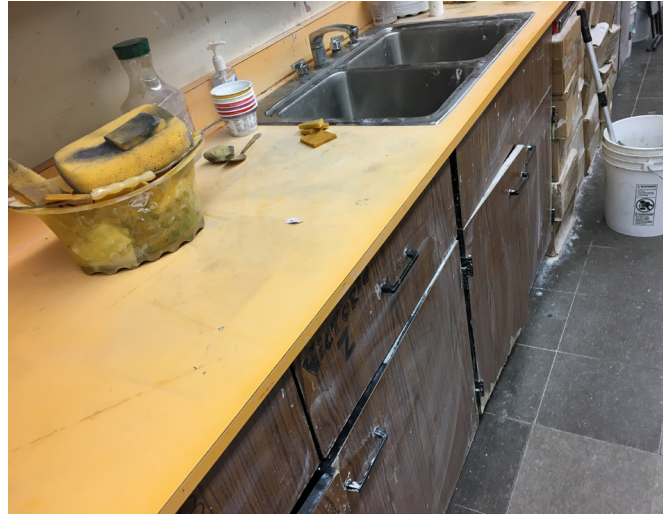
*Cabinet and countertop in deteriorated condition*

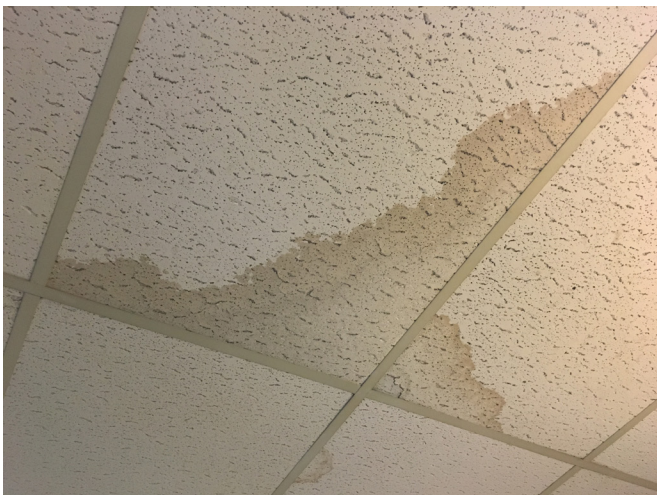
*Water damage at ceilings*

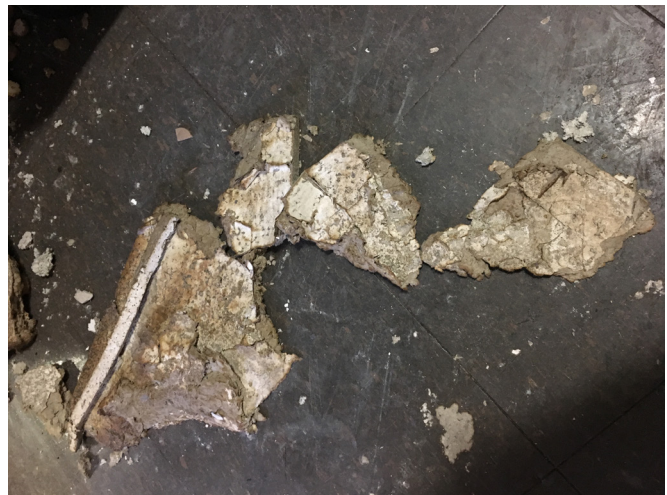
*Falling ceiling tiles due to water damage*

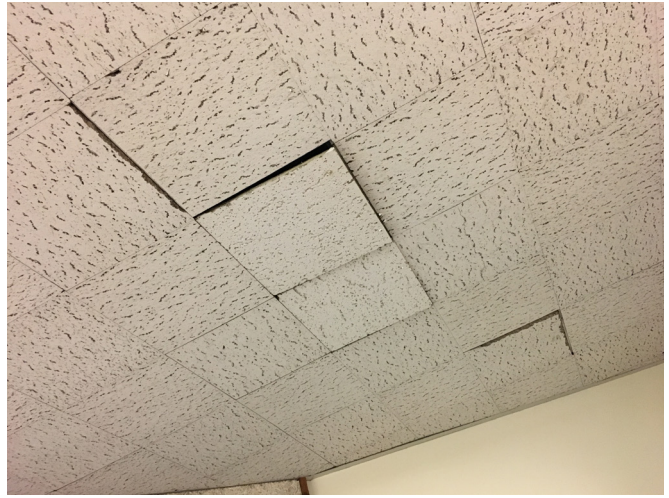
*Misaligned ceiling tiles*

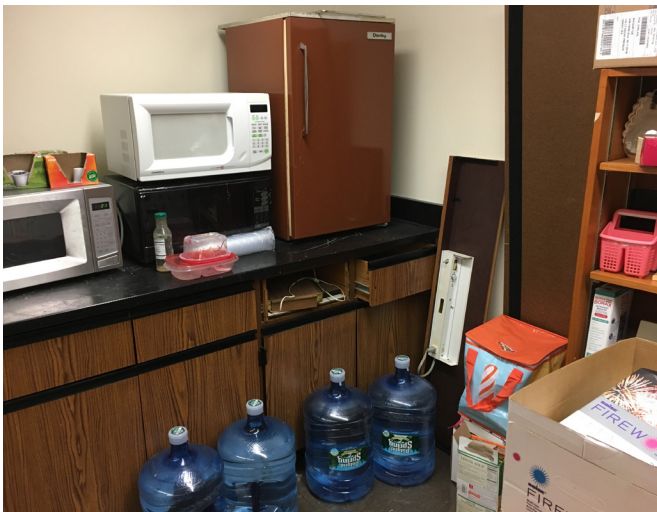
*Damaged cabinet drawers*

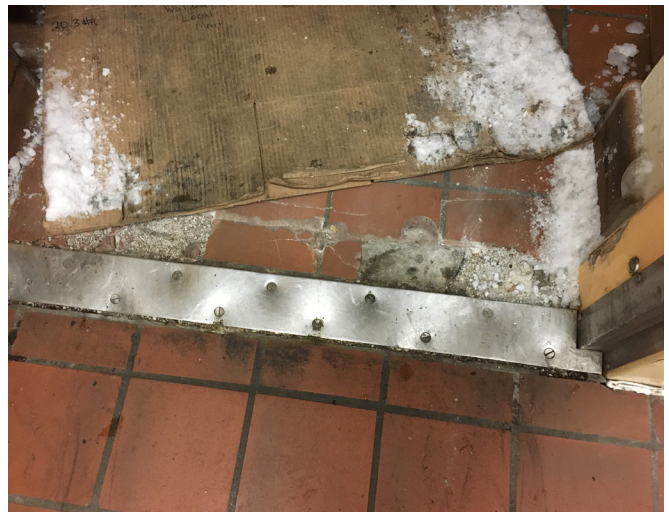
*Tile damage at kitchen freezer*

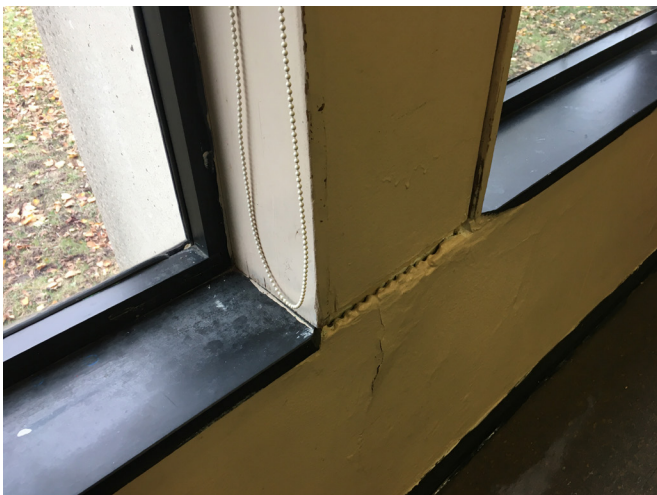
*Cracks in wall finish*

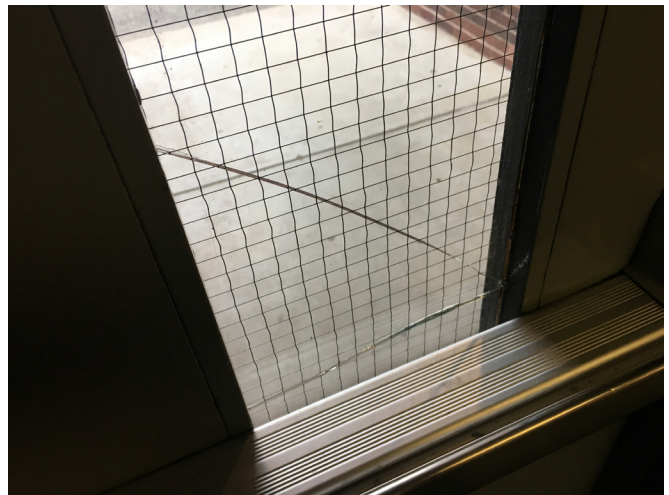
*Broken glass in window panel*

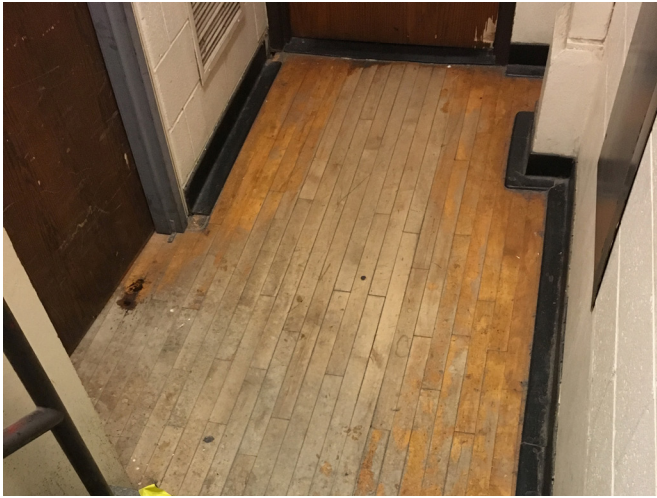
*Worn wood flooring at wood shop and orchestra room*

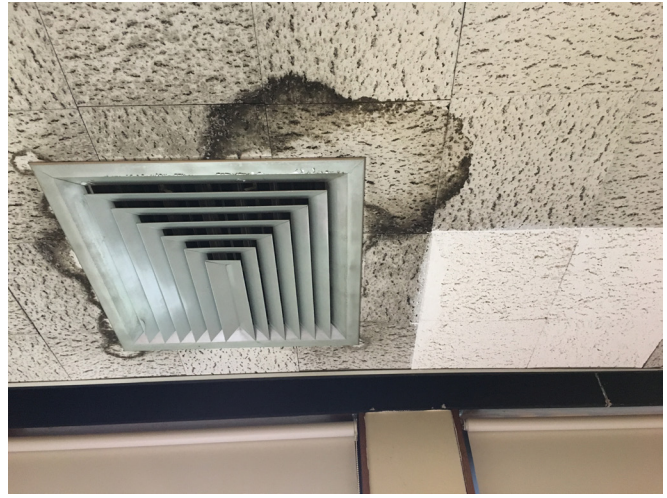
*Water damage at ceiling diffuser*

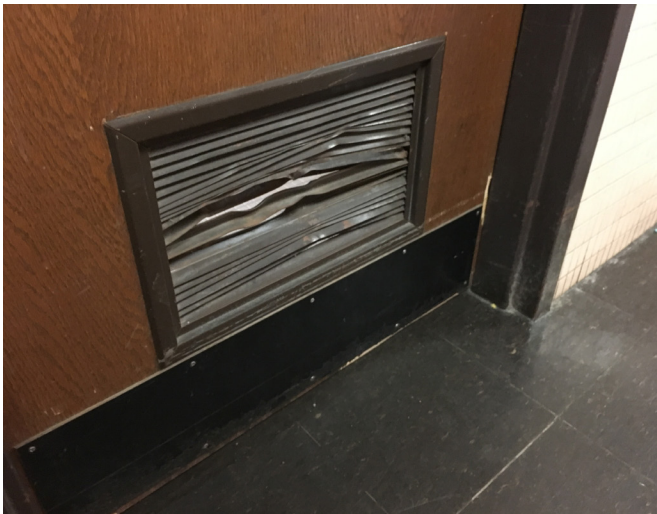
*Damaged door louver*

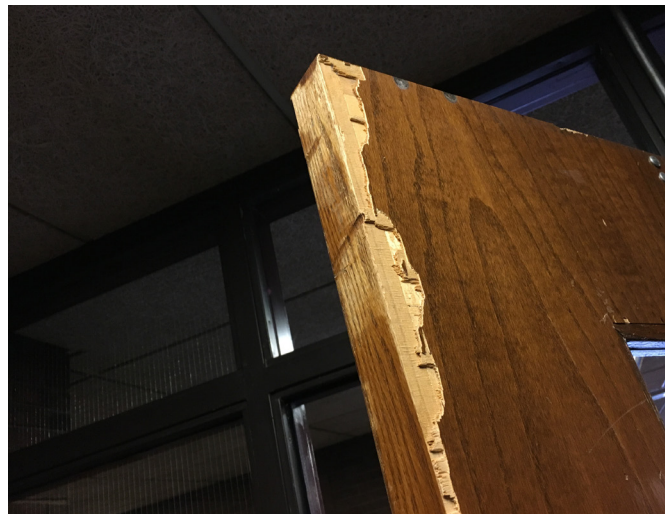
*Cracked and damaged wood doors*

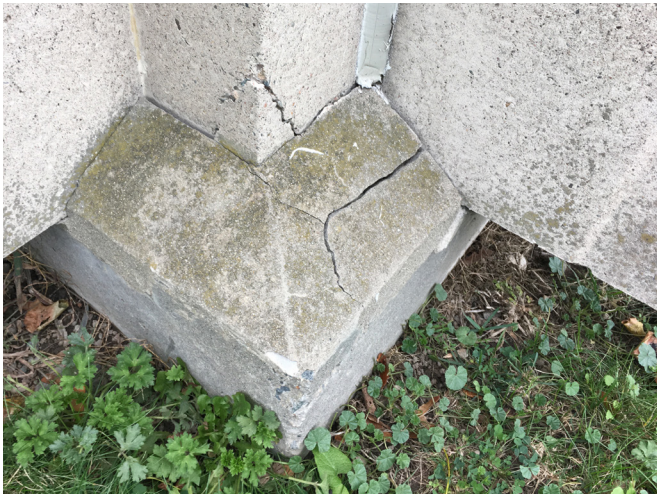
The exterior precast Concrete Lintels, Precast Concrete Columns and Concrete Platforms show signs of deterioration/crumbling around entire exterior perimeter. The composition panel window sills and air distribution louvers show signs of corrosion and deformation. Most of the brick masonry is visibly in good condition with minimal deterioration, but light fixtures are missing throughout exterior wall elevations with exposed wiring and holes. Aluminum glass frame and doors at main entry of school / courtyard area continually leak during rain storms as well as provide little climate controlled insulation. Much of the building roofing systems seem to be in good condition, but some of the colored aluminum fascia of theater is missing in certain locations, exposing the exterior plywood substrate.

*Deterioration throughout exterior concrete*

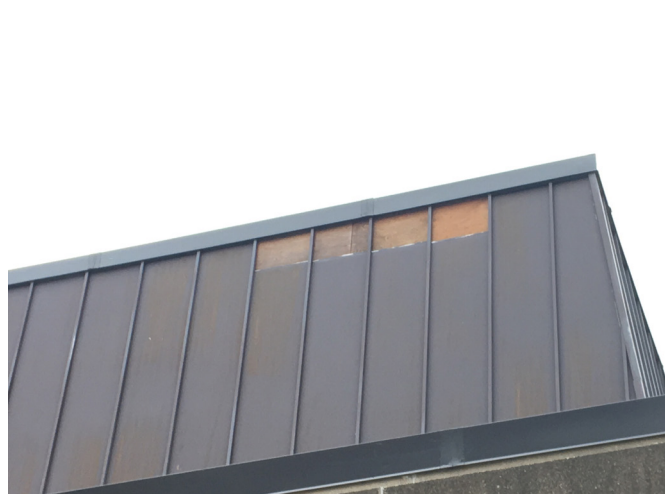
*Exposed exterior wood substrate at theatre*

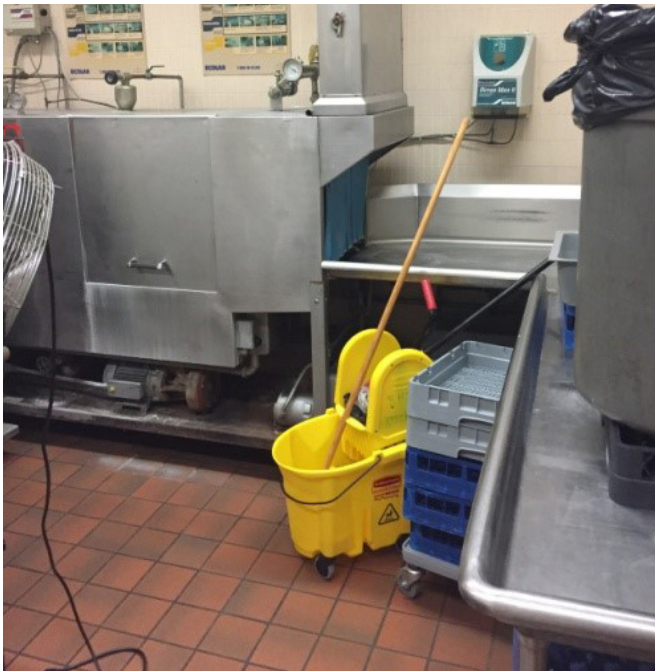
*The dish machine pictured is at least 10 years old. A new Energy Star rated unit will save a significant amount of water use, sewer cost and electrical demand.*

*This unit is near the end of its lifecycle.*

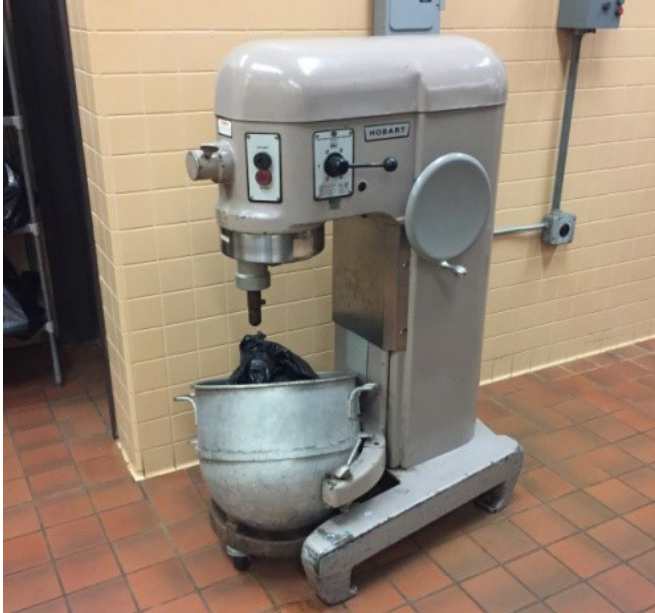
*This mixer should be replaced with the new unit that provides protective safety guards and stainless steel mixing bowls. The peeling paint on the body of the unit is not allowed by the board of health.*

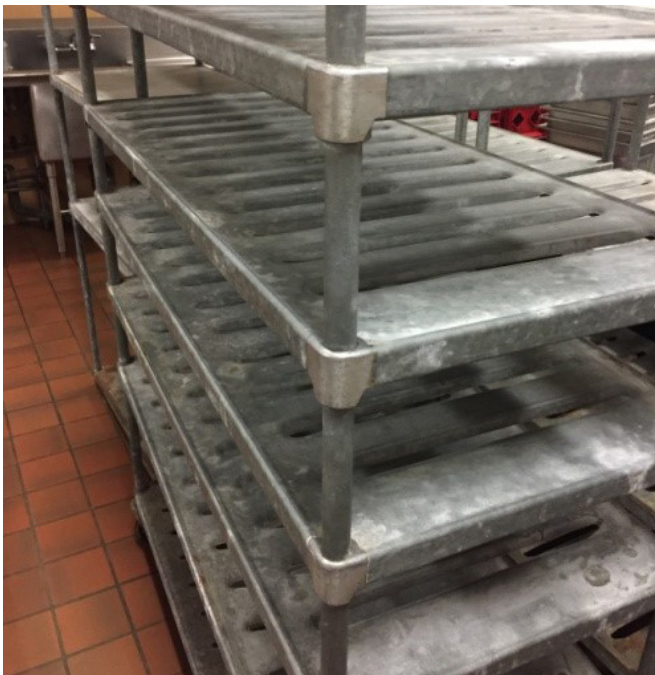
*Storage shelving made using galvalum is not resistant to chemicals and eventually corrodes as shown here. New shelving offers corrosion proof materials with easily removable sections that can be placed in a sink or dish washing machine for easy cleaning and sanitation must be exhausted from the room.*

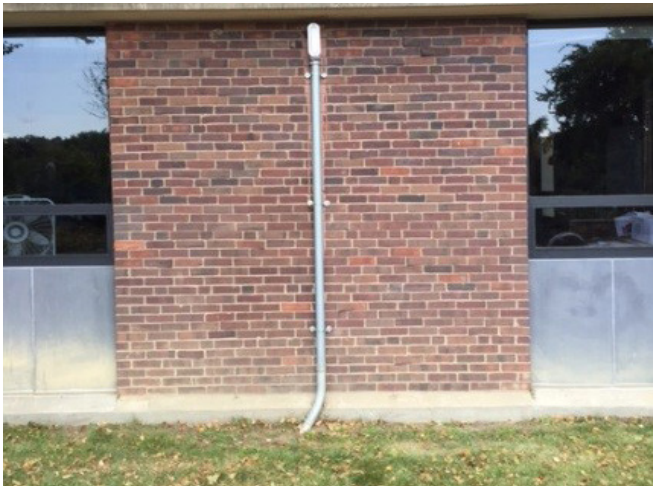
TELCO Entry Point

TELCO lines enter the high school underground at the front of the building, near the flagpole and are routed internally to a demarcation point near the main office. The demarcation point consists of several 110-blocks and cross connects on

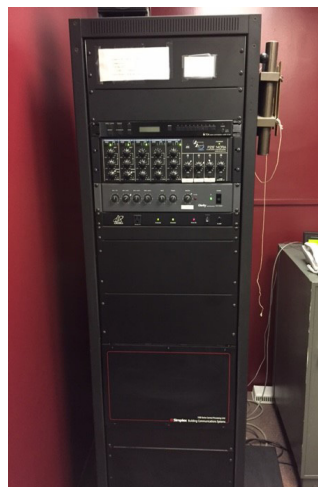
Intercom System in Office Area

The Intercom system is a Simplex 5100 Series Building Communication System. The master clock system is a Simplex 2350 Master Time System. The intercom main equipment is located in the Main Office. The master clock system is located in the TELCO demark, mounted on the voice termination wallboard. Any future project should provide a new system based on current technology.
