# MASTER PLAN AND FEASIBILITY STUDY FOR RENOVATIONS TO BELMONT HIGH SCHOOL

Submitted October 15, 2004

Design Partnership of Cambridge, Inc.  
Architects, Planners, Programmers  
Hood Business Park  
500 Rutherford Avenue  
Charlestown, MA 02129  
Robert Vogel, AIA

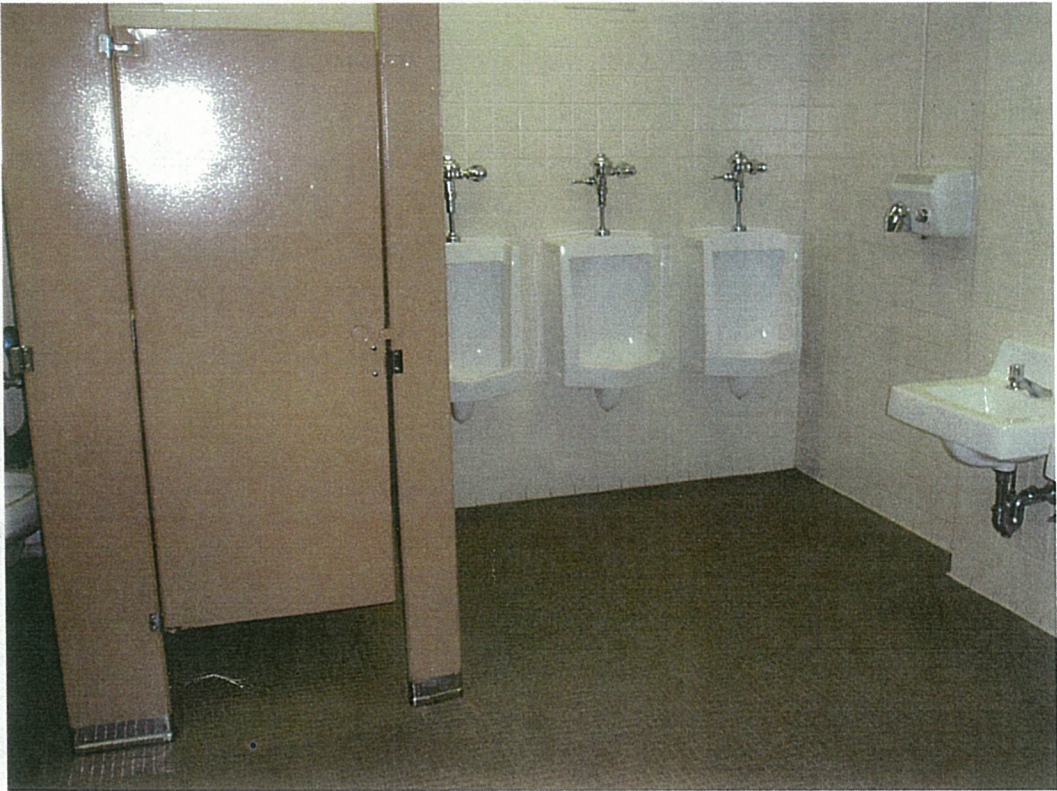
LOCKER ROOM TOILETS

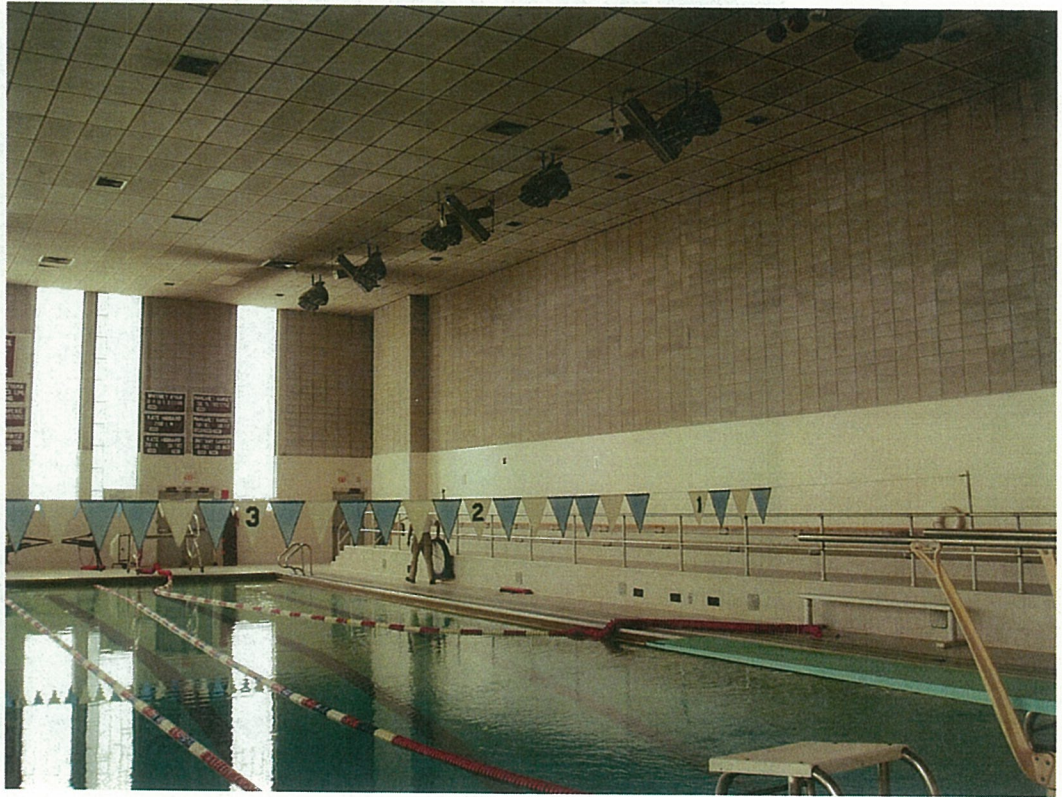
POOL HOUSE

- Pool area requires new pool filtration system, replacement of translucent panels, and upgrades to ventilation and locker rooms
- Analysis of the adequacy of office space and staff/program support spaces (conference/workroom/copy center/etc.)

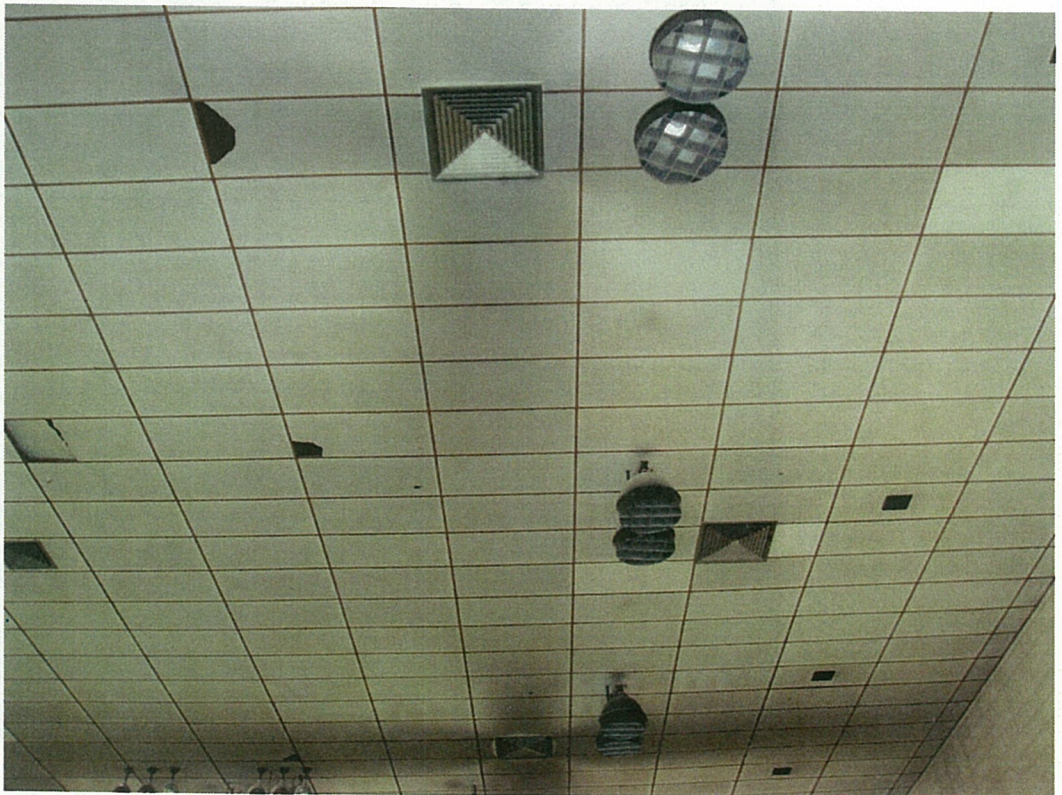
POOL HOUSE CEILING

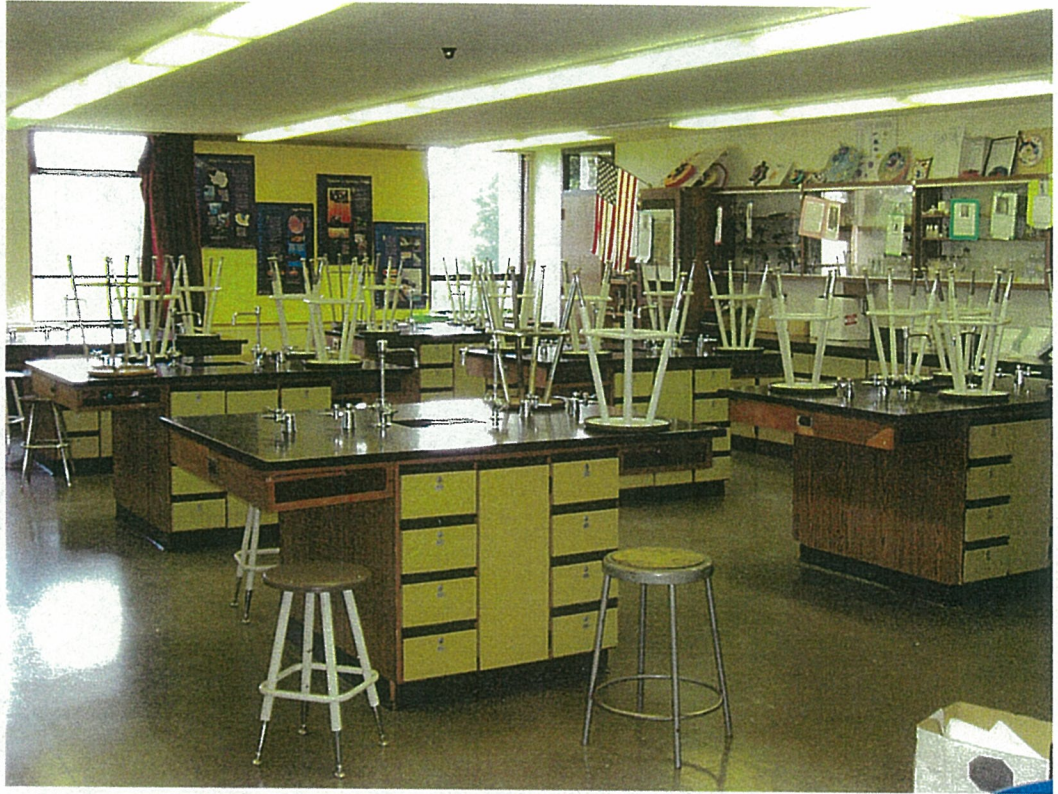
SCIENCE LABORATORY

- Replan and re-equip all Science Labs and Art Studios.
- Cure water infiltration into lower level of “Little Theater”; equip this space for use by Drama Department.

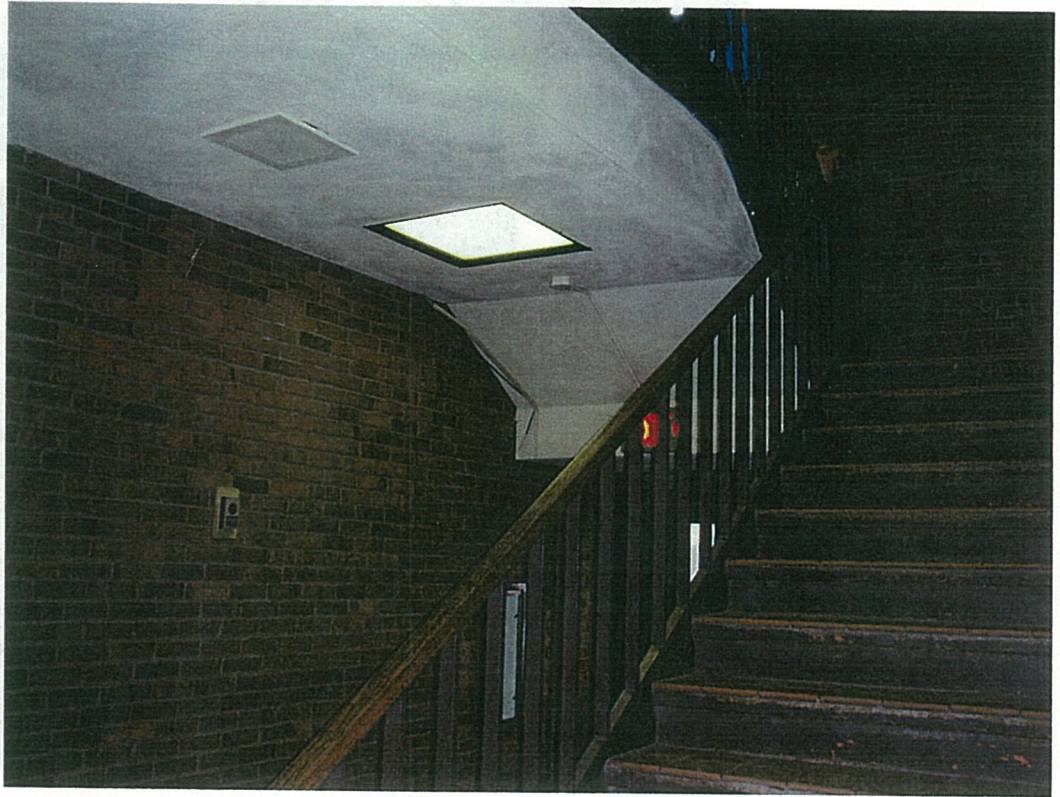
TYPICAL STAIR

- For all stairs, balconies and mezzanines, replace or add to existing railings to conform to present life-safety and barrier-free access codes.
- Add new riser covers to all stairs.

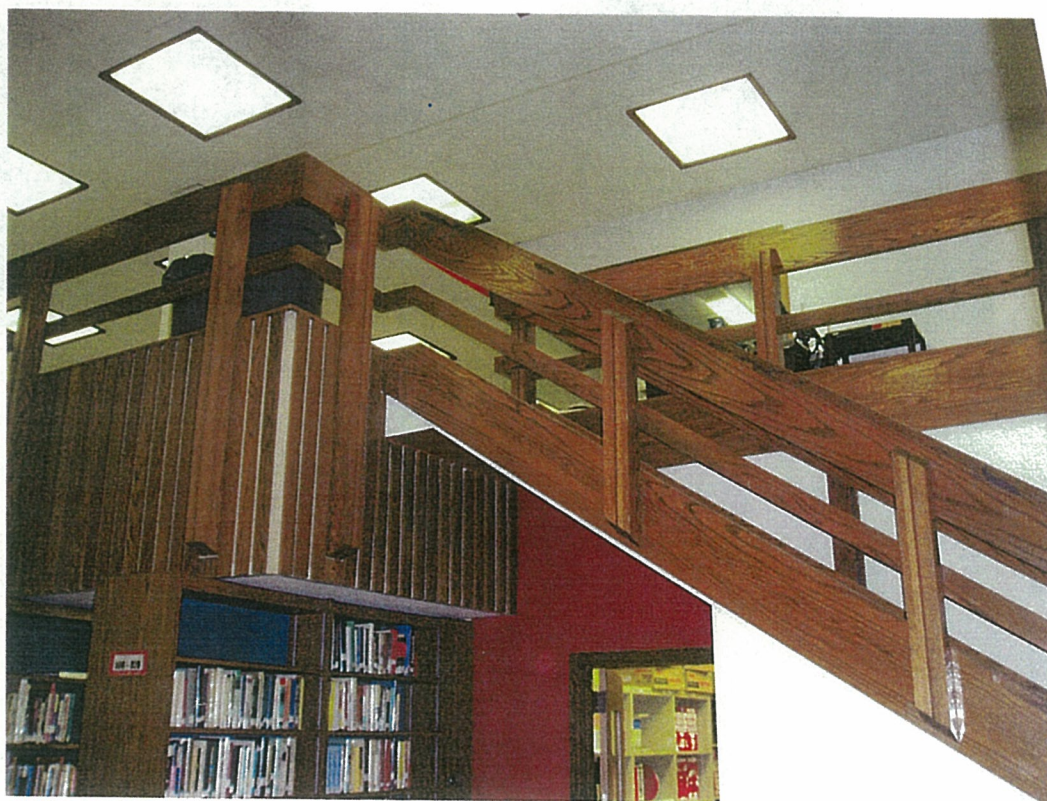
LIBRARY STAIRS LEADING TO MEZZANINE

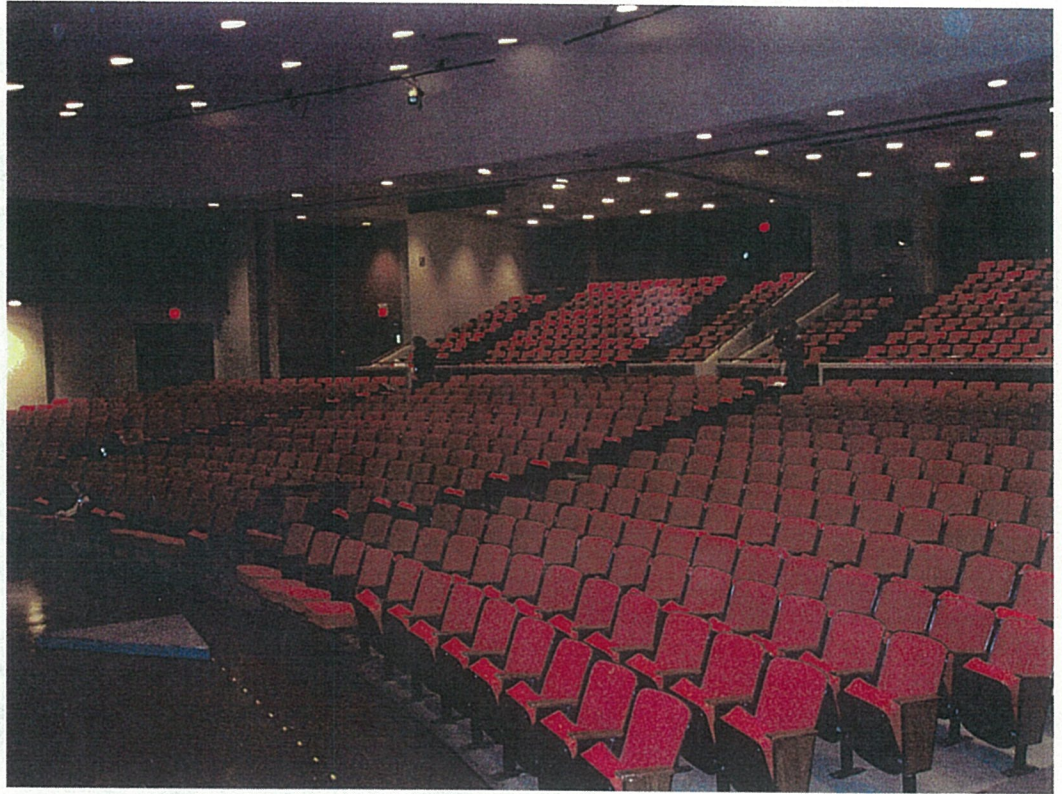
AUDITORIUM

- Redesign “Little Theater” and add lift for barrier-free access.
- Replace all carpet throughout building.
- In the Main Auditorium, remove ceiling as noted above and replace with acoustically tuned “clouds”.

- Replace Stage rigging and curtains.
- Replace Auditorium seating.
- Provide barrier-free access from cross-aisle level of audience chamber and also from lower level to Stage.

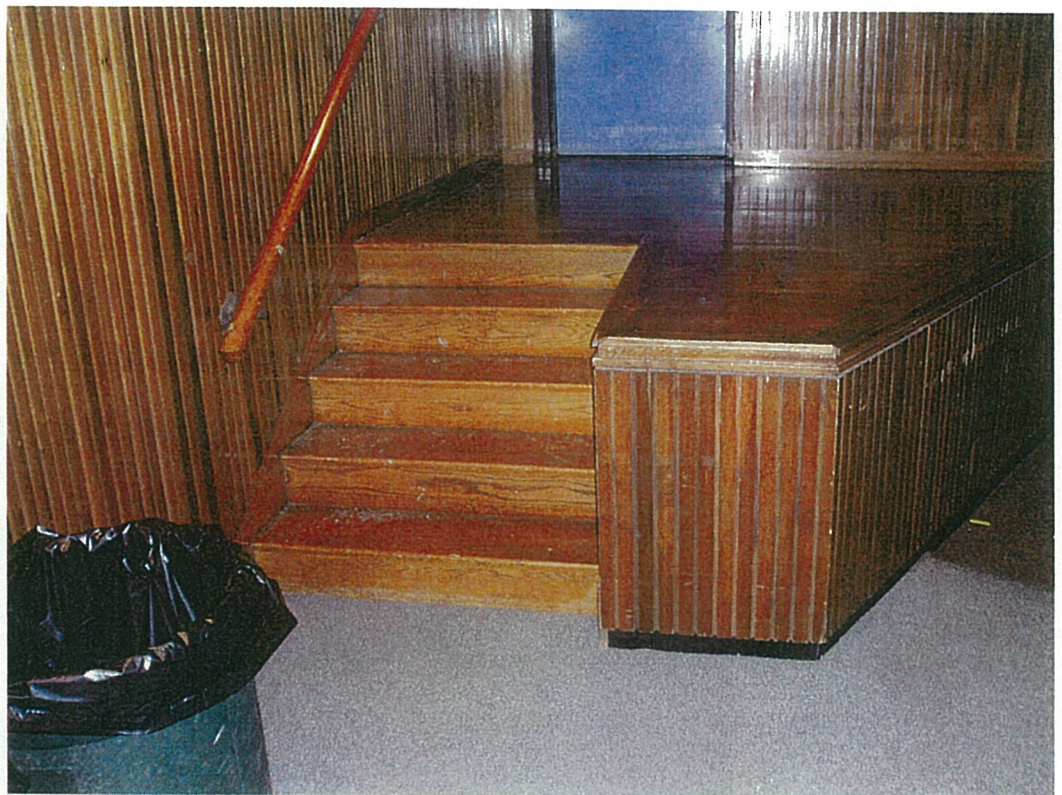
ACCESS TO STAGE

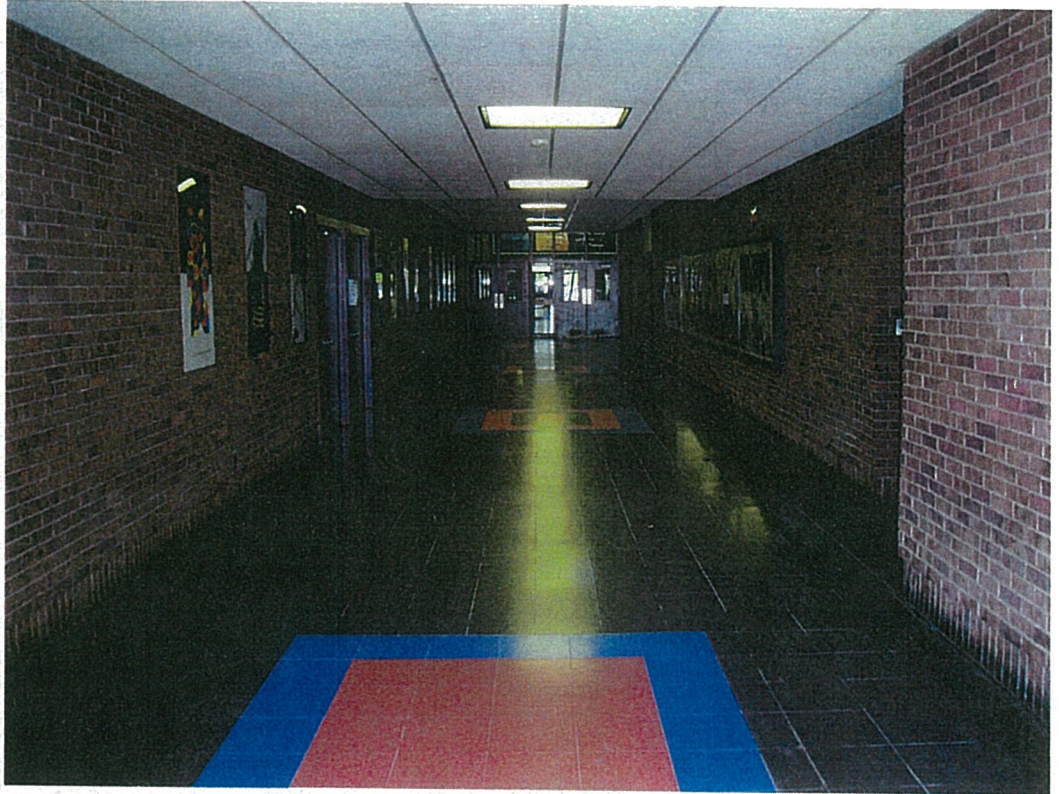
AUDITORIUM ENTRANCE CORRIDOR

- The Auditorium Lobby and the Corridor leading to it, spaces of frequent and significant community use, should be enlarged, enhanced and provided with a Ticket and/or Coat Room and direct access to food service opportunities.

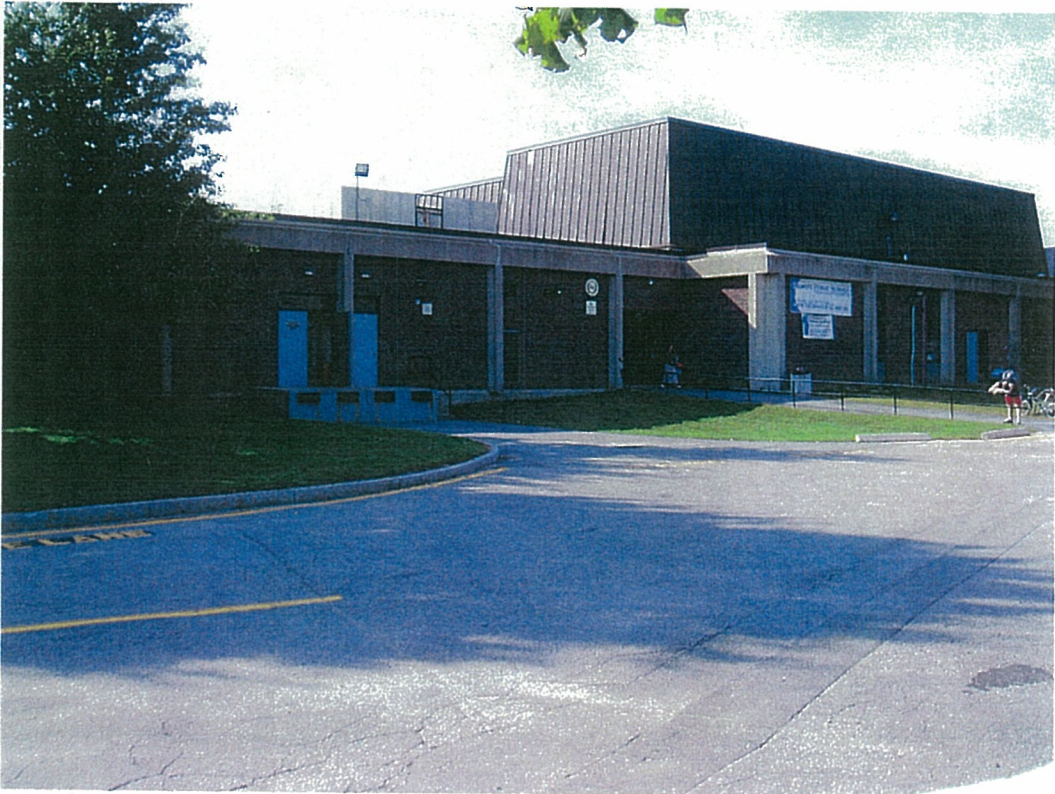
ENTRANCE TO AUDITORIUM FROM PARKING AREA

- The entrance from the parking lot leading to the Auditorium should similarly be visually and functionally upgraded in view of its heavy use.

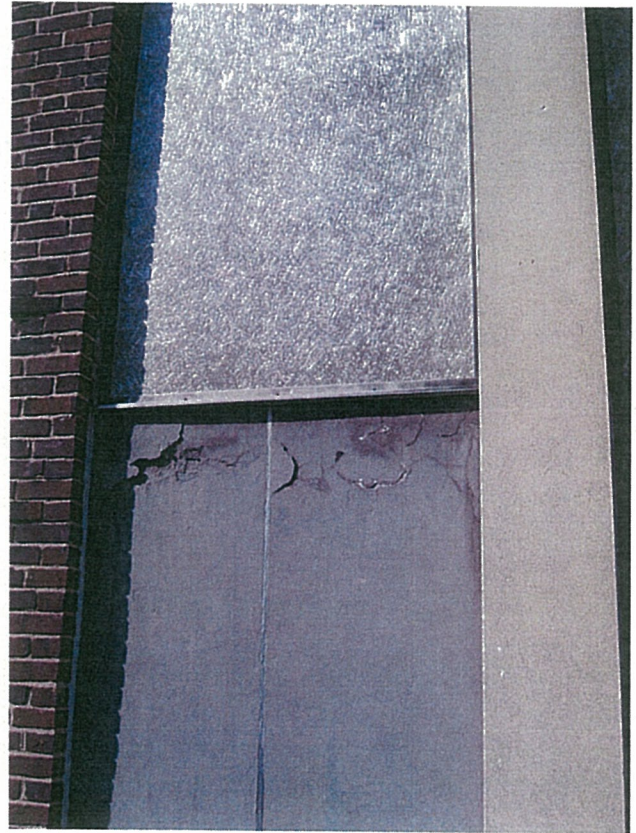
“TRANSITE” PANELS

- Abate asbestos spray-on fireproofing, fire doors, caulking, “transite” panels, pipe insulation, etc.
- Remove all ceilings to access asbestos, pipe and electrical runs, etc. and replace with new.
- Remove all vinyl-asbestos floor tiles and replace with new.
- Replace “Kalwall” panels in Fieldhouse and Pool House exterior walls.
- Replace all windows.
- Replace all exterior doors.
- Replace some interior doors that are damaged and fire doors with asbestos cores.
- Replace all door hardware for barrier-free access.
- Repaint all interior surfaces.
- Replace all athletic and student corridor lockers.

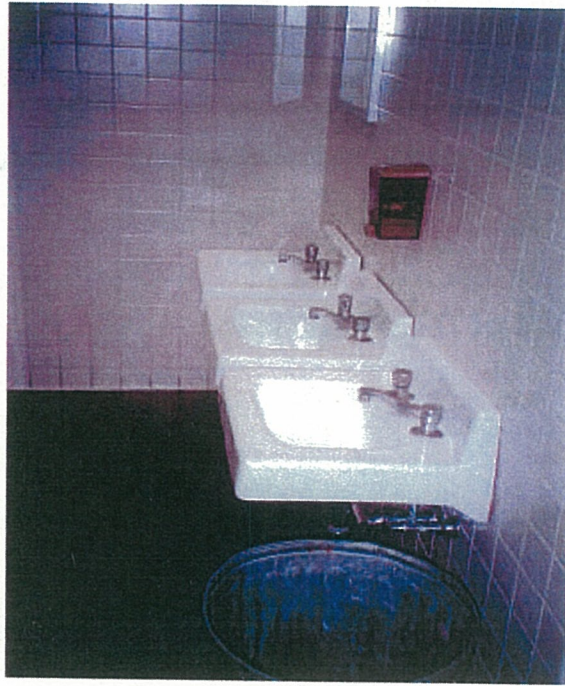
Picture 3

Lavatories are wall hung with separate hot water and cold water metering/push handles. Although the faucets are metering type, they do not have a temperature limiting device (see photograph #3).

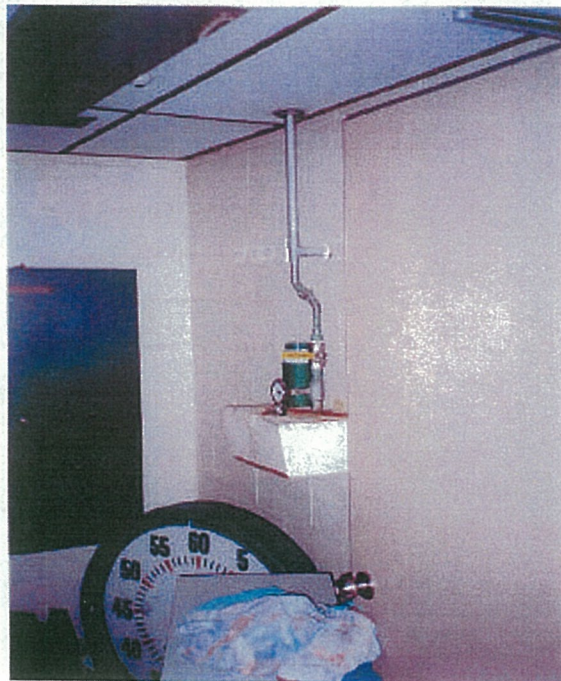
Picture 10

The pool showers are set up similar to the boys locker room showers. There are two separate shower areas. Each shower area is controlled by a master mixing valve, which is located in the coaches room between each shower (see photograph #10). Each shower area has a single floor drain with multiple shower heads (see photograph #11). This does not meet current sanitary codes.

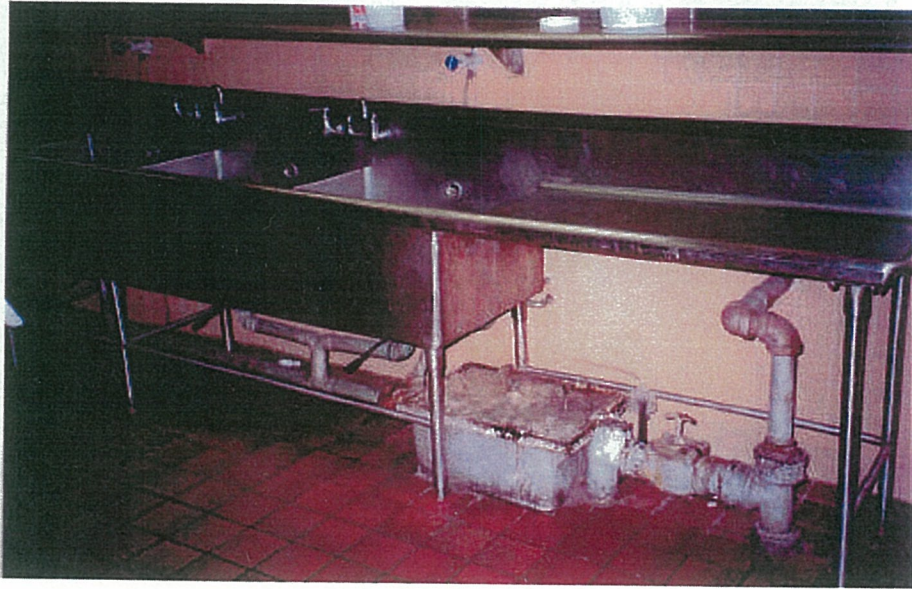
Picture 13

The triple compartment sink is connected to a code required grease interceptor (see photograph #13). The interceptor is mounted on the floor below the triple compartment sink. The grease interceptor appears to be maintained properly.

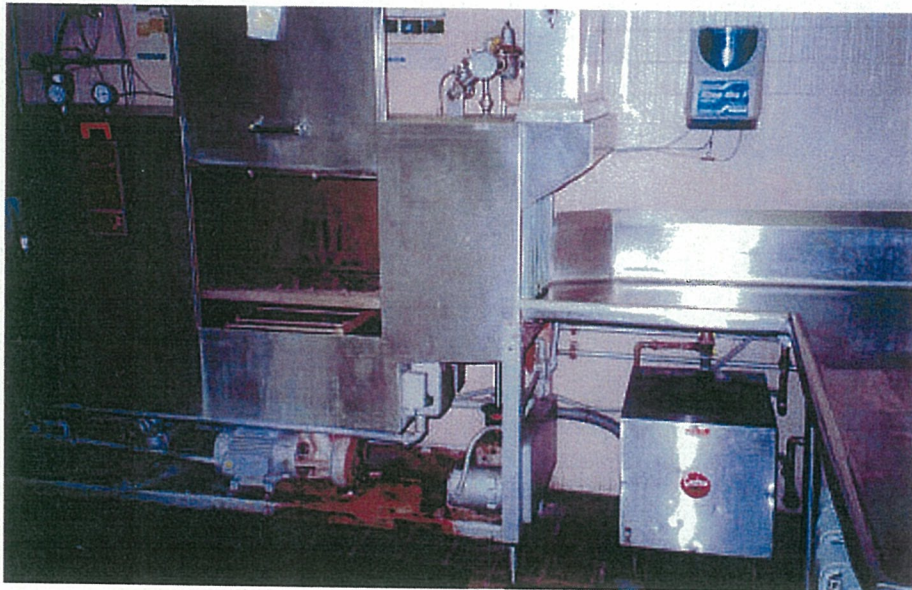
Picture 14

The existing dishwasher is a conveyor type with an electric booster. 140° hot water is being delivered to the washer and the booster is raising the temperature to 180° (see photograph #14). The washer also has a grease interceptor installed on the waste line exiting the washer (see photograph #15). Current engineering practice is to not install the grease interceptor due to the water exiting the dishwasher being 140°. Any grease would simply flow through the grease interceptor.

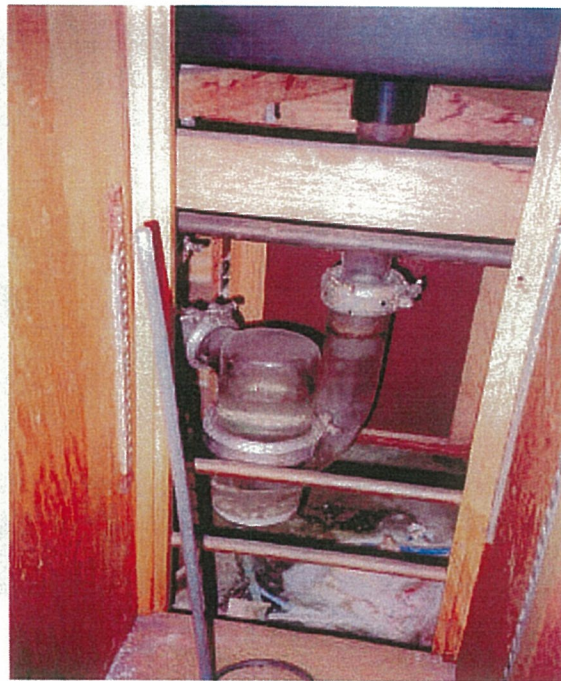
Picture 16

Plumbing services to the science wing are in fair condition. Currently the waste from the science wing is completely separate from the standard sanitary system, but does not have an acid neutralization system, which is in code violation. The waste piping that could be observed was glass pipe (see photograph #16). There are also drum traps installed at all sinks, which is not acceptable by current code. The acid waste system exits the building separately and the existing plans show the acid waste line connecting to the standard waste outside the building. The acid vent system is also separated from the standard venting system. The acid vent penetrates the roof separately from the standard venting system.

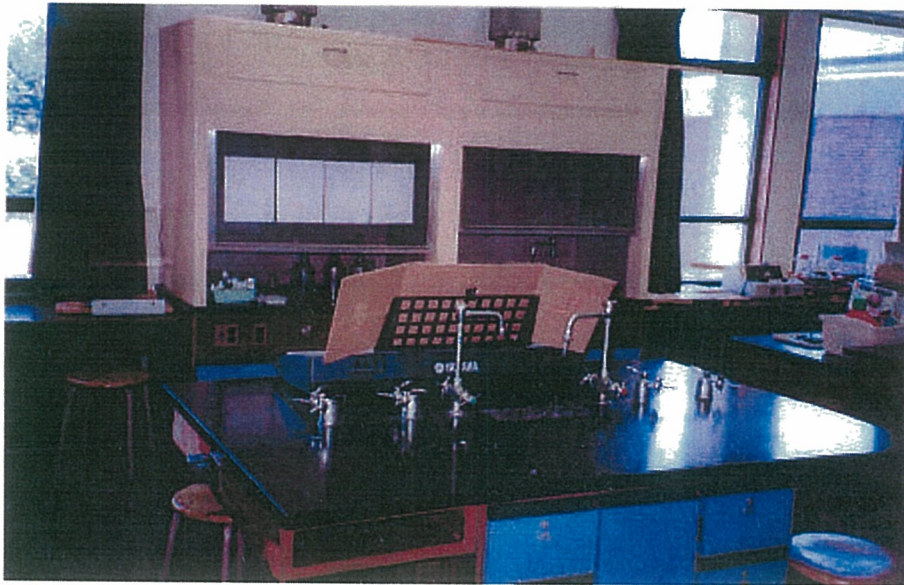
Picture 17

The domestic hot and cold water to all lab faucets is connected to the same system as the rest of the building. There is not a separate non-potable water system. The system is protected by vacuum breakers on each faucet, which is an acceptable method of backflow prevention (see photograph #17). The faucets are in fair condition, but there were locations where some faucets were damaged.

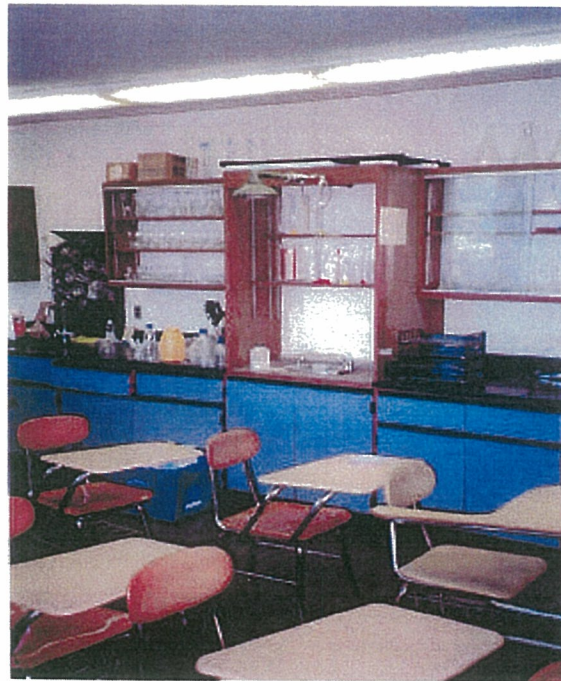
Picture 18

Each science room is provided with an emergency shower, however, each shower is fed by cold water, and is located away from the entry door (see photograph #18). Currently code requires emergency showers to be fed with tempered water and to be located adjacent to the entry door.
