To: Belmont Historic District Commission  
Re: Proposed Repair to Front Vestibule and Rear Deck at 596 Pleasant Street, Belmont

## ENTRY VESTIBULE

**Patalas/Schaffer Residence**  
 596 Pleasant Street  
 Belmont, MA

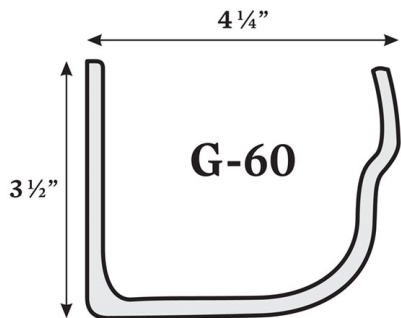
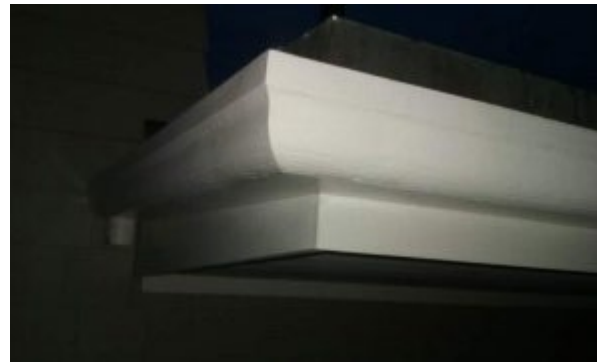
The product to be used is Fiberglass Gutter Company profile G-60 as shown below, finished with a gel coat to match the existing color.

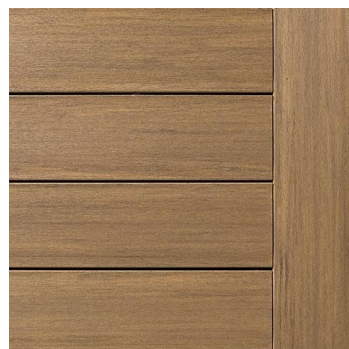
TimberTech Azek in Weathered Teak

The current decking is a composite product and will be replaced in kind. The product selected is TimberTech Azek in Weathered Teak.

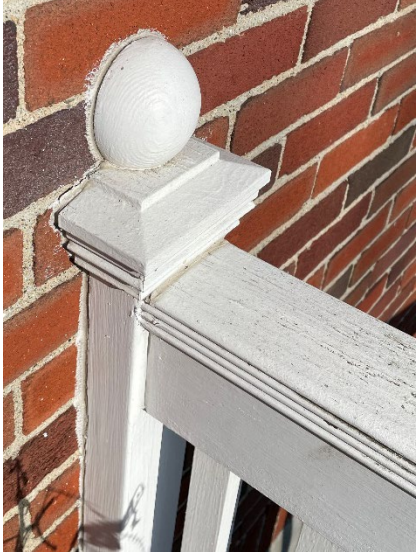
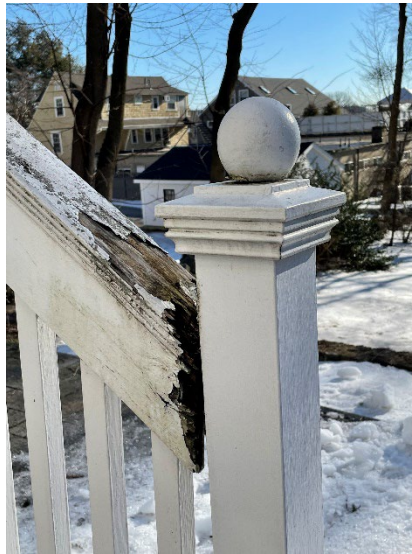
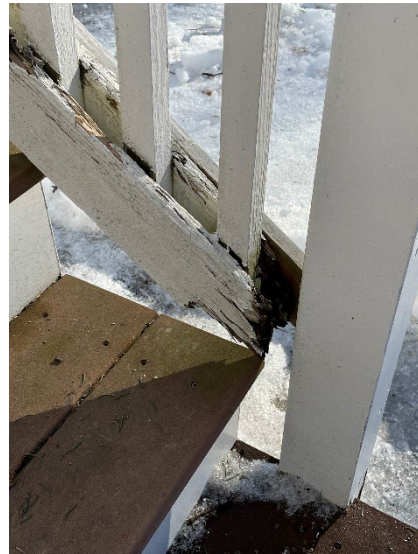
TimberTech Premier Rail in Matte White; 3/4" square balusters

TimberTech TX4X4ICAPW 4x4 Island Post Cap

TimberTech AZT4X4PSKIRTW 4x4 Post Skirt

While the existing posts are face mounted, the new ones will be deck mounted, with TimberTech 4"x4" composite post sleeves and 3/4" square balusters to maintain existing proportions. Post bases, caps, and ball finials will be applied per selections shown below. The rail requires a new midpoint post for structural integrity, so a new handrail will be installed inboard of the guard to provide a continuous graspable rail per code.
