SCHEMATIC DESIGN

TOWN OF BELMONT

BELMONT RINK & SPORTS FACILITY

March 9, 2023

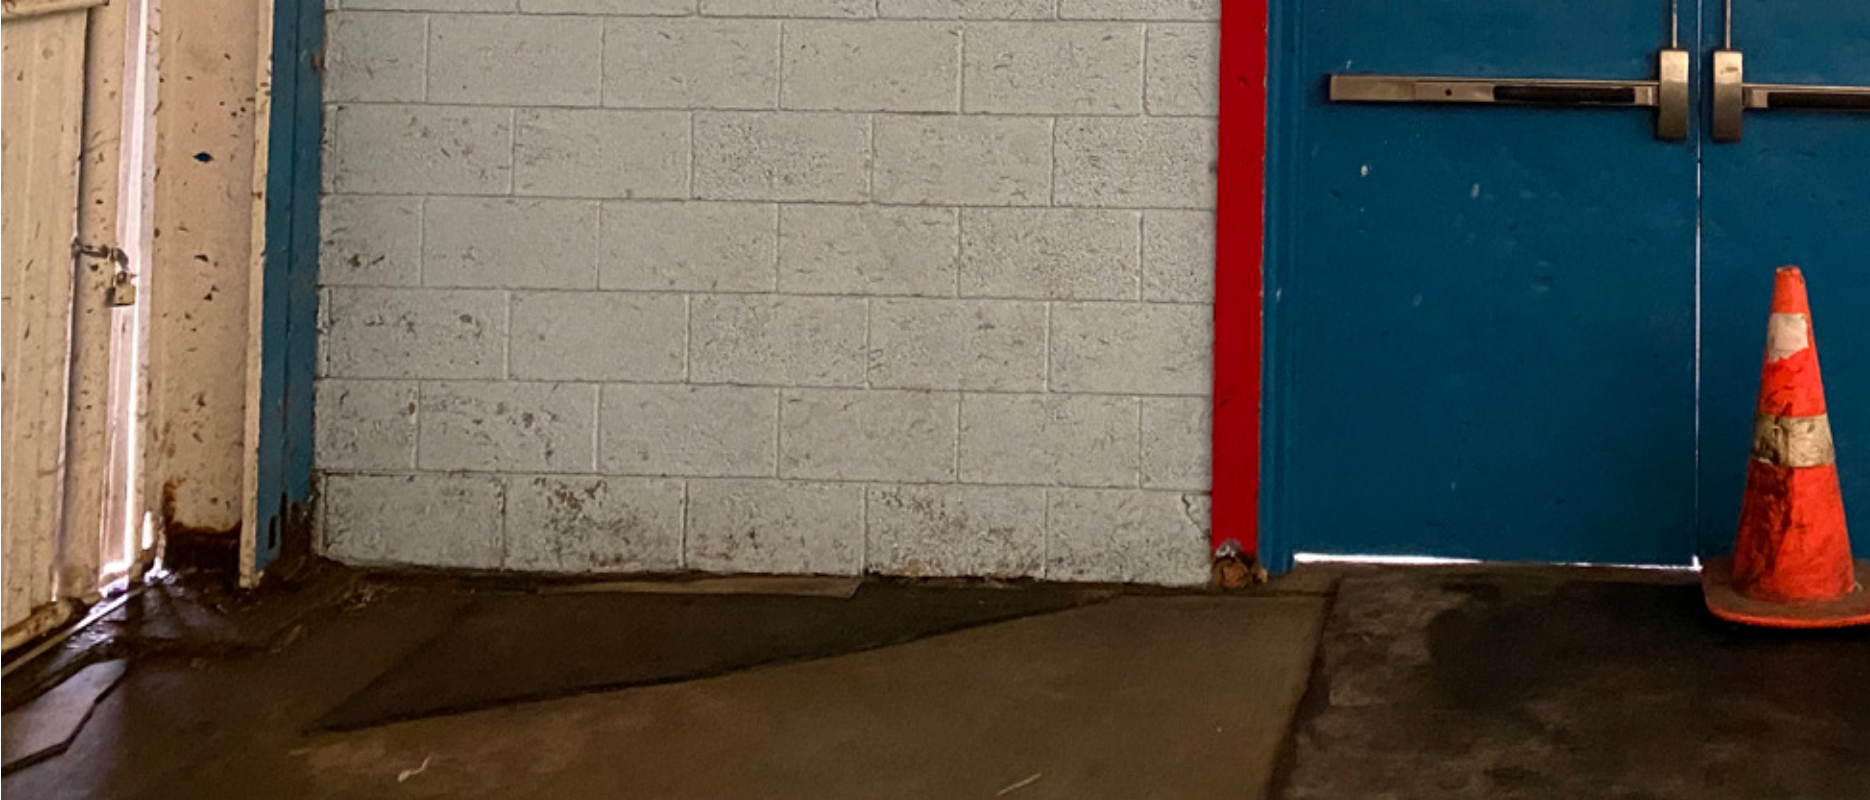
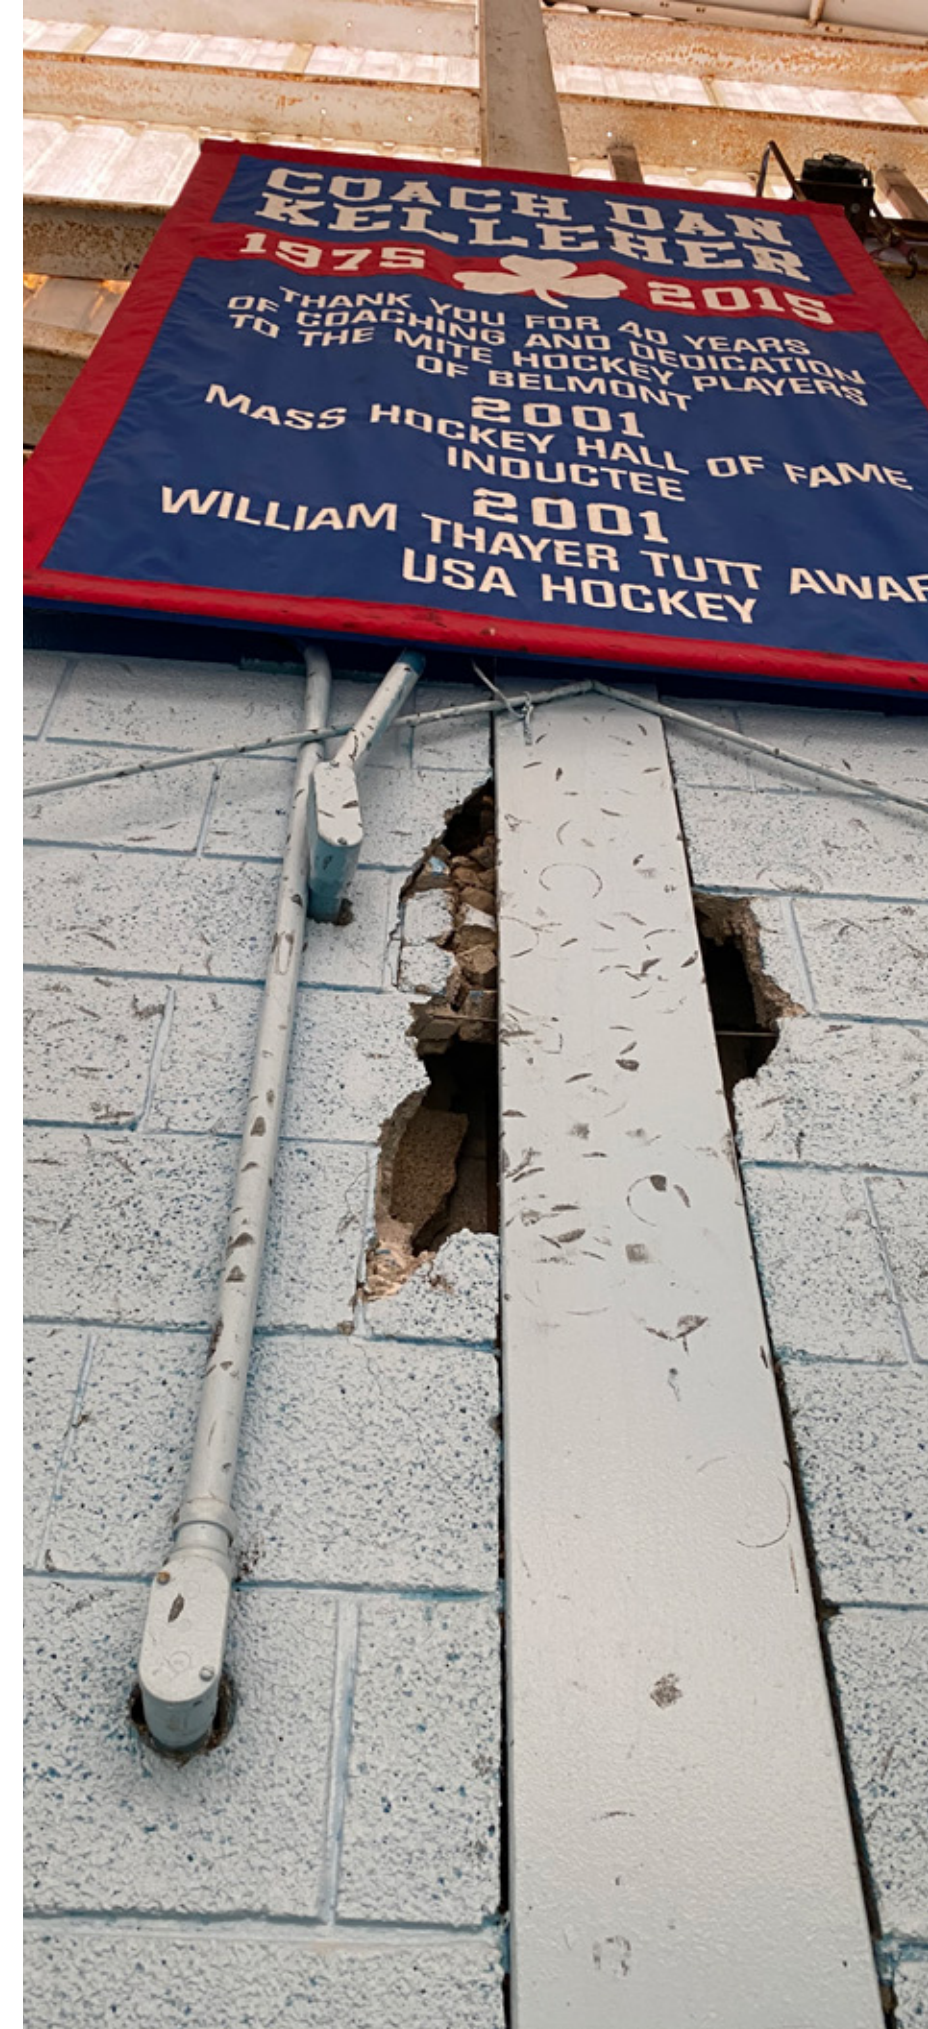
Deficiencies

- Building not insulated
- Roof leaks
- Rusted structure

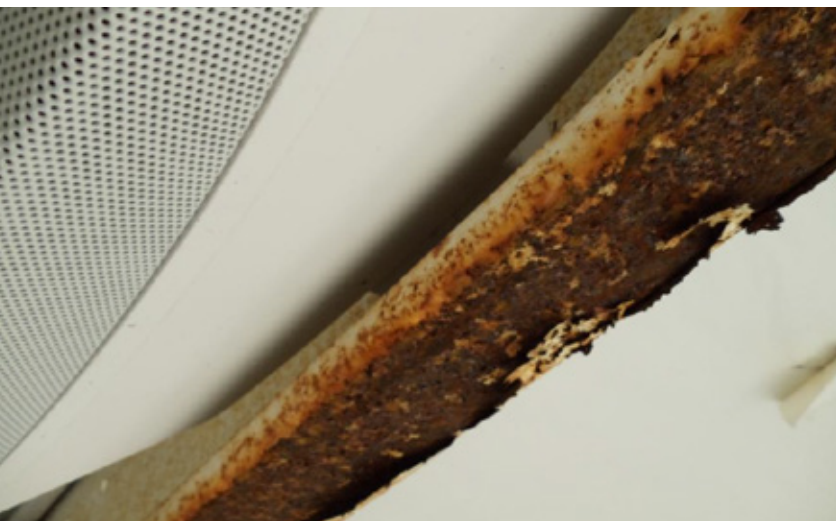
Rusted Purlin

In general, the building components are beyond their anticipated 30 to 35 year life span and require major renovation. The majority of roof purlins exhibit minor rusting and some of the translucent panels appear to be allowing water penetration. The purlin above the fallen debris shows visible loss of section (photos Nos. 2 & 3). In some areas, previously attached equipment

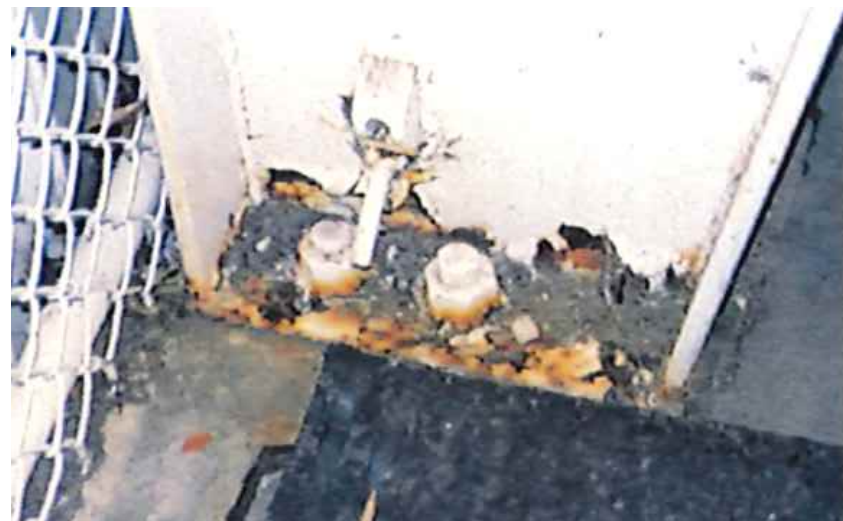
Rusted bents

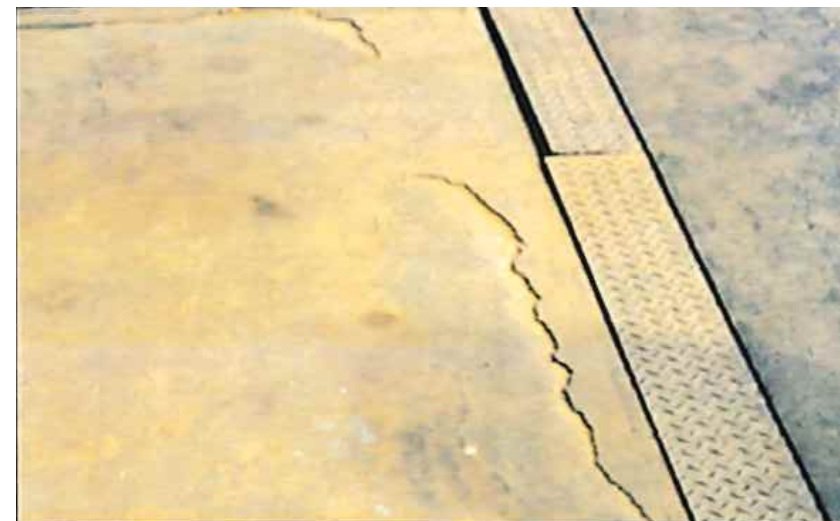
Cracked floor

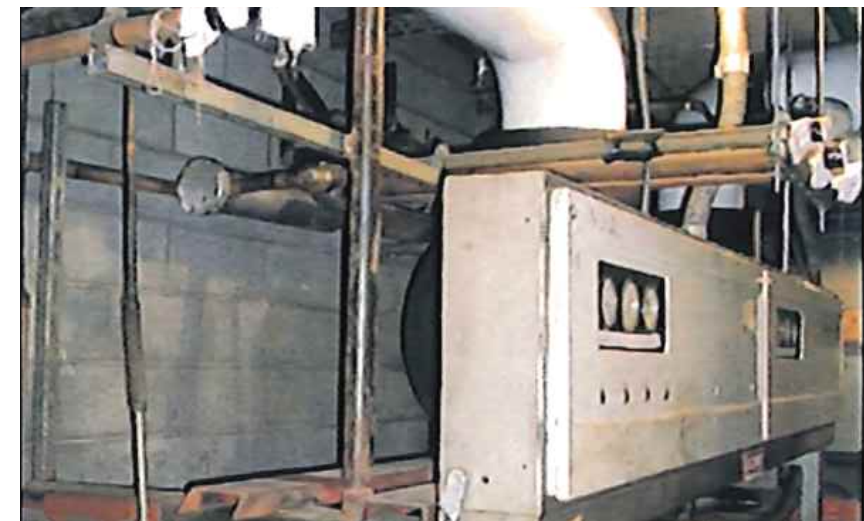
Energy Waste

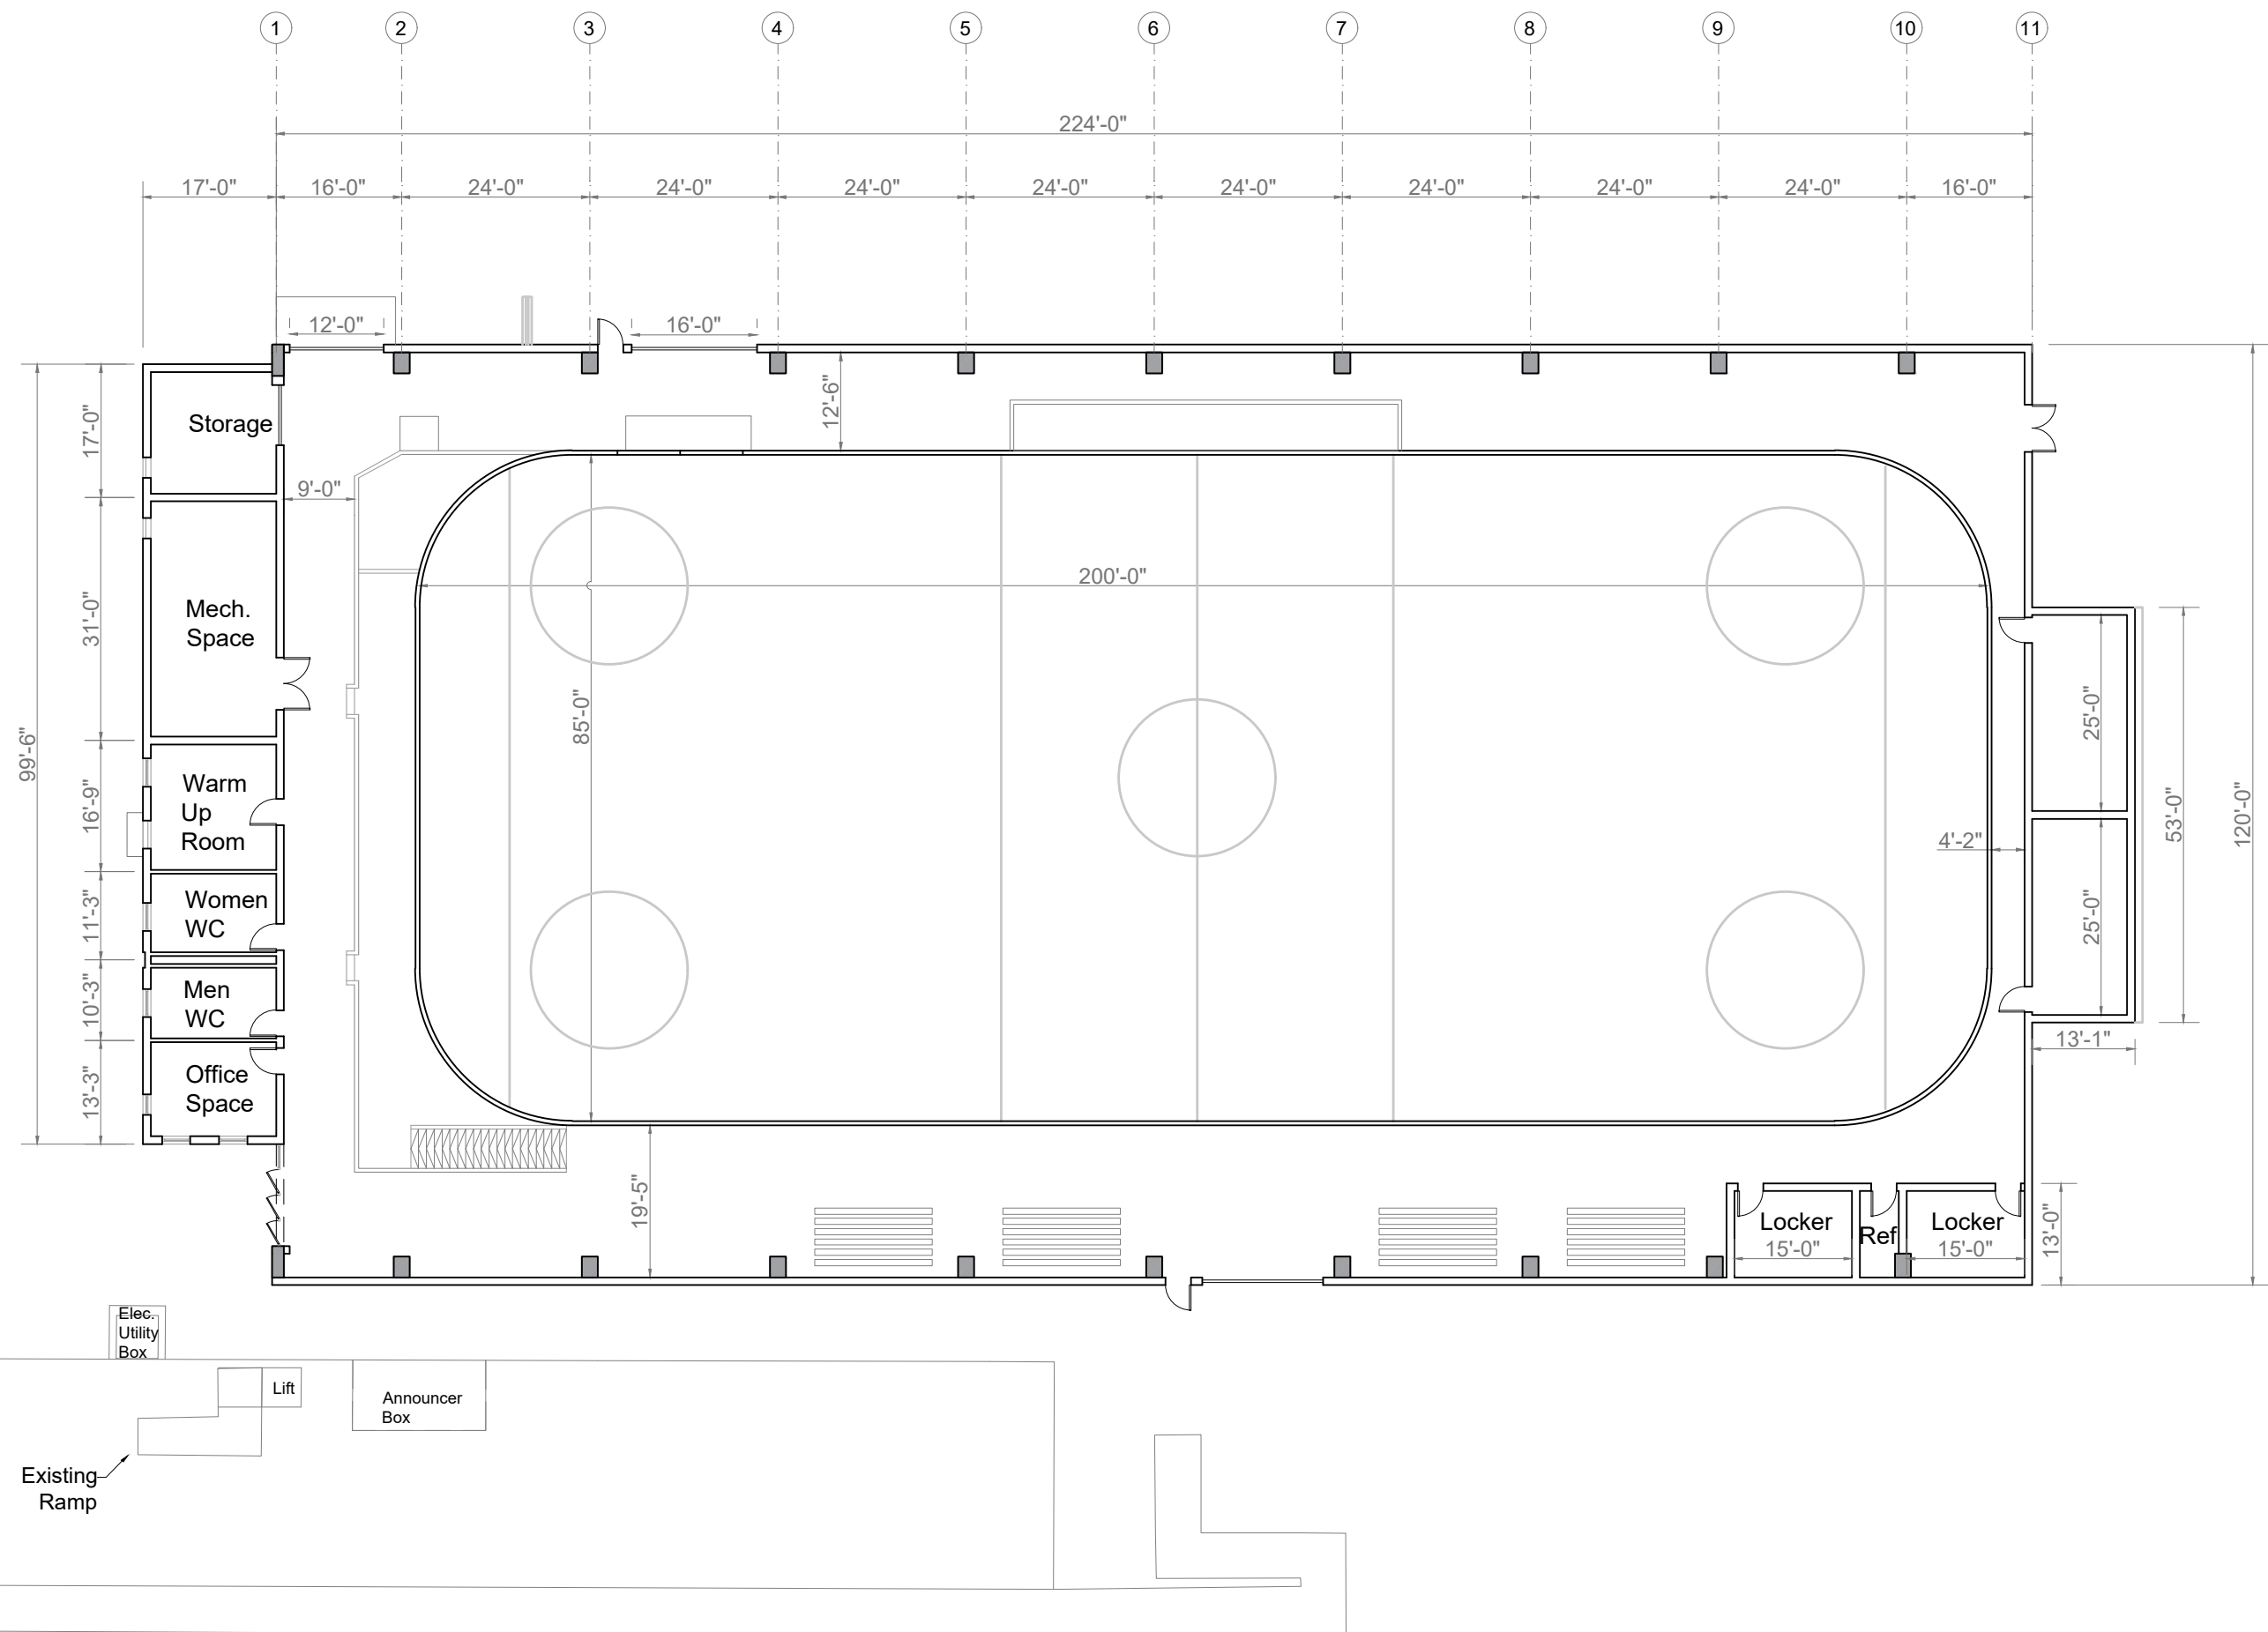
Existing Floor Plan ± 29,600 sf
Building occupied for 4 months

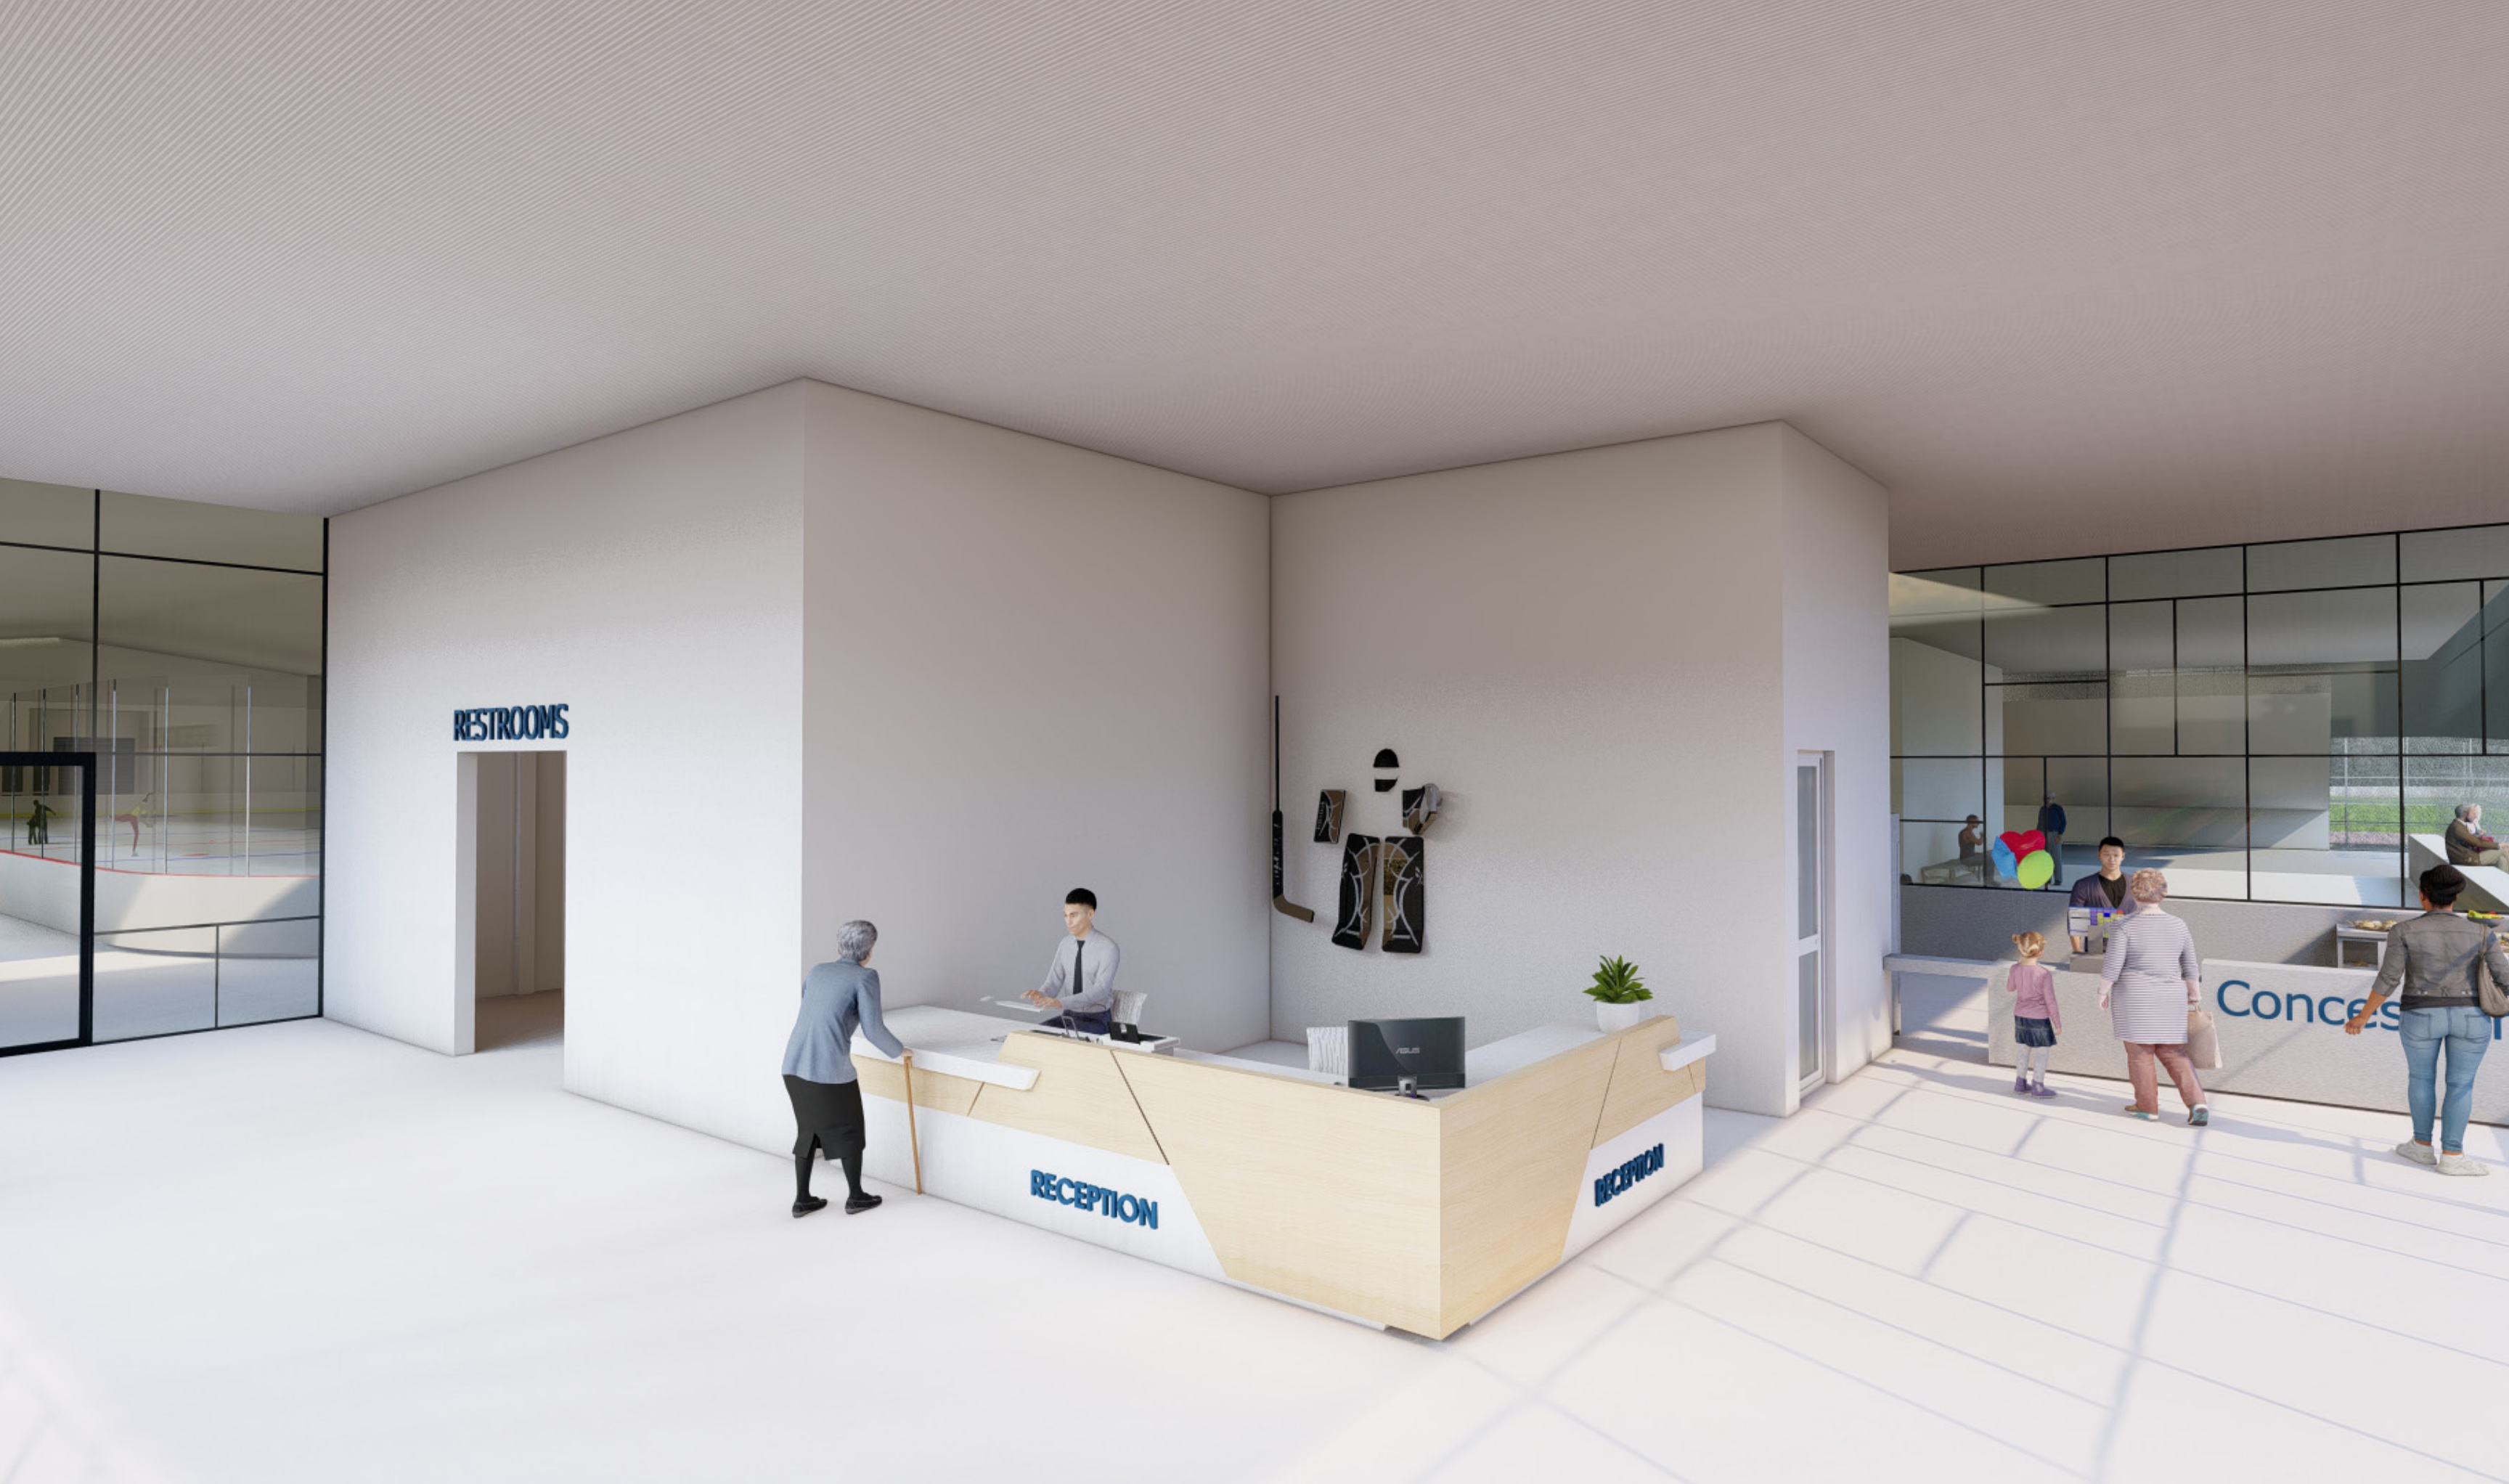
PROPOSED

Community Concession & Restrooms

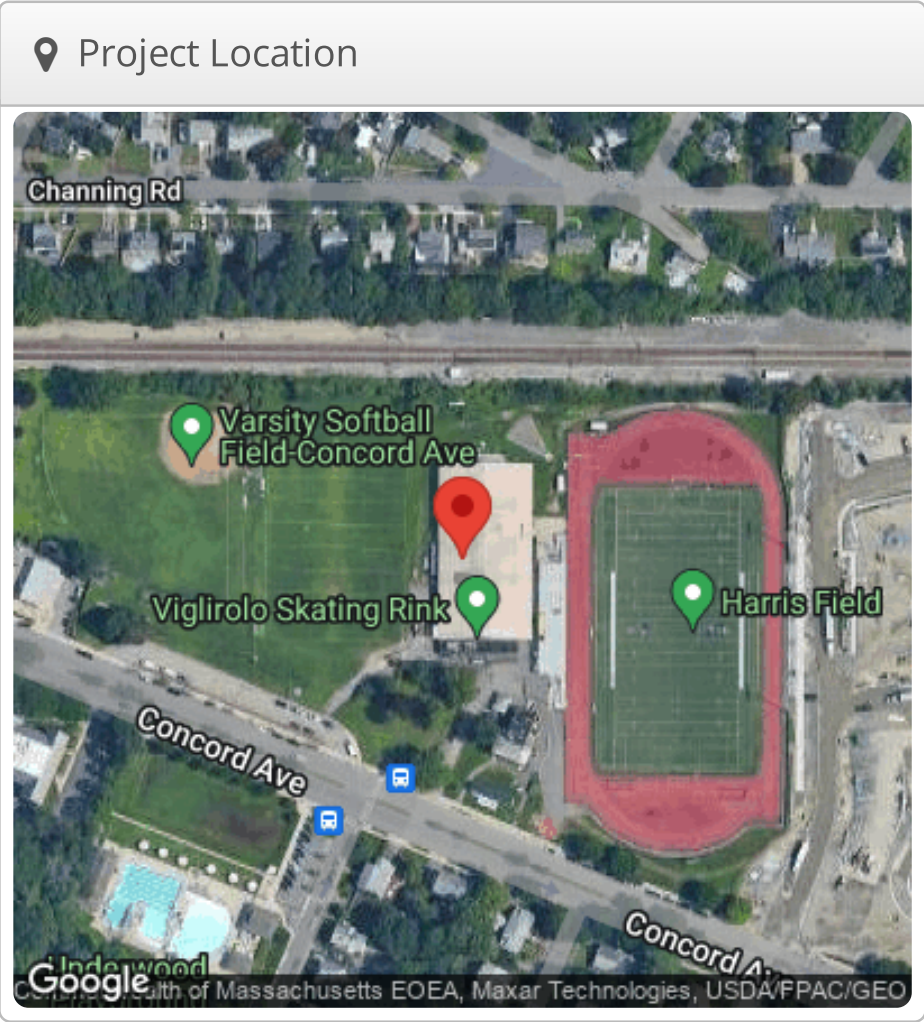
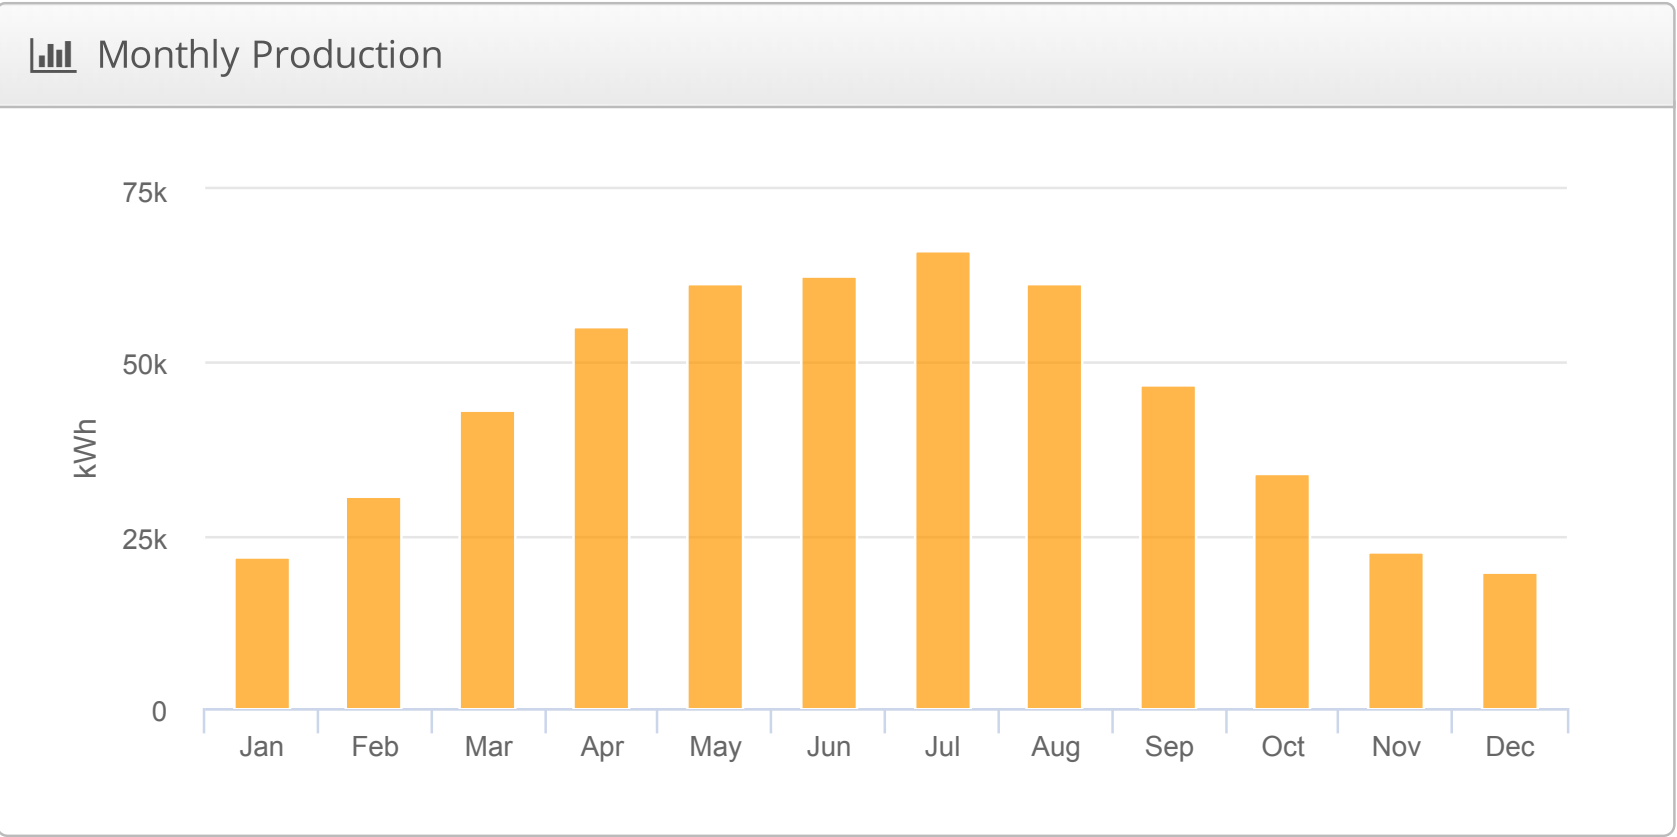
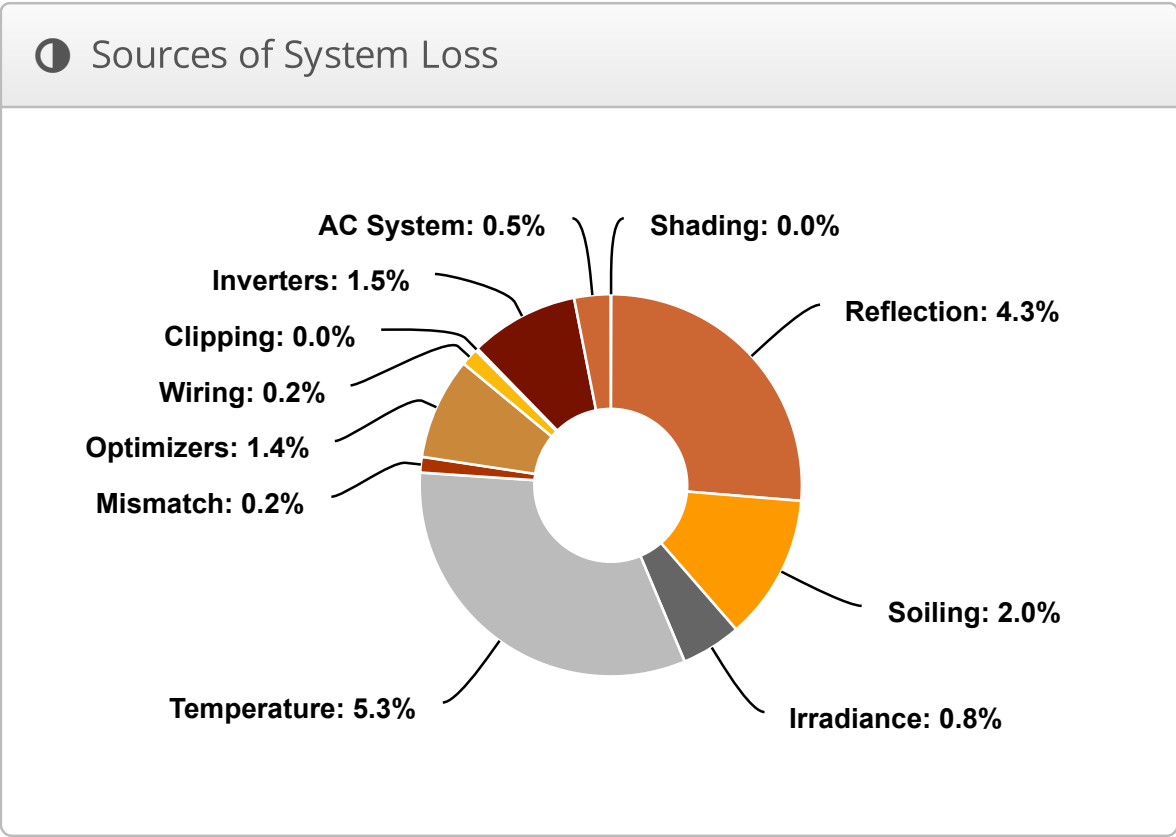
🔧 Report	
Project Name	Belmont Skating Rink
Project Address	221 Concord Ave, Belmont, MA 02478
Prepared By	Nicholas Lawrence nlawrence@solar design.com

📊 System Metrics	
Design	Parametric design 1
Module DC Nameplate	436.8 kW
Inverter AC Nameplate	400.0 kW Load Ratio: 1.09
Annual Production	526.1 MWh
Performance Ratio	84.8%
kWh/kWp	1,204.4
Weather Dataset	TMY, 10km grid (42.35,-71.15), NREL (prospector)
Simulator Version	42f17df9d2-29fbd7cae3-be39569fd0-3d3015eac0

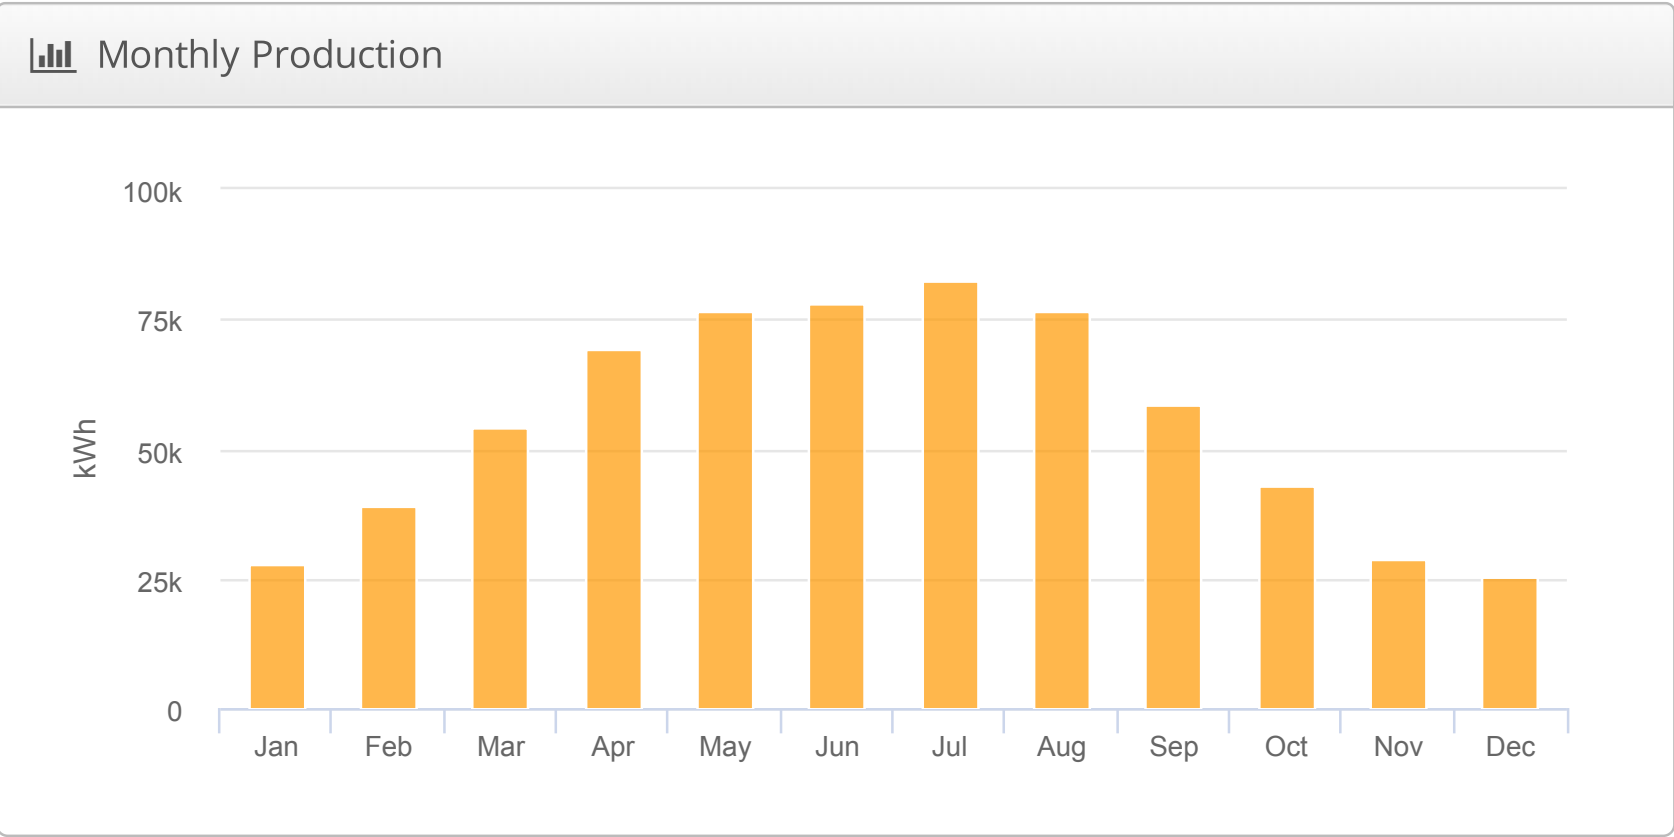
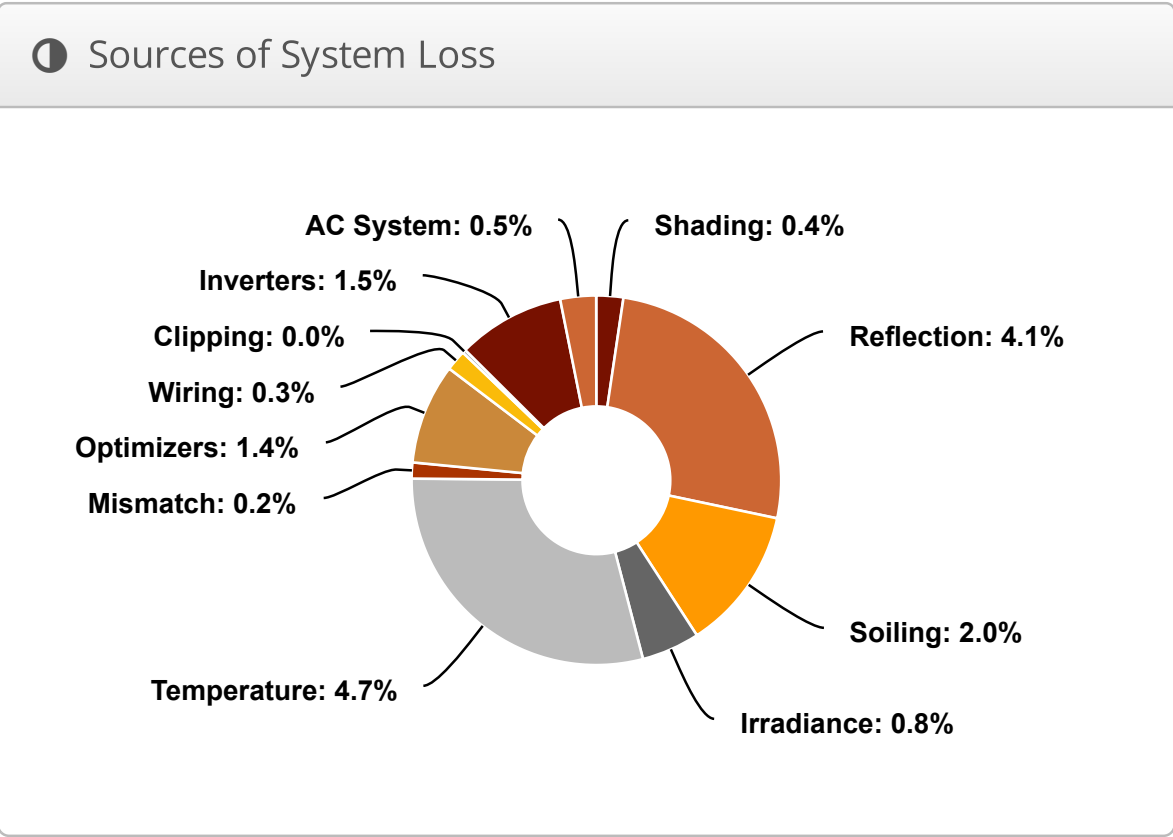
🔧 Report	
Project Name	Belmont Skating Rink
Project Address	221 Concord Ave, Belmont, MA 02478
Prepared By	Nicholas Lawrence nlawrence@solar design.com

📊 System Metrics	
Design	Parametric design 2
Module DC Nameplate	539.5 kW
Inverter AC Nameplate	466.6 kW Load Ratio: 1.16
Annual Production	659.2 MWh
Performance Ratio	85.1%
kWh/kWp	1,221.9
Weather Dataset	TMY, 10km grid (42.35,-71.15), NREL (prospector)
Simulator Version	a5a2eb7823-61c71e8a65-d850928be8-6d900b2c1d
