APPENDIX H

Long Term Pollution Prevention,
Operations and Maintenance Plan

Stormwater Operation and Maintenance Plan Belmont Hill School, Belmont, MA

Re: Geotechnical Exploration and Infiltration Test Results
Belmont Hill School
Belmont, Massachusetts
Langan Project No.: 151021202

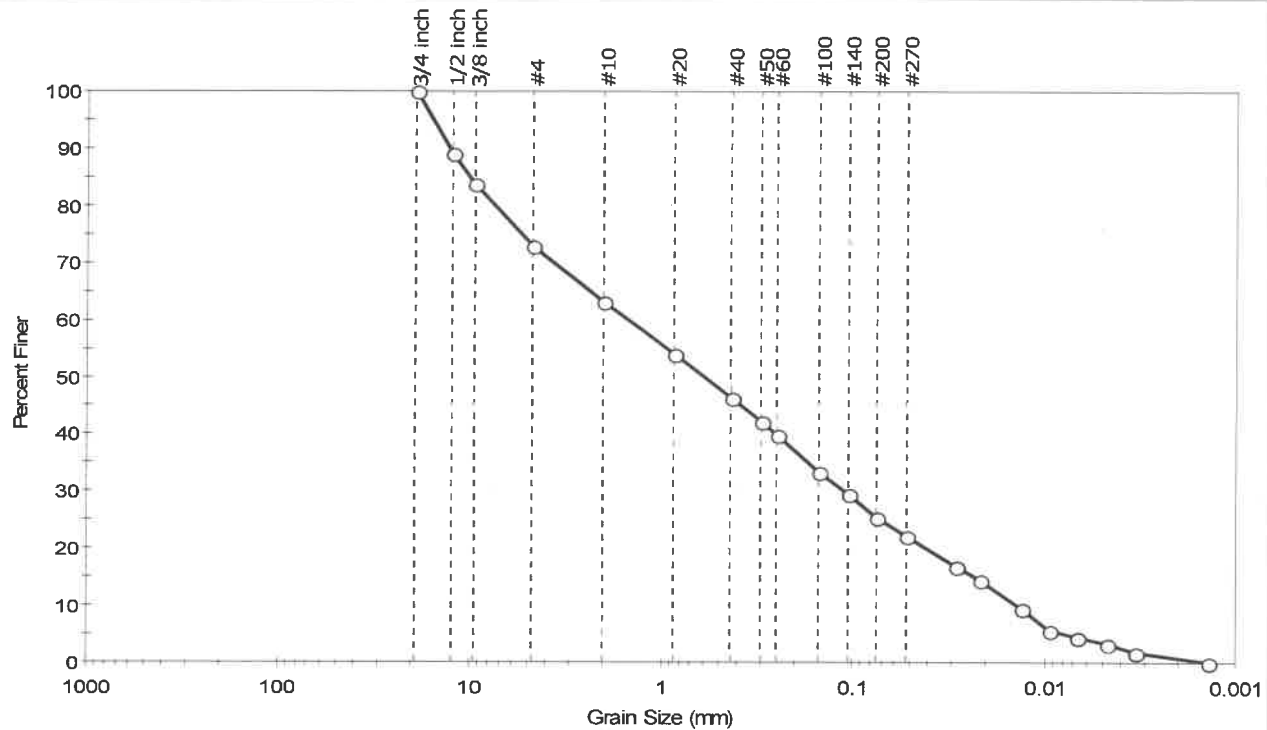
Particle Size Analysis - ASTM D6913/D7928

Client:	Langan Engineering	Project No:	GTX-314519
Project:	Belmont High School	Tested By:	ckg
Location:	Belmont, MA	Checked By:	bfs
Boring ID:	TP-5	Sample Type:	bag
Sample ID:	S-3	Test Date:	10/28/21
Depth:	4.5-5.0 ft	Test Id:	636902
Test Comment:	---		
Visual Description:	Moist, gray silty sand with gravel		
Sample Comment:	---

% Cobble	% Gravel	% Sand	% Silt & Clay Size
—	27.2	47.4	25.4

Sieve Name	Sieve Size, mm	Percent Finer	Spec. Percent	Complies
3/4 inch	19.00	100		
1/2 inch	12.50	89		
3/8 inch	9.50	84		
#4	4.75	73		
#10	2.00	63		
#20	0.85	54		
#40	0.42	46		
#50	0.30	42		
#60	0.25	40		
#100	0.15	33		
#140	0.11	30		
#200	0.075	25		
#270	0.053	22		
Hydrometer	Particle Size (mm)	Percent Finer	Spec. Percent	Complies
---	0.0290	17		
---	0.0216	14		
---	0.0131	9		
---	0.0093	6		
---	0.0067	4		
---	0.0048	3		
---	0.0034	2		
---	0.0014	0

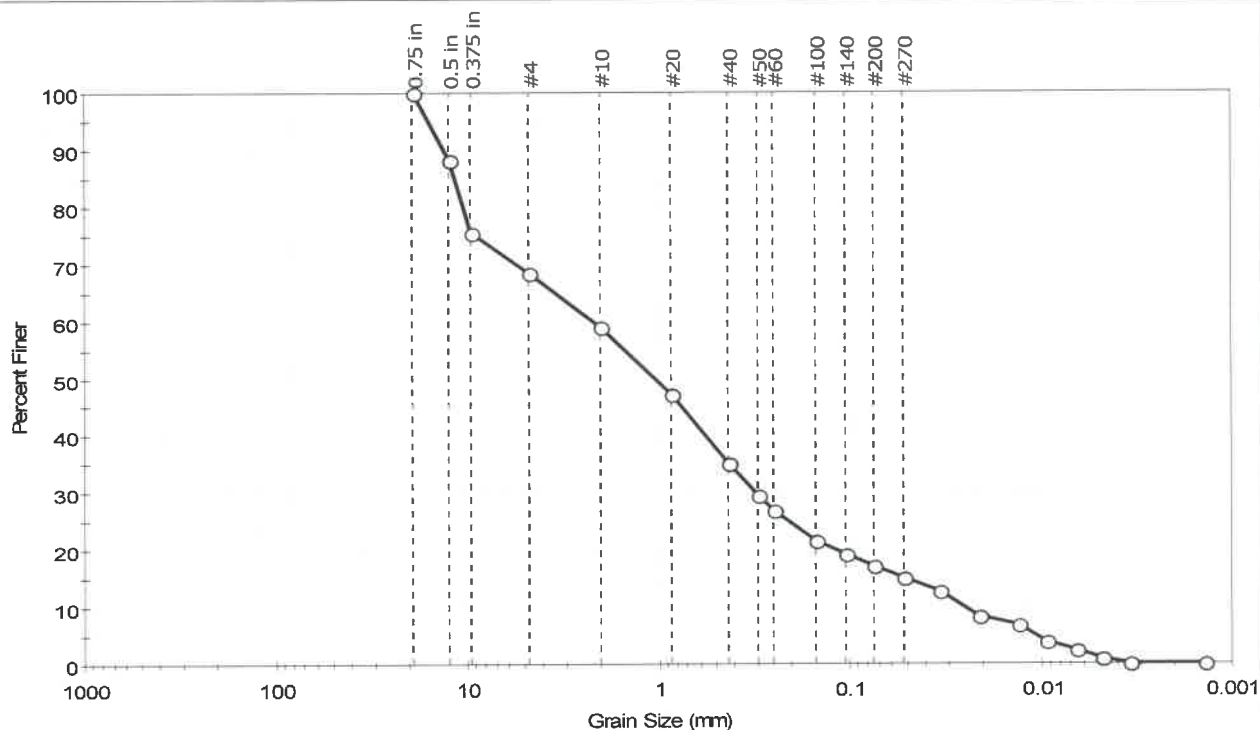
Particle Size Analysis - ASTM D6913/D7928

Client:	Langan Engineering		
Project:	Belmont High School		
Location:	Belmont, MA	Project No:	GTX-314519
Boring ID:	TP-202	Sample Type:	bag
Sample ID:	S-1	Test Date:	10/28/21
Depth :	4.0-4.5 ft	Test Id:	636903
Test Comment:	---		
Visual Description:	Moist, dark brown silty sand with gravel		
Sample Comment:	Removed one unrepresentative 2 inch rock

%Cobble	%Gravel	%Sand	%Silt & Clay Size
—	31.5	51.4	17.1

Sieve Name	Sieve Size, mm	Percent Finer	Spec. Percent	Complies
0.75 in	19.00	100		
0.5 in	12.50	88		
0.375 in	9.50	76		
#4	4.75	68		
#10	2.00	59		
#20	0.85	47		
#40	0.42	35		
#50	0.30	30		
#60	0.25	27		
#100	0.15	22		
#140	0.11	19		
#200	0.075	17		
#270	0.053	15		
Hydrometer	Particle Size (mm)	Percent Finer	Spec. Percent	Complies
---	0.0343	13		
---	0.0211	8		
---	0.0131	7		
---	0.0094	4		
---	0.0066	2		
---	0.0048	1		
---	0.0034	0		
---	0.0014	0

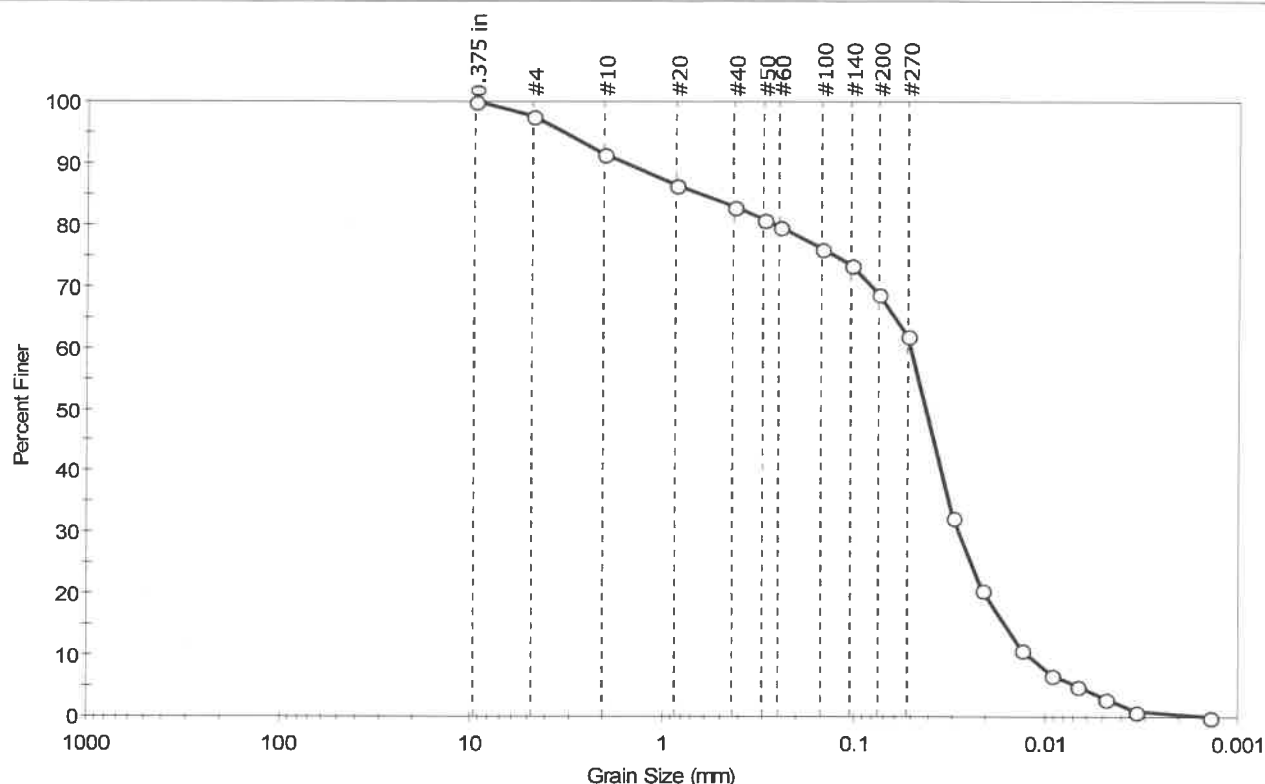
Particle Size Analysis - ASTM D6913/D7928

Client:	Langan Engineering	Project No:	GTX-314519
Project:	Belmont High School	Tested By:	ckg
Location:	Belmont, MA	Checked By:	bfs
Boring ID:	TP-206	Sample Type:	bag
Sample ID:	S-1	Test Date:	10/28/21
Depth:	1.5-2.0 ft	Test Id:	636904
Test Comment:	---		
Visual Description:	Moist, dark yellowish brown sandy silt		
Sample Comment:	---

% Cobble	% Gravel	% Sand	% Silt & Clay Size
—	2.5	28.8	68.7

Sieve Name	Sieve Size, mm	Percent Finer	Spec. Percent	Complies
0.375 in	9.50	100		
#4	4.75	98		
#10	2.00	91		
#20	0.85	87		
#40	0.425	83		
#50	0.30	81		
#60	0.25	80		
#100	0.15	76		
#140	0.11	73		
#200	0.075	69		
#270	0.053	62		
Hydrometer	Particle Size (mm)	Percent Finer	Spec. Percent	Complies
---	0.0306	32		
---	0.0214	21		
---	0.0132	11		
---	0.0092	7		
---	0.0067	5		
---	0.0048	3		
---	0.0034	1		
---	0.0014	0

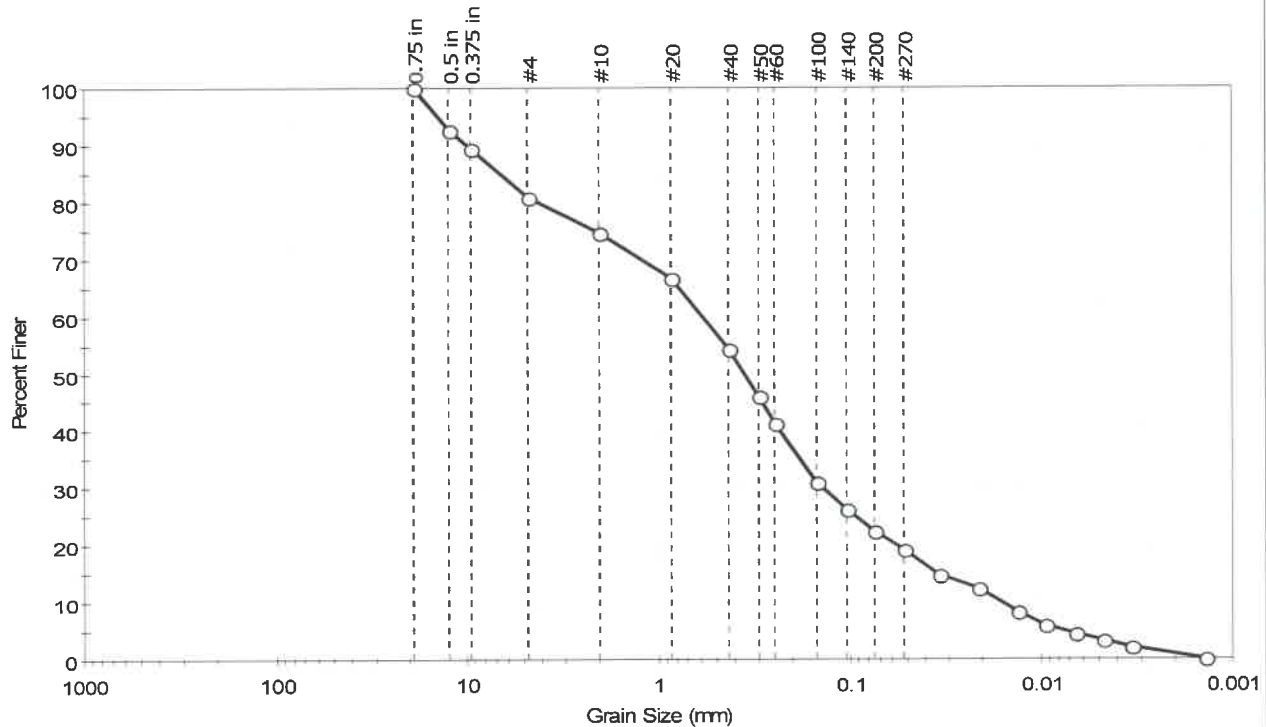
Particle Size Analysis - ASTM D6913/D7928

Client: Langan Engineering	Project No: GTX-314519
Project: Belmont High School	
Location: Belmont, MA	
Boring ID: TP-207	Sample Type: bag
Sample ID: S-2	Tested By: ckg
Depth: 1.0-1.5 ft	Test Date: 10/28/21
	Checked By: bfs
	Test Id: 636905
Test Comment: ---	
Visual Description: Moist, dark brown silty sand with gravel	
Sample Comment: ---

% Cobble	% Gravel	% Sand	% Silt & Clay Size
—	19.1	58.6	22.3

Sieve Name	Sieve Size, mm	Percent Finer	Spec. Percent	Complies
0.75 in	19.00	100		
0.5 in	12.50	93		
0.375 in	9.50	89		
#4	4.75	81		
#10	2.00	75		
#20	0.85	67		
#40	0.42	54		
#50	0.30	46		
#60	0.25	41		
#100	0.15	31		
#140	0.11	26		
#200	0.075	22		
#270	0.053	19		
Hydrometer	Particle Size (mm)	Percent Finer	Spec. Percent	Complies
---	0.0343	15		
---	0.0210	12		
---	0.0132	8		
---	0.0095	6		
---	0.0066	5		
---	0.0047	3		
---	0.0034	2		
---	0.0014	0

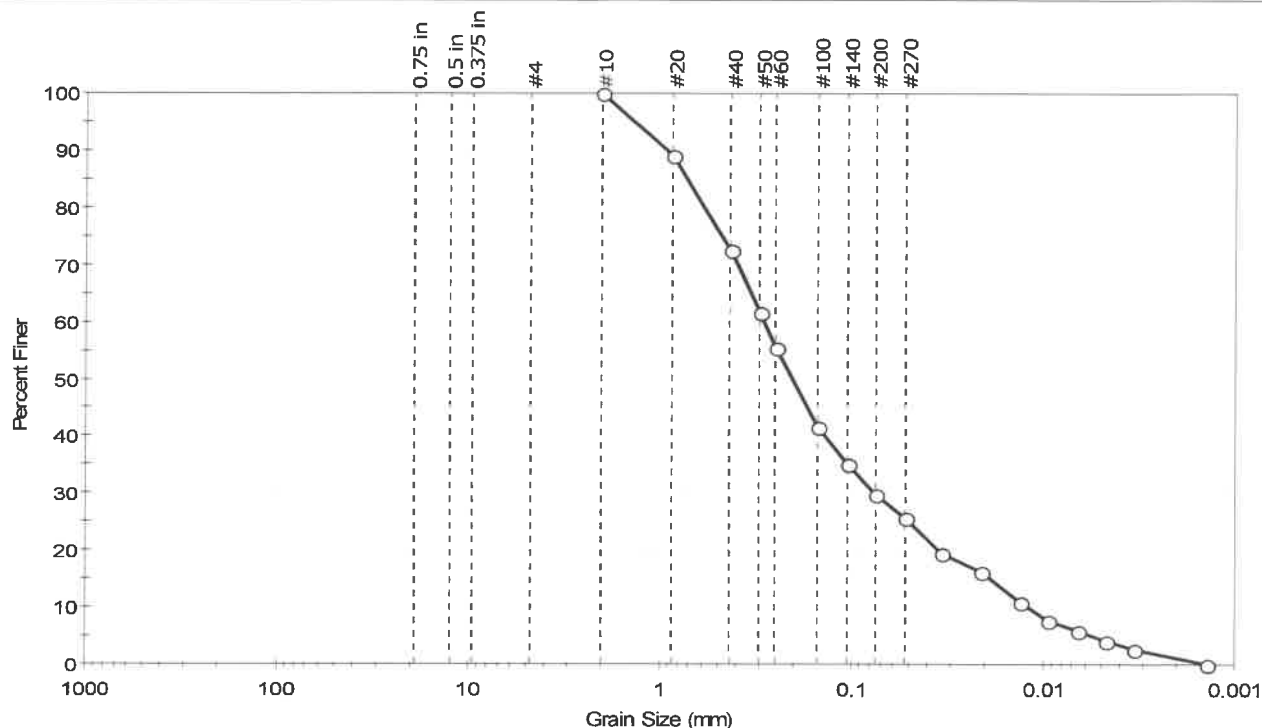
Particle Size Analysis - ASTM D6913/D7928

Client:	Langan Engineering	Project No:	GTX-314519
Project:	Belmont High School	Tested By:	ckg
Location:	Belmont, MA	Checked By:	bfs
Boring ID:	TP-207	Sample Type:	bag
Sample ID:	S-2	Test Date:	10/28/21
Depth:	1.0-1.5 ft	Test Id:	636905
Test Comment:	Only minus No. 10 sieve for USDA classification		
Visual Description:	Moist, dark brown silty sand with gravel		
Sample Comment:	---

% Cobble	% Gravel	% Sand	% Silt & Clay Size
—	0.0	70.1	29.9

Sieve Name	Sieve Size, mm	Percent Finer	Spec. Percent	Complies
#10	2.00	100		
#20	0.85	89		
#40	0.42	73		
#50	0.30	62		
#60	0.25	55		
#100	0.15	42		
#140	0.11	35		
#200	0.075	30		
#270	0.053	26		
Hydrometer	Particle Size (mm)	Percent Finer	Spec. Percent	Complies
---	0.0343	20		
---	0.0210	16		
---	0.0132	11		
---	0.0095	8		
---	0.0066	6		
---	0.0047	4		
---	0.0034	3		
---	0.0014	0
