## **BELMONT HIGH SCHOOL**

**EXISTING CONDITIONS SUMMARY**

#### AGENDA Existing Conditions Summary

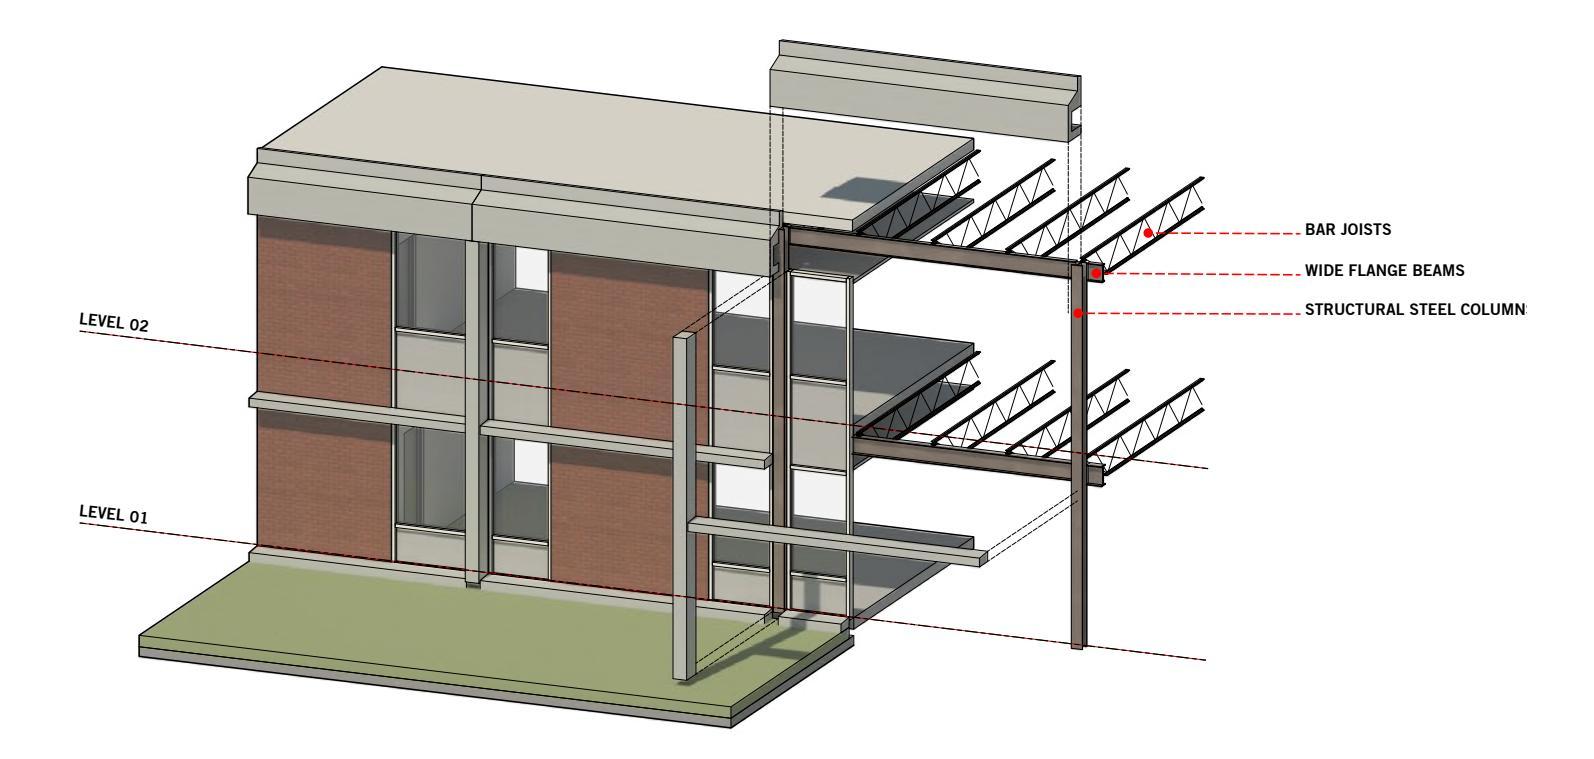
#### **04/ STRUCTURE: EXISTING CONDITIONS**

**TYPICAL ROOF:** Poured gypsum over form deck supported on steel bulb tees, steel joists and beams.

**TYPICAL FLOOR:** 2 1/2" thick concrete slab-on-form deck supported on steel bar joists and wide flange steel girders.

**FIRST FLOOR**: Mix of reinforced concrete structural slab and concrete slab-on-grade

UTILITY TUNNELS: Below first floor corridor

**FIELDHOUSE ROOF:** is typical rood construction supported on structural steel bents

**FOUNDATIONS:** Concrete filled steel piles and pile caps supporting the building columns, walls and first floor slab at the majority of the footprint

**LATERAL LOAD:** No explicit lateral load resisting system (shear walls, braced frames, etc.) for resisting seismic and wind loads

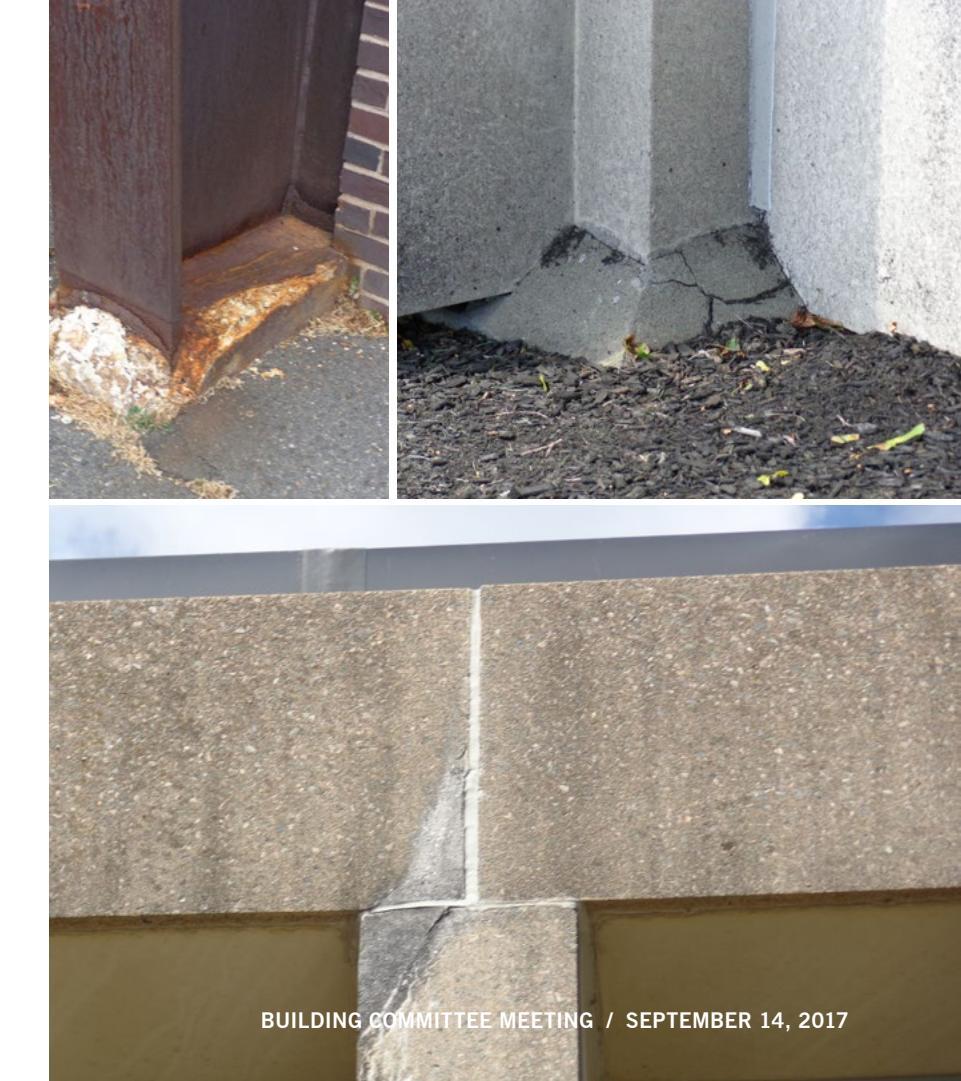
The existing structure is performing well

Signs of past water leaks were observed

Minor cracks in the interior masonry walls and masonry facade were observed

No undue vibration from footfall was perceived at supported slabs

No signs of foundation settlement were observed

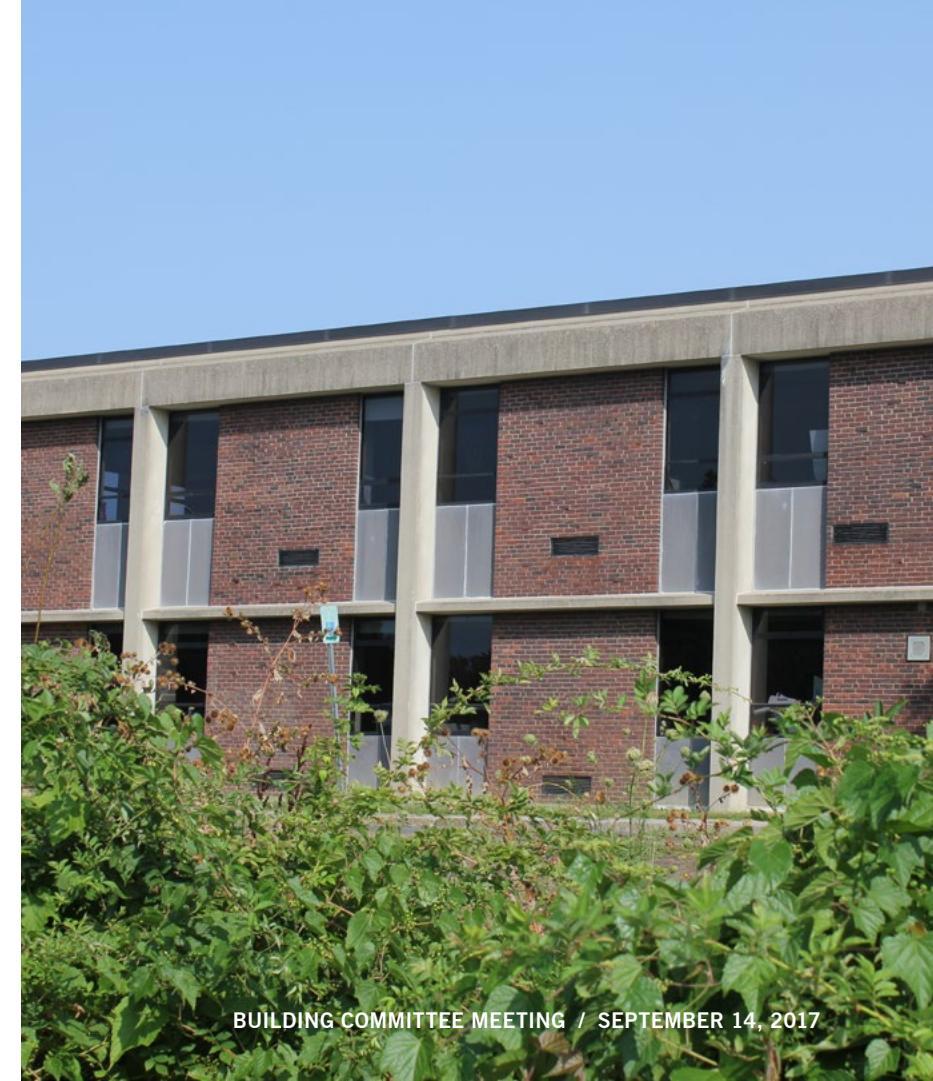
Compliance with International Existing Building Code

Compliance Method: Work Area Compliance Method

Work area will be greater than 50%; thus, Level 3 Alterations

**SEISMIC CLIPPING:** of all existing masonry walls will be required

**DEMISING WALLS:** Majority of walls do not appear to be structural in nature

**RENOVATIONS:** Proposed renovations will trigger an analysis of the existing building and will require the addition of shear walls or braced frames, which will probably require addition of piles within the building

**SLAB ON GRADE AREAS:** Addition of tie beams connecting pile caps at slab-on-grade areas.

#### GRADE BEAMS AND PILES: will be

required for phased and partial demolition to support the new exterior walls.

**RENOVATIONS:** will require trenching of existing slabs:

- Not easy to trench under supported structural slabs, will need to maintain continuity of reinforcement of the slab

- Have to be careful in trenching through Fieldhouse floor due to tension cables

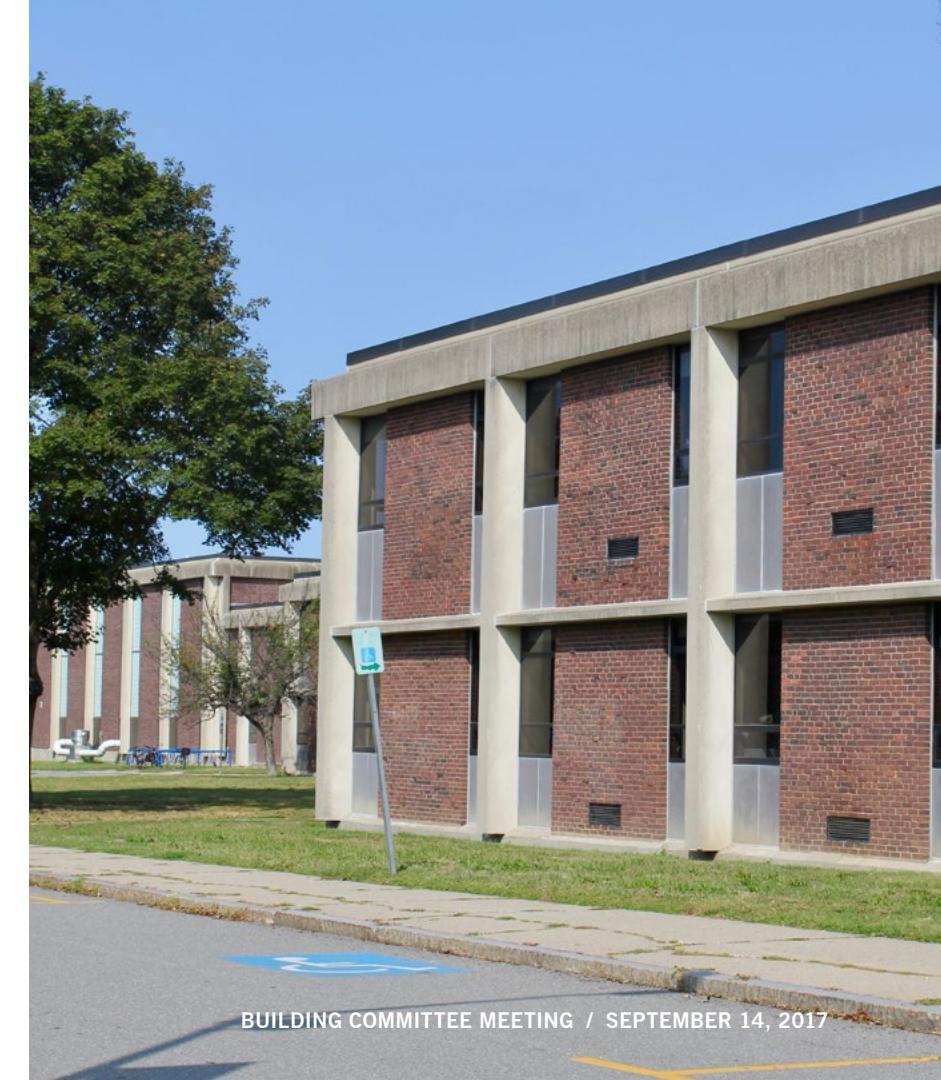
Proposed additions should be horizontal additions, separated from the existing structure by expansion joints.

Vertical additions may not be feasible, due to limited capacity of foundations and columns. The existing roof structure will not have capacity to support floor loads.

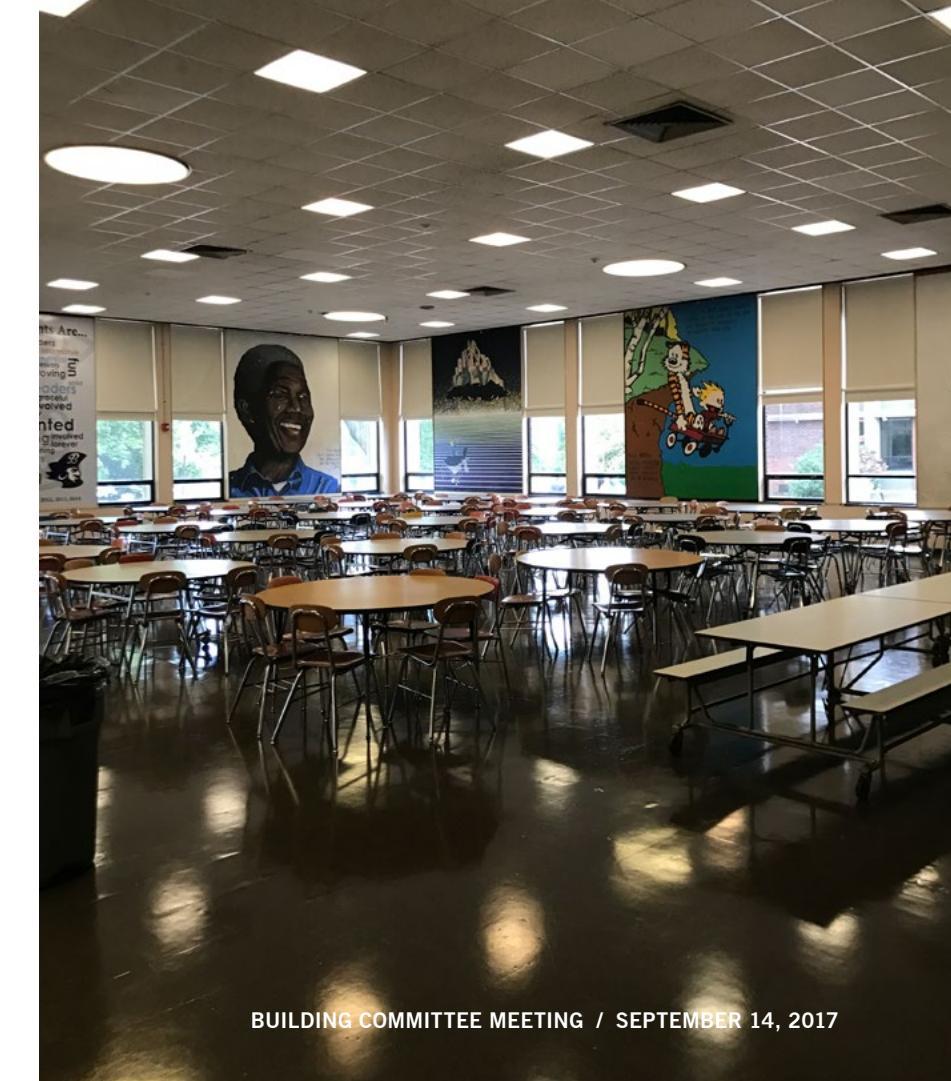
**LARGE SPACES LIGHTING:** Cafeteria lighting is typical for the library/Media Center as well as other large spaces throughout the building.

**ORIGINAL FIXTURES:** Similar to many spaces throughout the building, the fixtures are original to the building, utilizing fluorescent lamps and inefficient vs. higher efficient LED fixtures.

**CONTROLS:** local line voltage switches vs. low voltage employing dimming, vacancy sensors and day lighting controls.

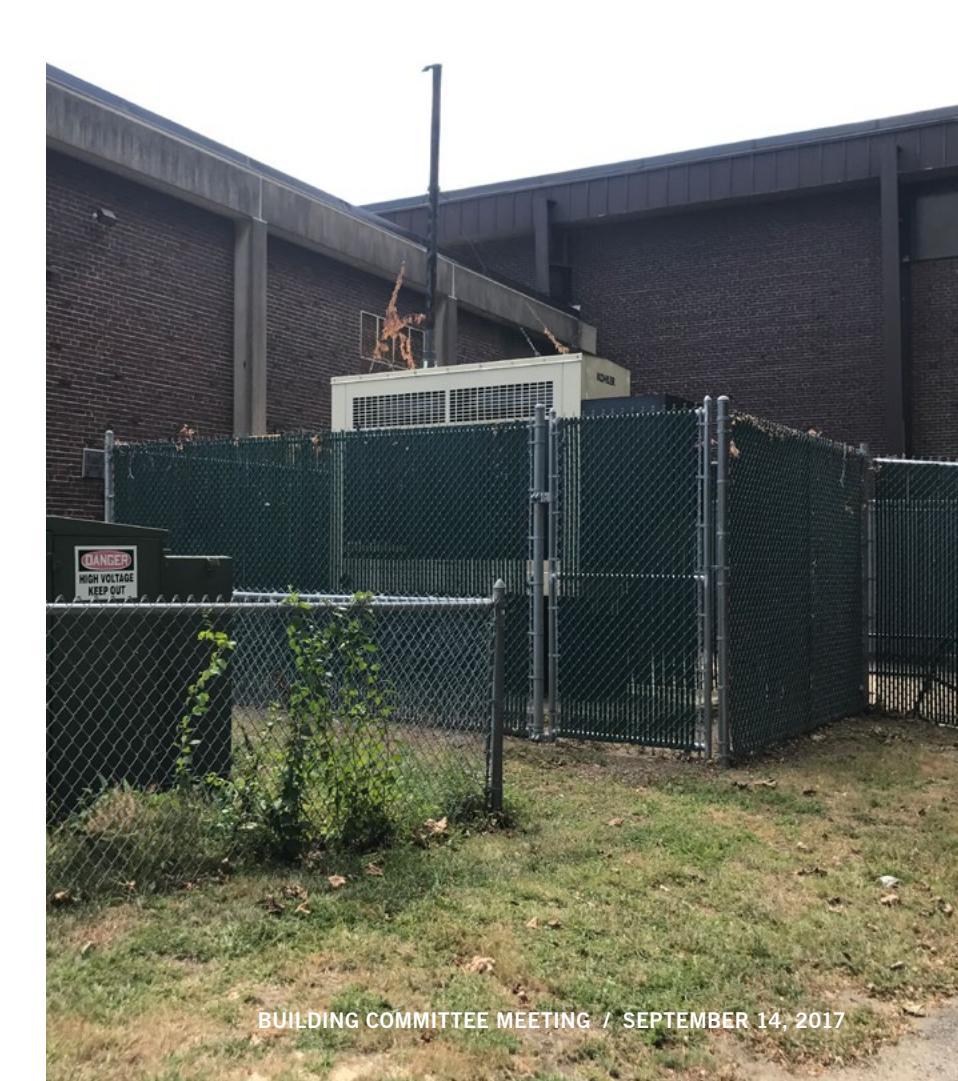
#### UTILITY TRANSFORMER AND BACKUP GENERATOR: Existing (see photo).

**TRANSFORMER**: With any projected upgrades/ additions or rebuild the transformer size and/location will need to be addressed.

**GENERATOR:** The generator size offers limited opportunity to add equipment. The existing distribution does not meet todays code required separation of systems.

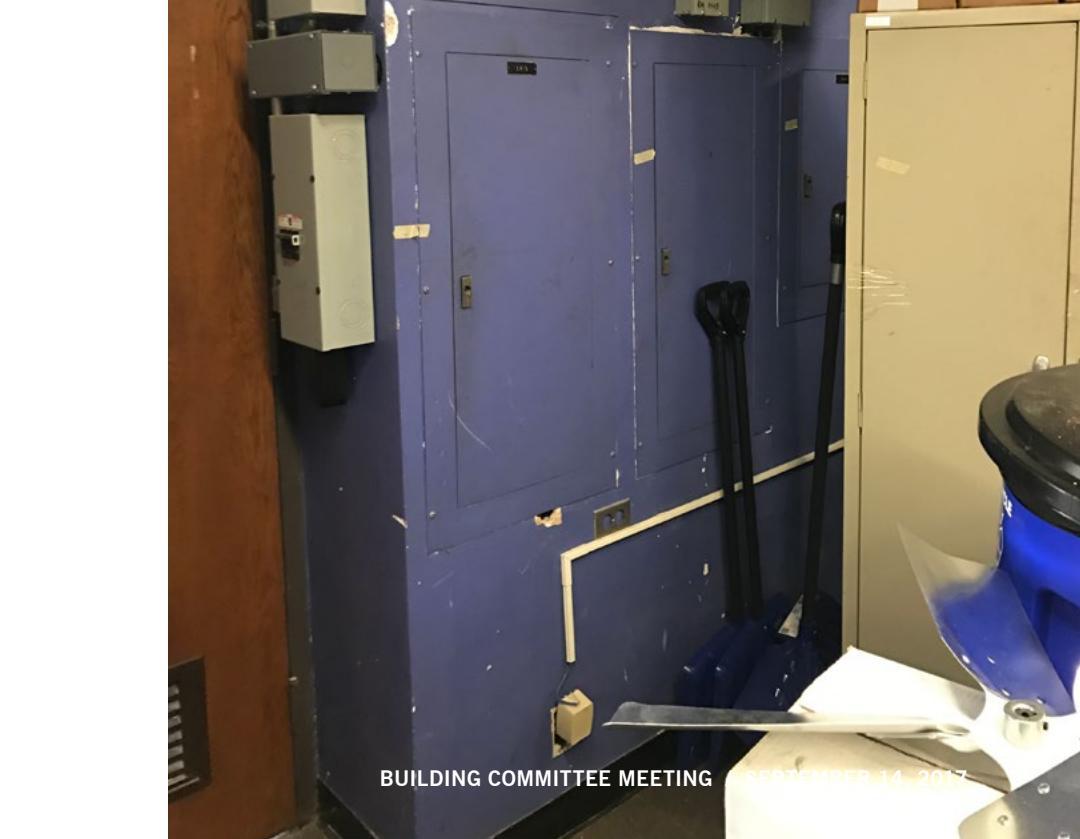
For new or renovated designs all electrical equipment would be in dedicated electric closets. No equipment in storage closets or other non dedicated areas.

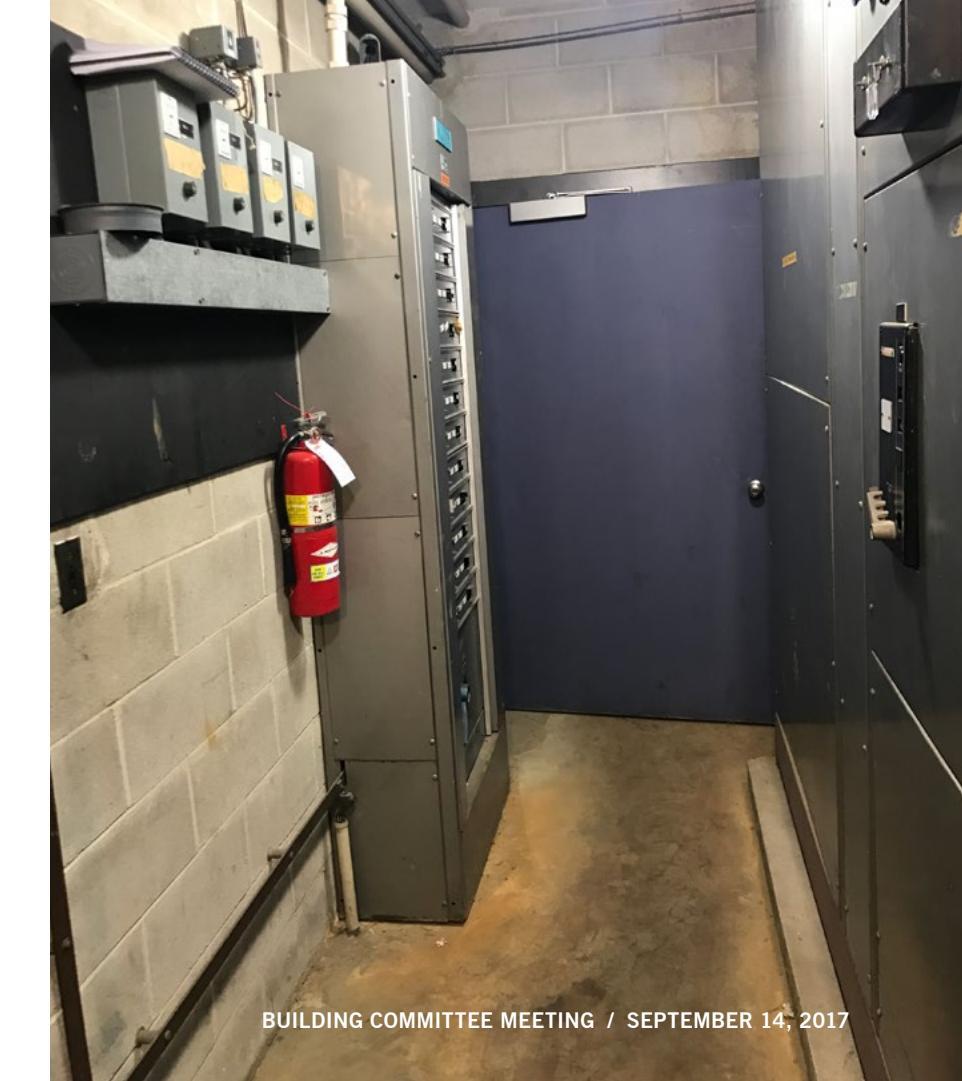
MAIN ELECTRIC ROOM: Space Limitations

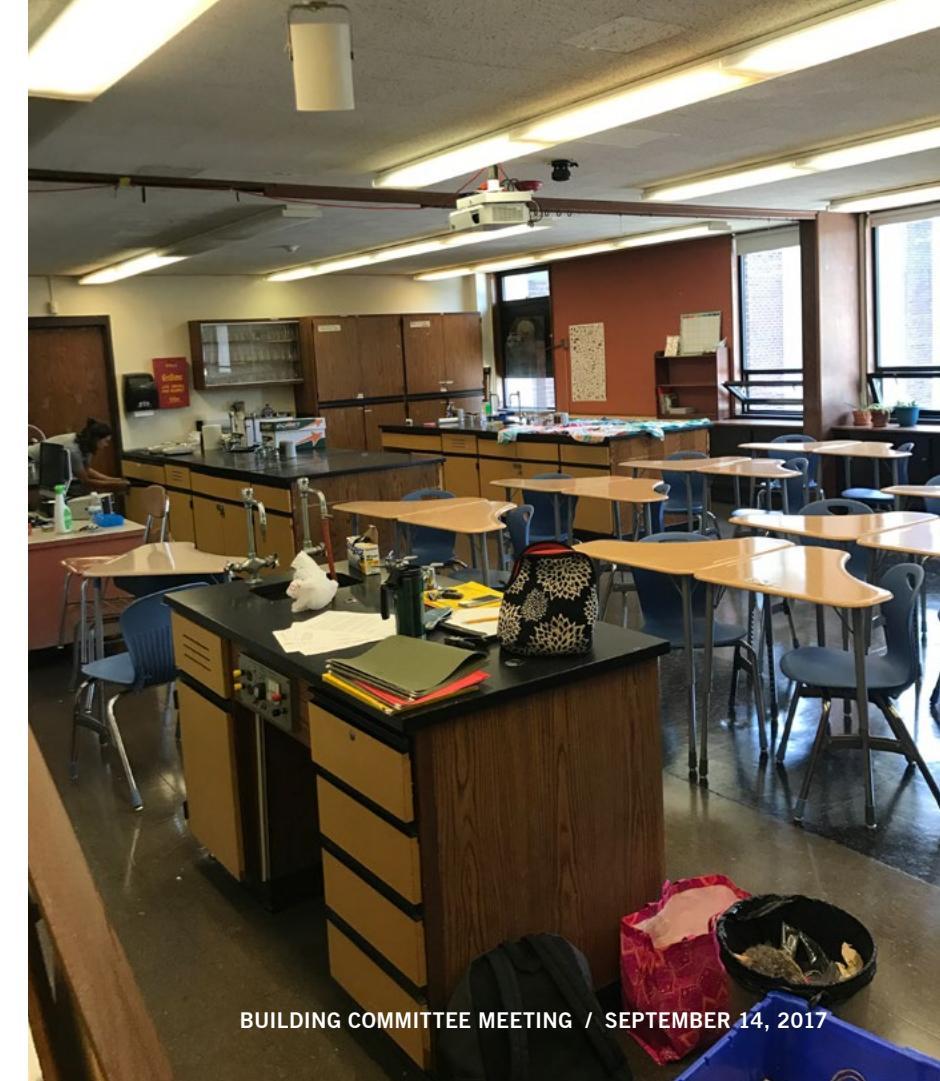
#### **SCIENCE ROOMS**

**FLUORESCENT LIGHTING:** is typical for most of the classrooms throughout the building. The fixtures are original to the building with fluorescent lamps vs. todays LED fixtures offering higher efficiencies.

**CONTROLS**: are original to the building consisting of local line voltage switching vs. todays low voltage dimming, vacancy sensors and day lighting controls

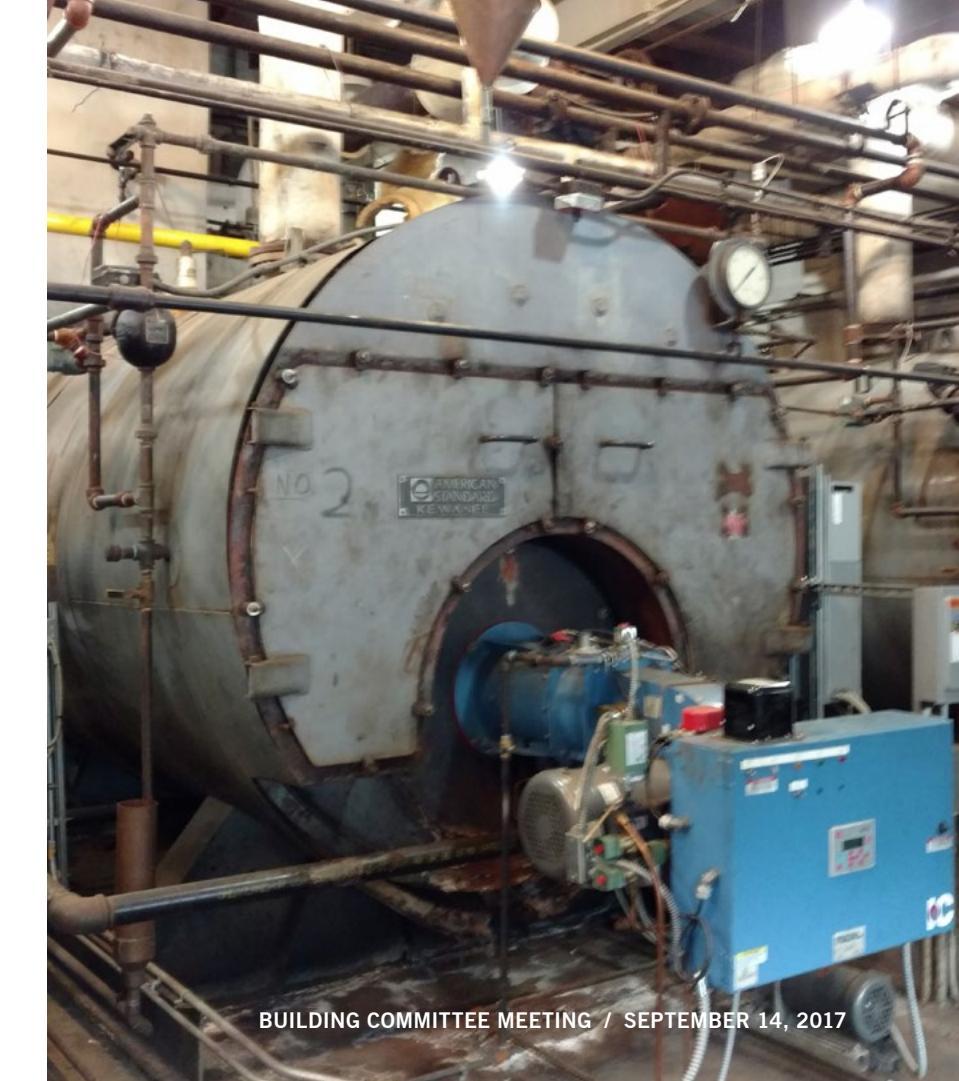
STEAM BOILERS: 47+ year old steam boilers.
DUEL FUEL: burners can burn gas or fuel oil.
BOILERS: have been partially or completely re-tubed several times.

**STEAM SYSTEM:** requires maintenance of steam traps, condensate pumps, receiver tanks, control valves, anti-corrosion chemicals.

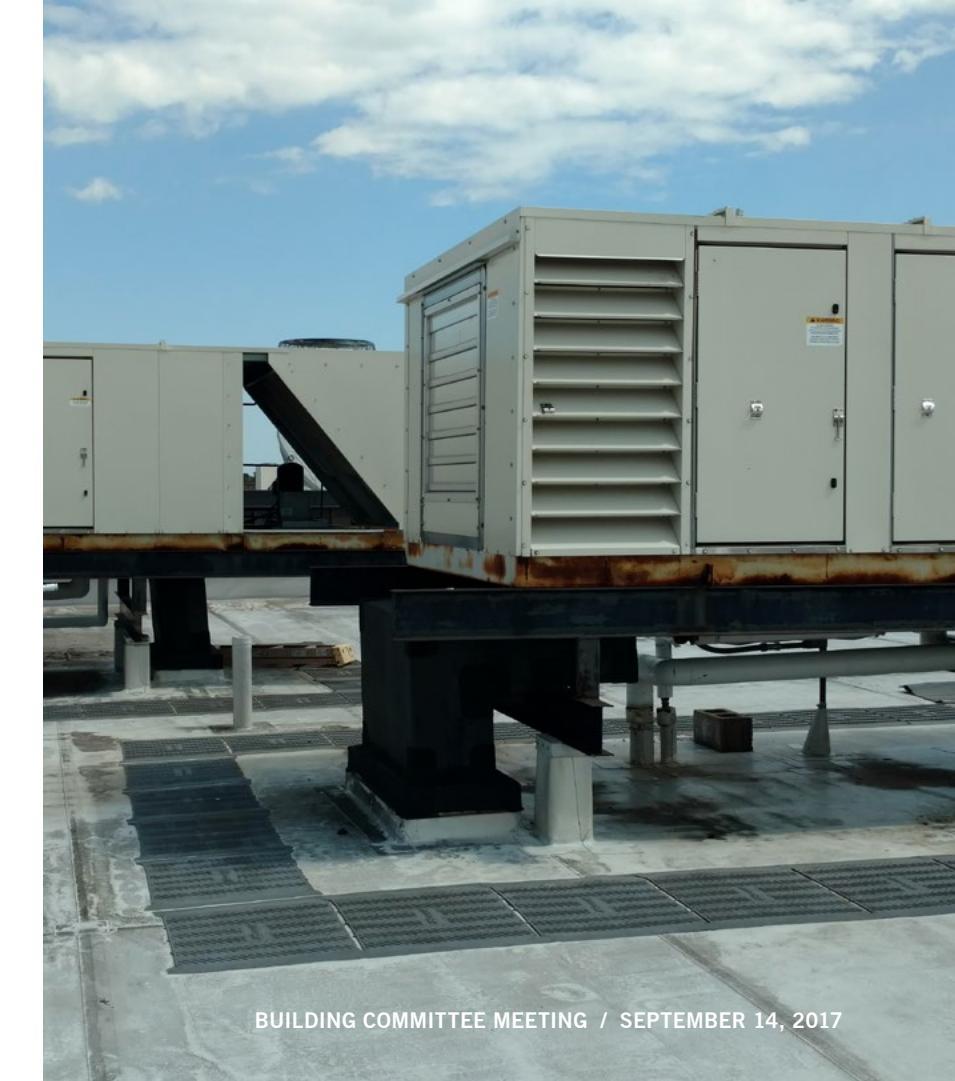
#### **ROOF TOP UNITS**

Casings are in good condition. Corrosion around the unit base.

There are two vintages of units. Same manufacturer, but with differences in technology. Five units have web interfaces.

All have steam heating coils.

Some have DX cooling.
