FORM B - BUILDING

MASSACHUSETTS HISTORICAL COMMISSION
294 WASHINGTON STREET, BOSTON, MA 02108

City Belmont
Address 567 Concord Avenue
Historic Name Site of original Holiday Farm House - now Mugar House

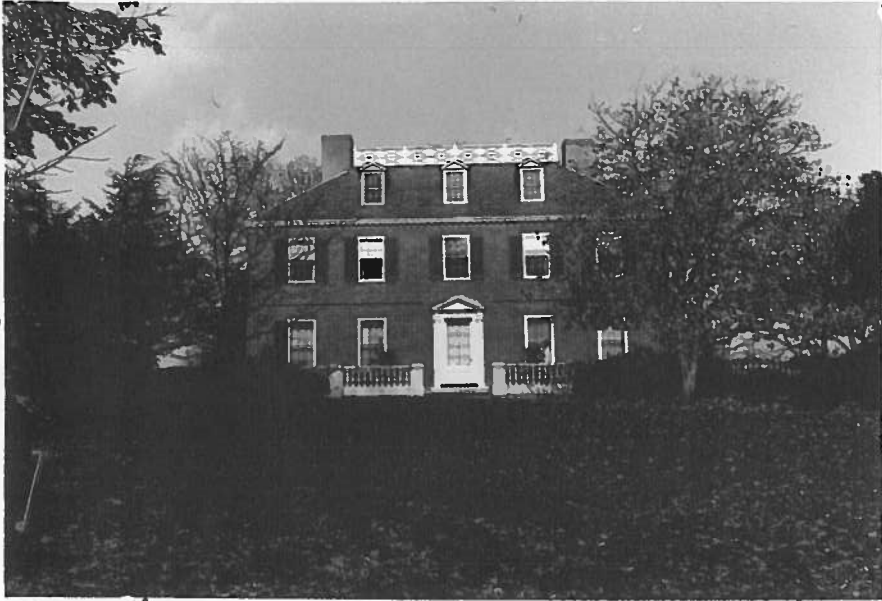
The 1918, 2½-story, 5-bay brick Georgian Revival house by Henry Richardson Shepley is significant as one of the few high-style estate houses in Belmont. The high hipped roof with balustrade at the deck, the double-end chimneys, brick quoins and string course define the blocky Georgian massing of this house.

The entry is a major design element with a balustraded terrace leading to the central door whose classical surround is established with Ionic pilasters and pediment. Other characteristics are three

pedimented dormers, modillion blocks at the eaves, segmental brick arches over the windows and six over six lights in all windows (unusual for such an otherwise detailed Georgian Revival).
