24 March 2023 Re: 711 Pleasant Street – HDC Application 1 – Façade Restoration

Applicant Statement

Façade restoration project (deferred maintenance). Replace in kind / paint to match various existing rotted wood: front porch (except roof); replace siding and trim (northeast façade, limited area at tool porch first floor); rear wood gutters and trim boards; basement door and window; trellis over deck. See scope photos, plot plan, site section attached.

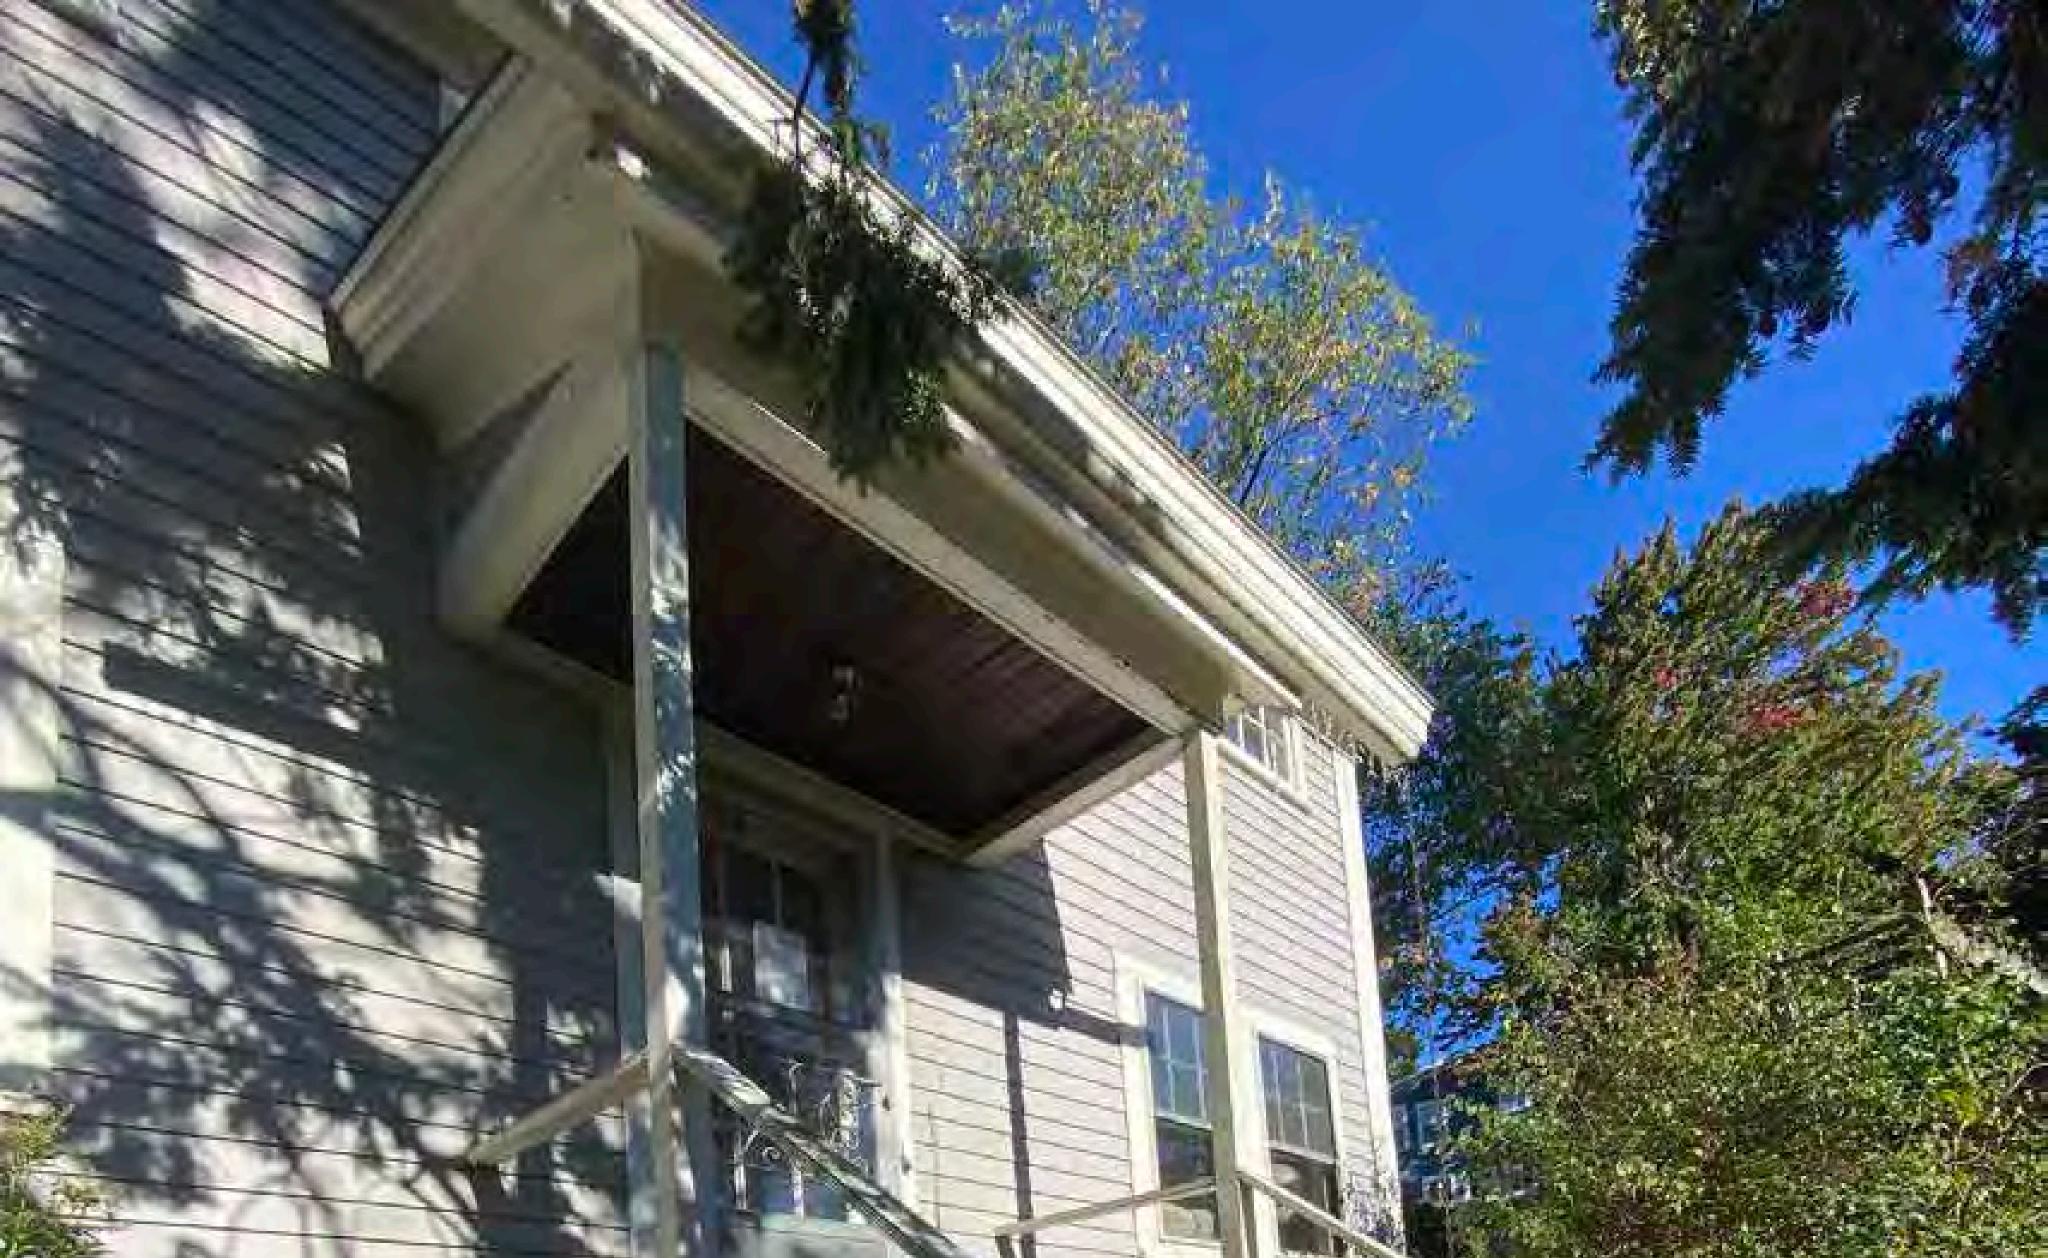
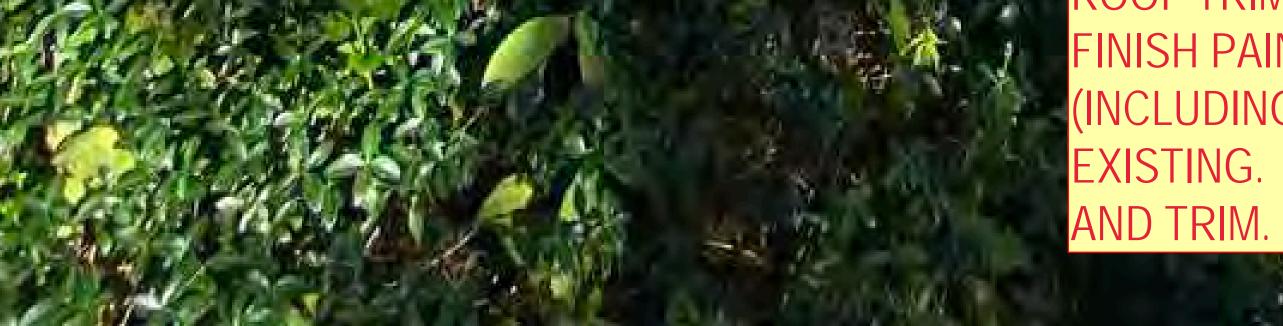
SCOPE 1 - REBUILD FRONT PORCH TO MATCH EXISTING. FIR TREADS, PT STRINGERS, LATTICE, PINE TRIM, RAILINGS + POSTS. REPLACE SECTION OF MISSING ROOF TRIM. PRIME AND TWO COATS OF

FINISH PAINT ON ALL NEW WOOD.

(INCLUDING BACKPAINT), TO MATCH

EXISTING. TYPICAL FOR ALL NEW SIDING

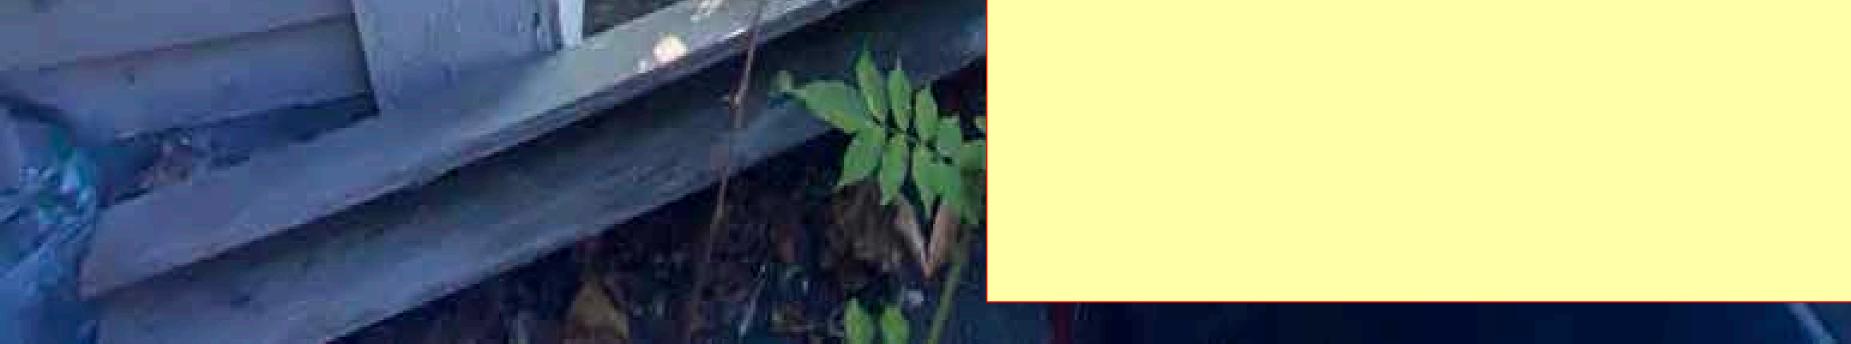
SCOPE 2 - PAINT 2 NEW STRUTS HOLDING WISTERIA AT BRICK PATIO EAST SIDE.

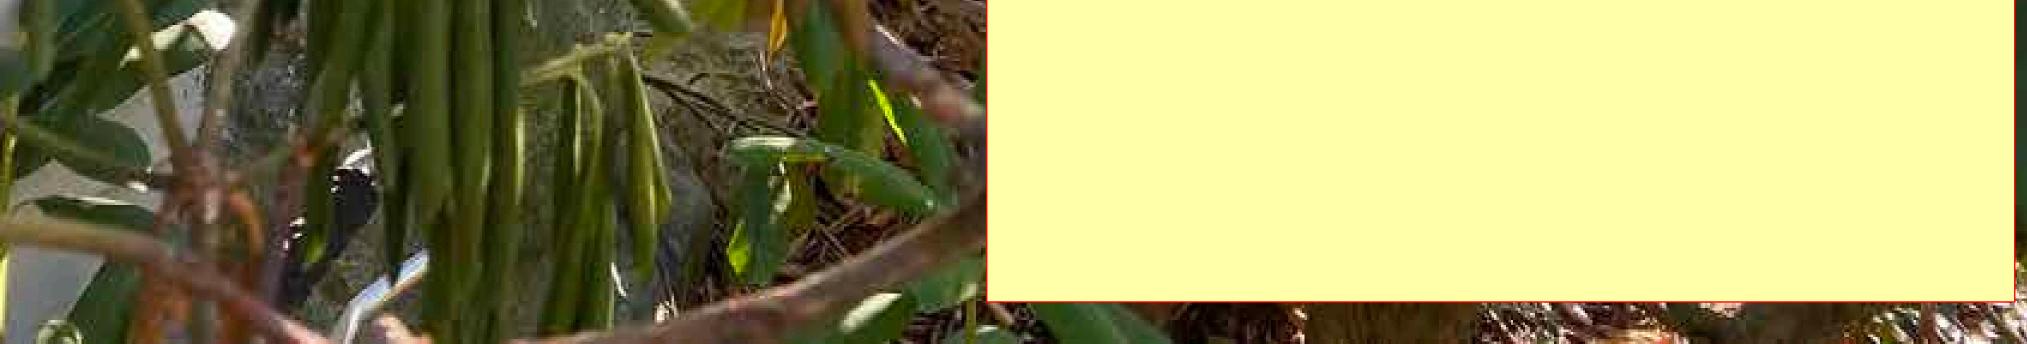
SCOPE 2 - PAINT 2 NEW STRUTS HOLDING WISTERIA AT BRICK PATIO EAST SIDE.

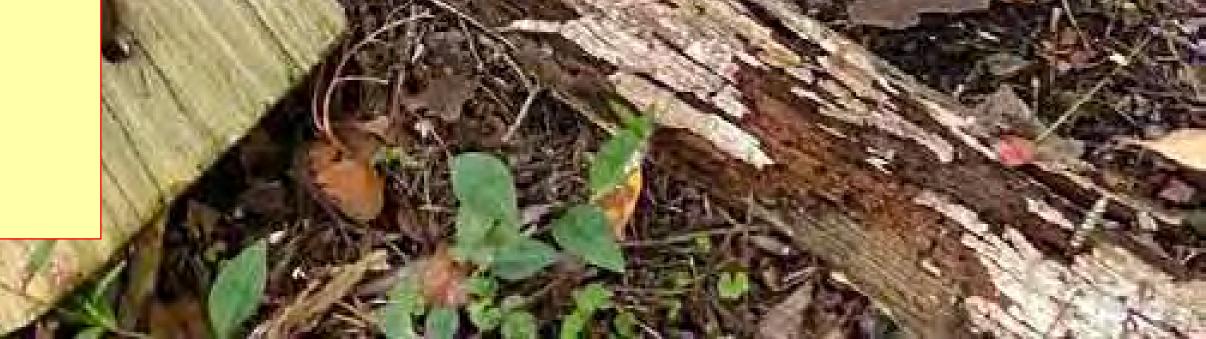
SCOPE 3 REMOVE + REPLACE TO MATCH BEVEL SIDING, SHEATHING, FLASHING AND

ROTTED TRIM AT TOOL PORCH.

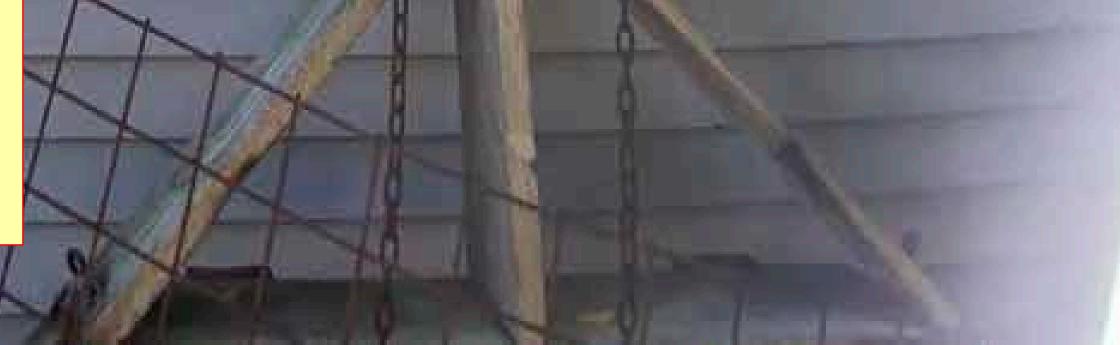
SCOPE 3 REPLACE DAMAGED AND MISSING WINDOW SILL BOARDS AT

SECOND FLOOR PORCH BEDROOM WINDOWS

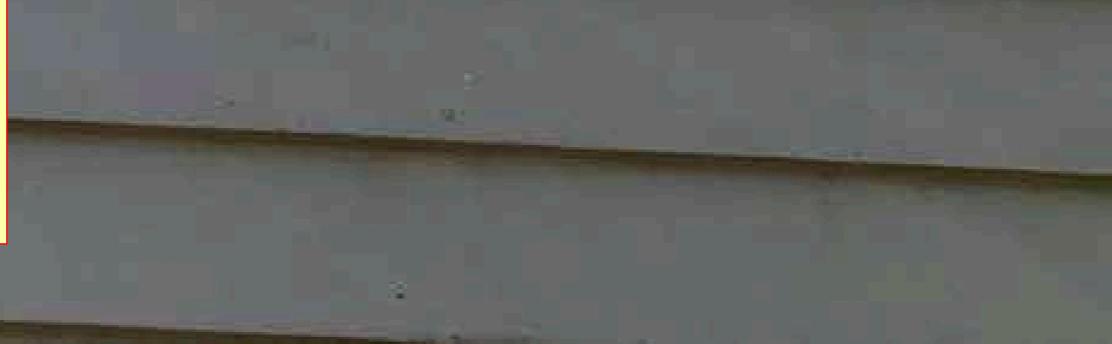
SCOPE 3 REPLACE DAMAGED AND MISSING WINDOW SILL BOARDS AT

WINDOWS

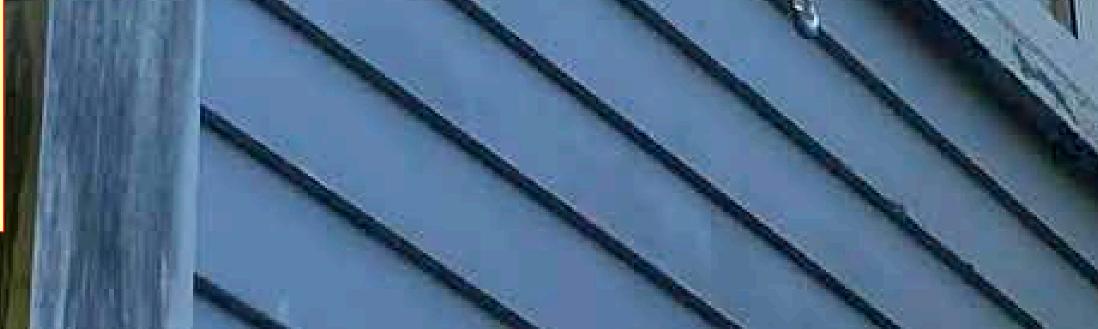
SCOPE 3 REPLACE DAMAGED AND MISSING WINDOW SILLS AT SECOND

FLOOR PORCH BEDROOM WINDOWS

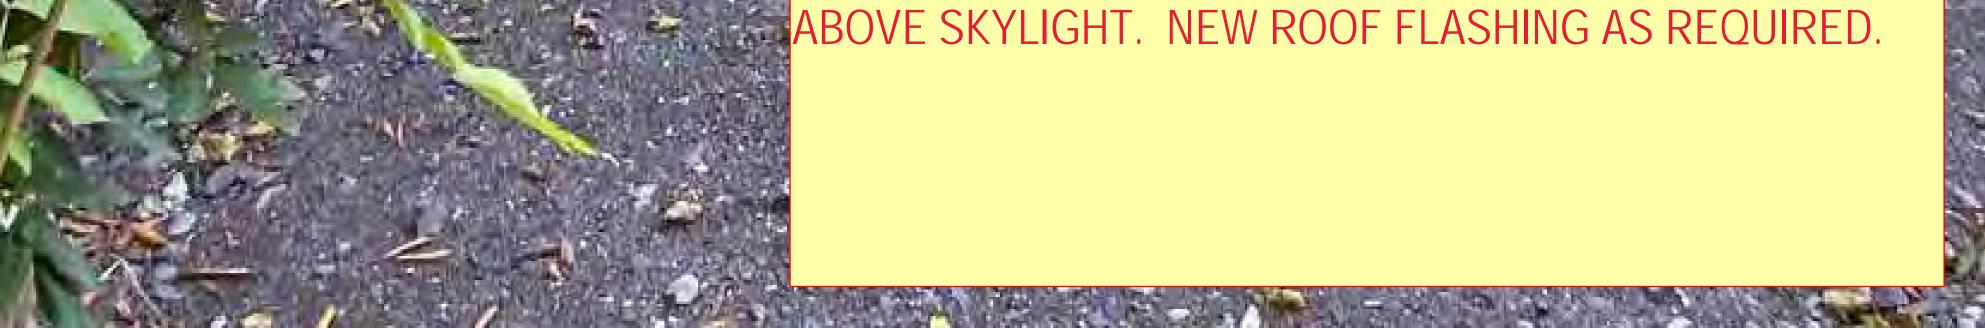
SCOPE 4 REMOVE AND REPLACE IN KIND THREE REAR GUTTERS AND BACKER BOARDS, PLUS ONE ROTTED TRIM BOARD AT TRIANGULAR WINDOW IN MASTER BATHROOM

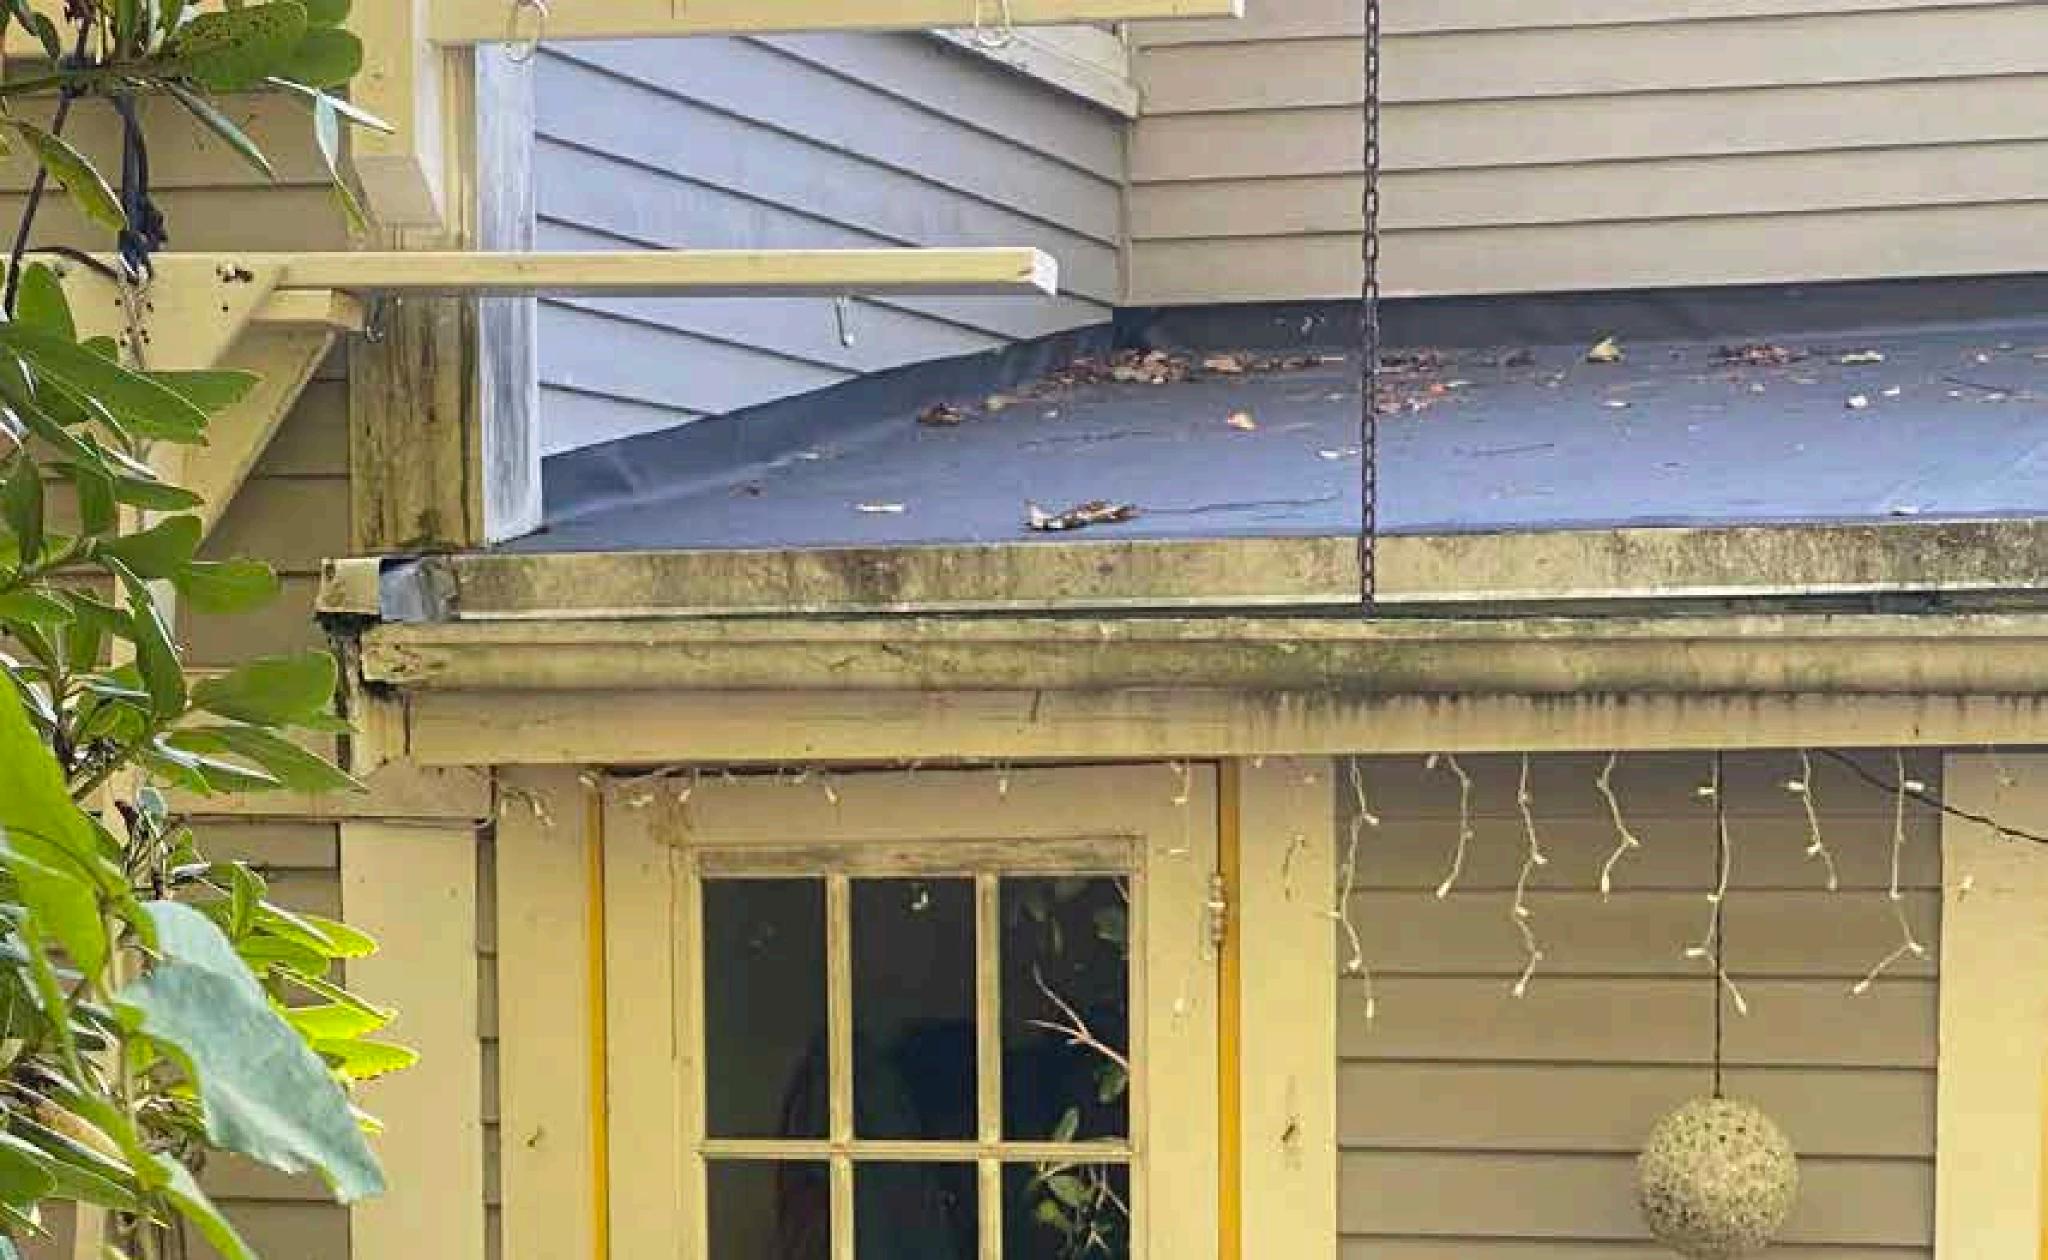
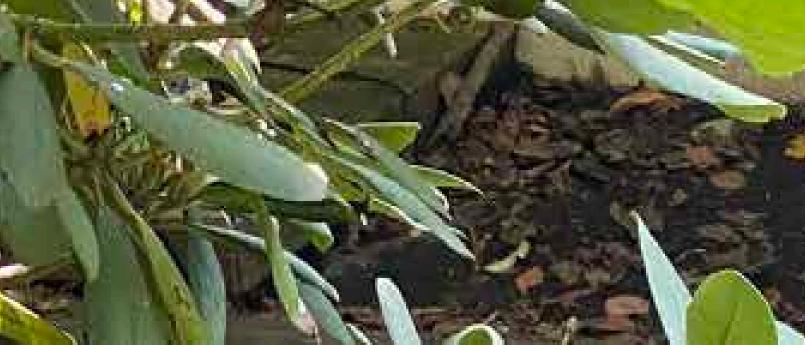
SCOPE 4 REMOVE AND REPLACE IN KIND THREE REAR GUTTERS AND BACKER BOARDS, PLUS ONE ROTTED TRIM BOARD AT TRIANGULAR WINDOW IN MASTER BATHROOM

ABOVE SKYLIGHT. NEW ROOF FLASHING AS REQUIRED.

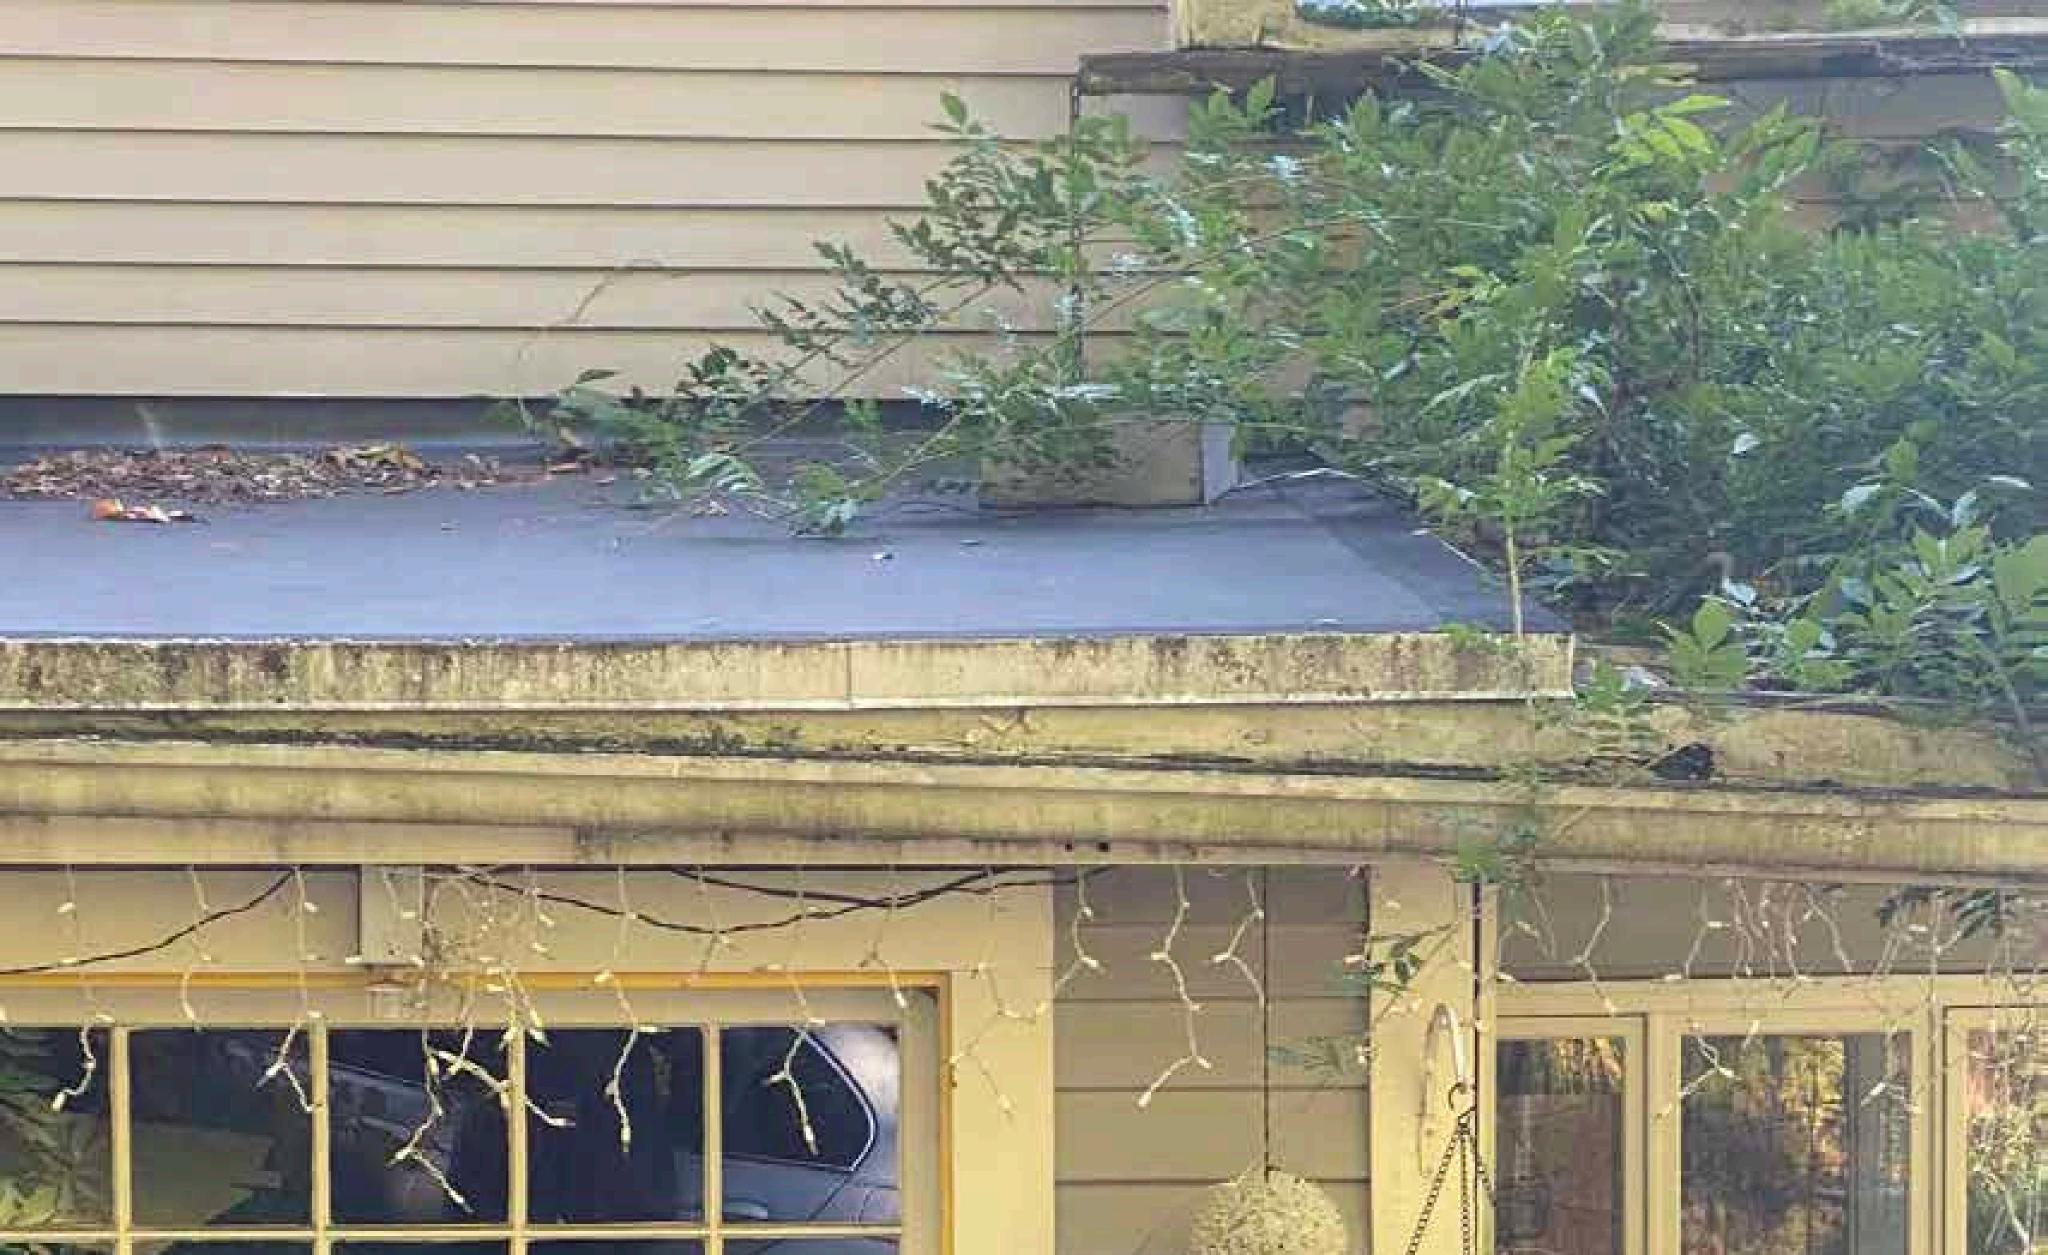
SCOPE 4 REMOVE AND REPLACE IN KIND THREE REAR GUTTERS AND BACKER BOARDS, PLUS ONE ROTTED TRIM BOARD AT TRIANGULAR WINDOW IN MASTER BATHROOM

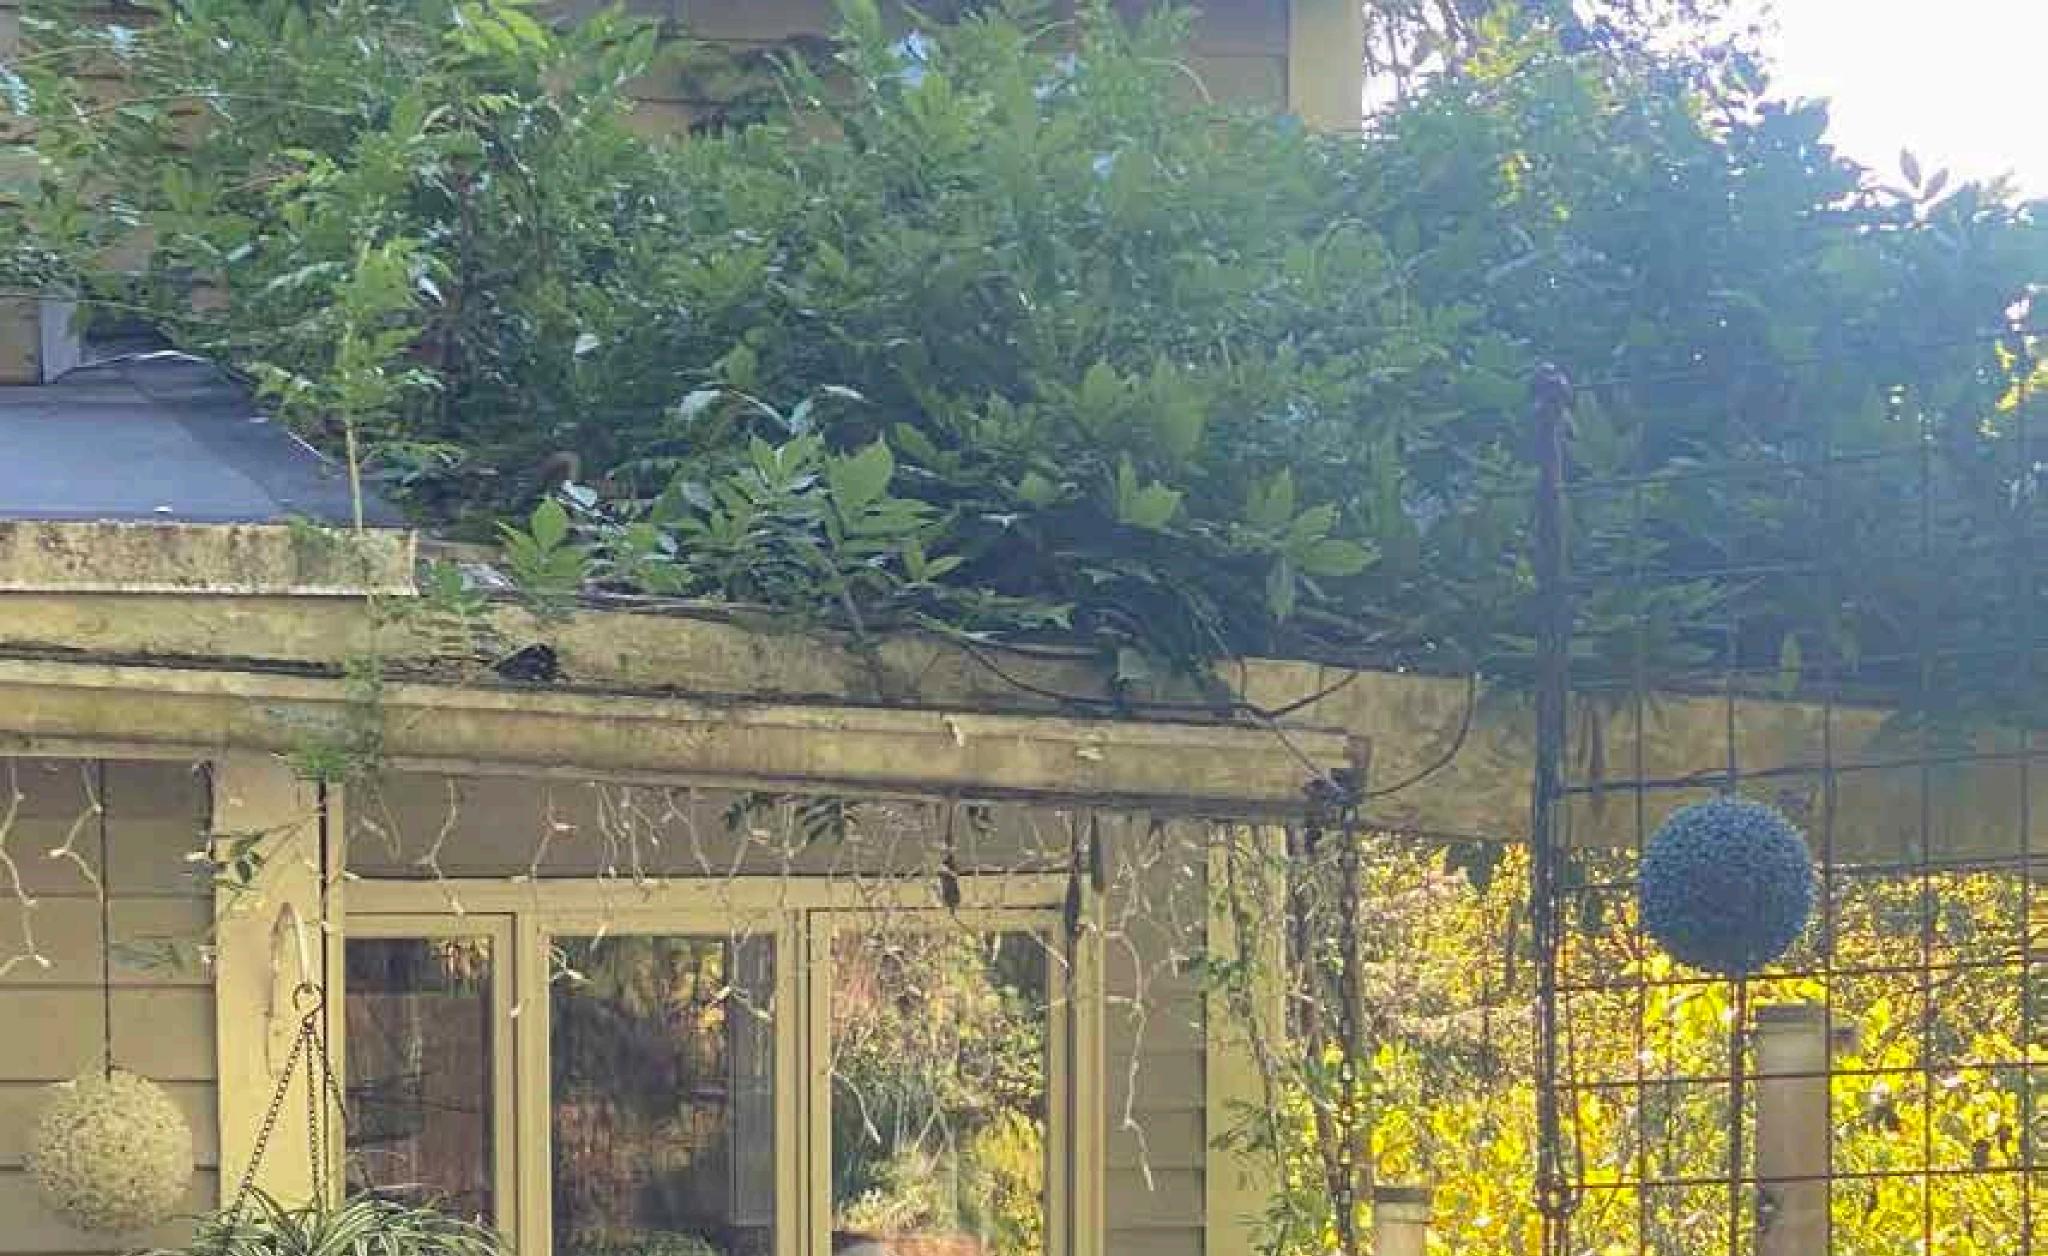
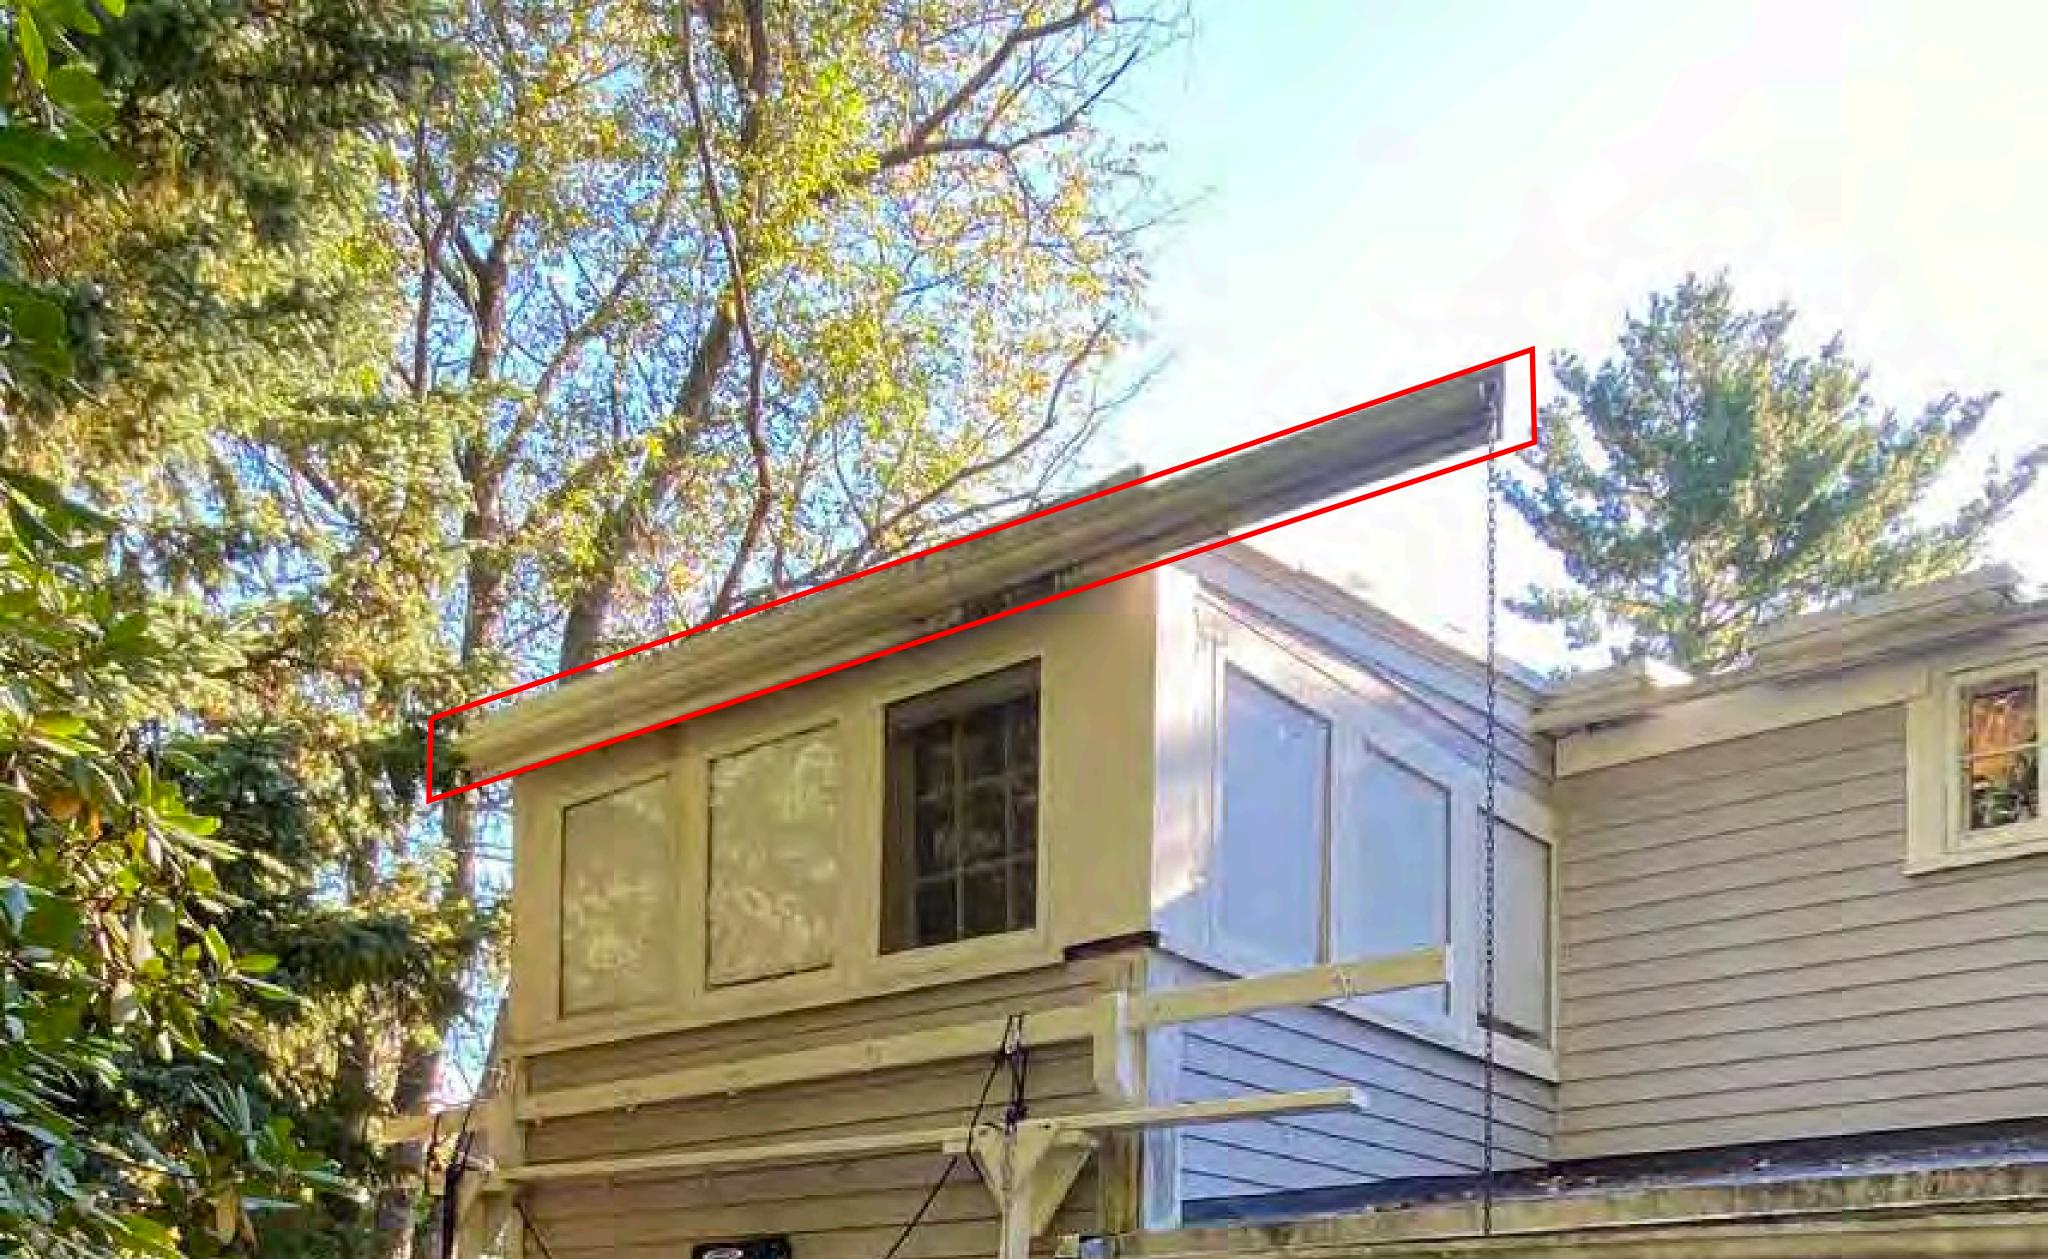
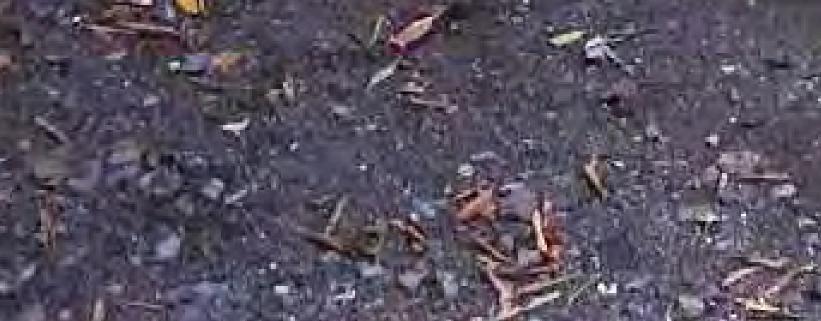
ABOVE SKYLIGHT. NEW ROOF FLASHING AS REQUIRED.

- 1. Remove all wood gutter and fascia and replace with (solid gold) trim and 4 x 5 fir gutter. Apply two (2) flood coats of linseed oil to trough.
- 2. Rebuild trellis (protect vine) using fir 2 x 6. Back prime all wood and cut with oil-based primer.

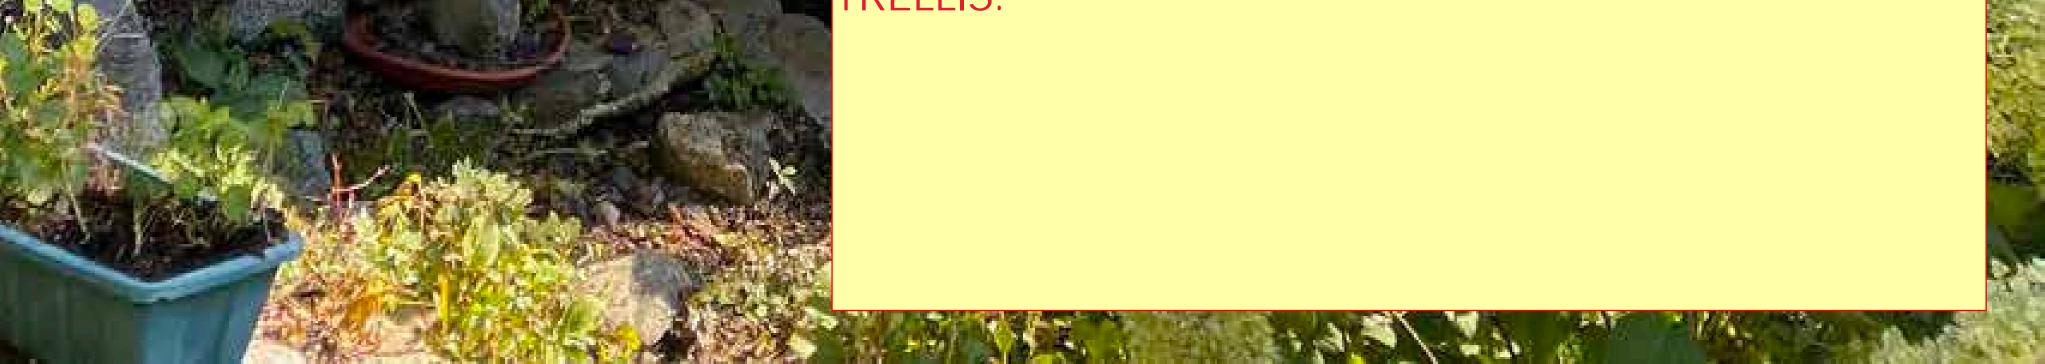
SCOPE 4 REPLACE EXISTING TRELLIS OVER DECK . PROTECT WISTERIA VINE AND REATTACH TO NEW TRELLIS.

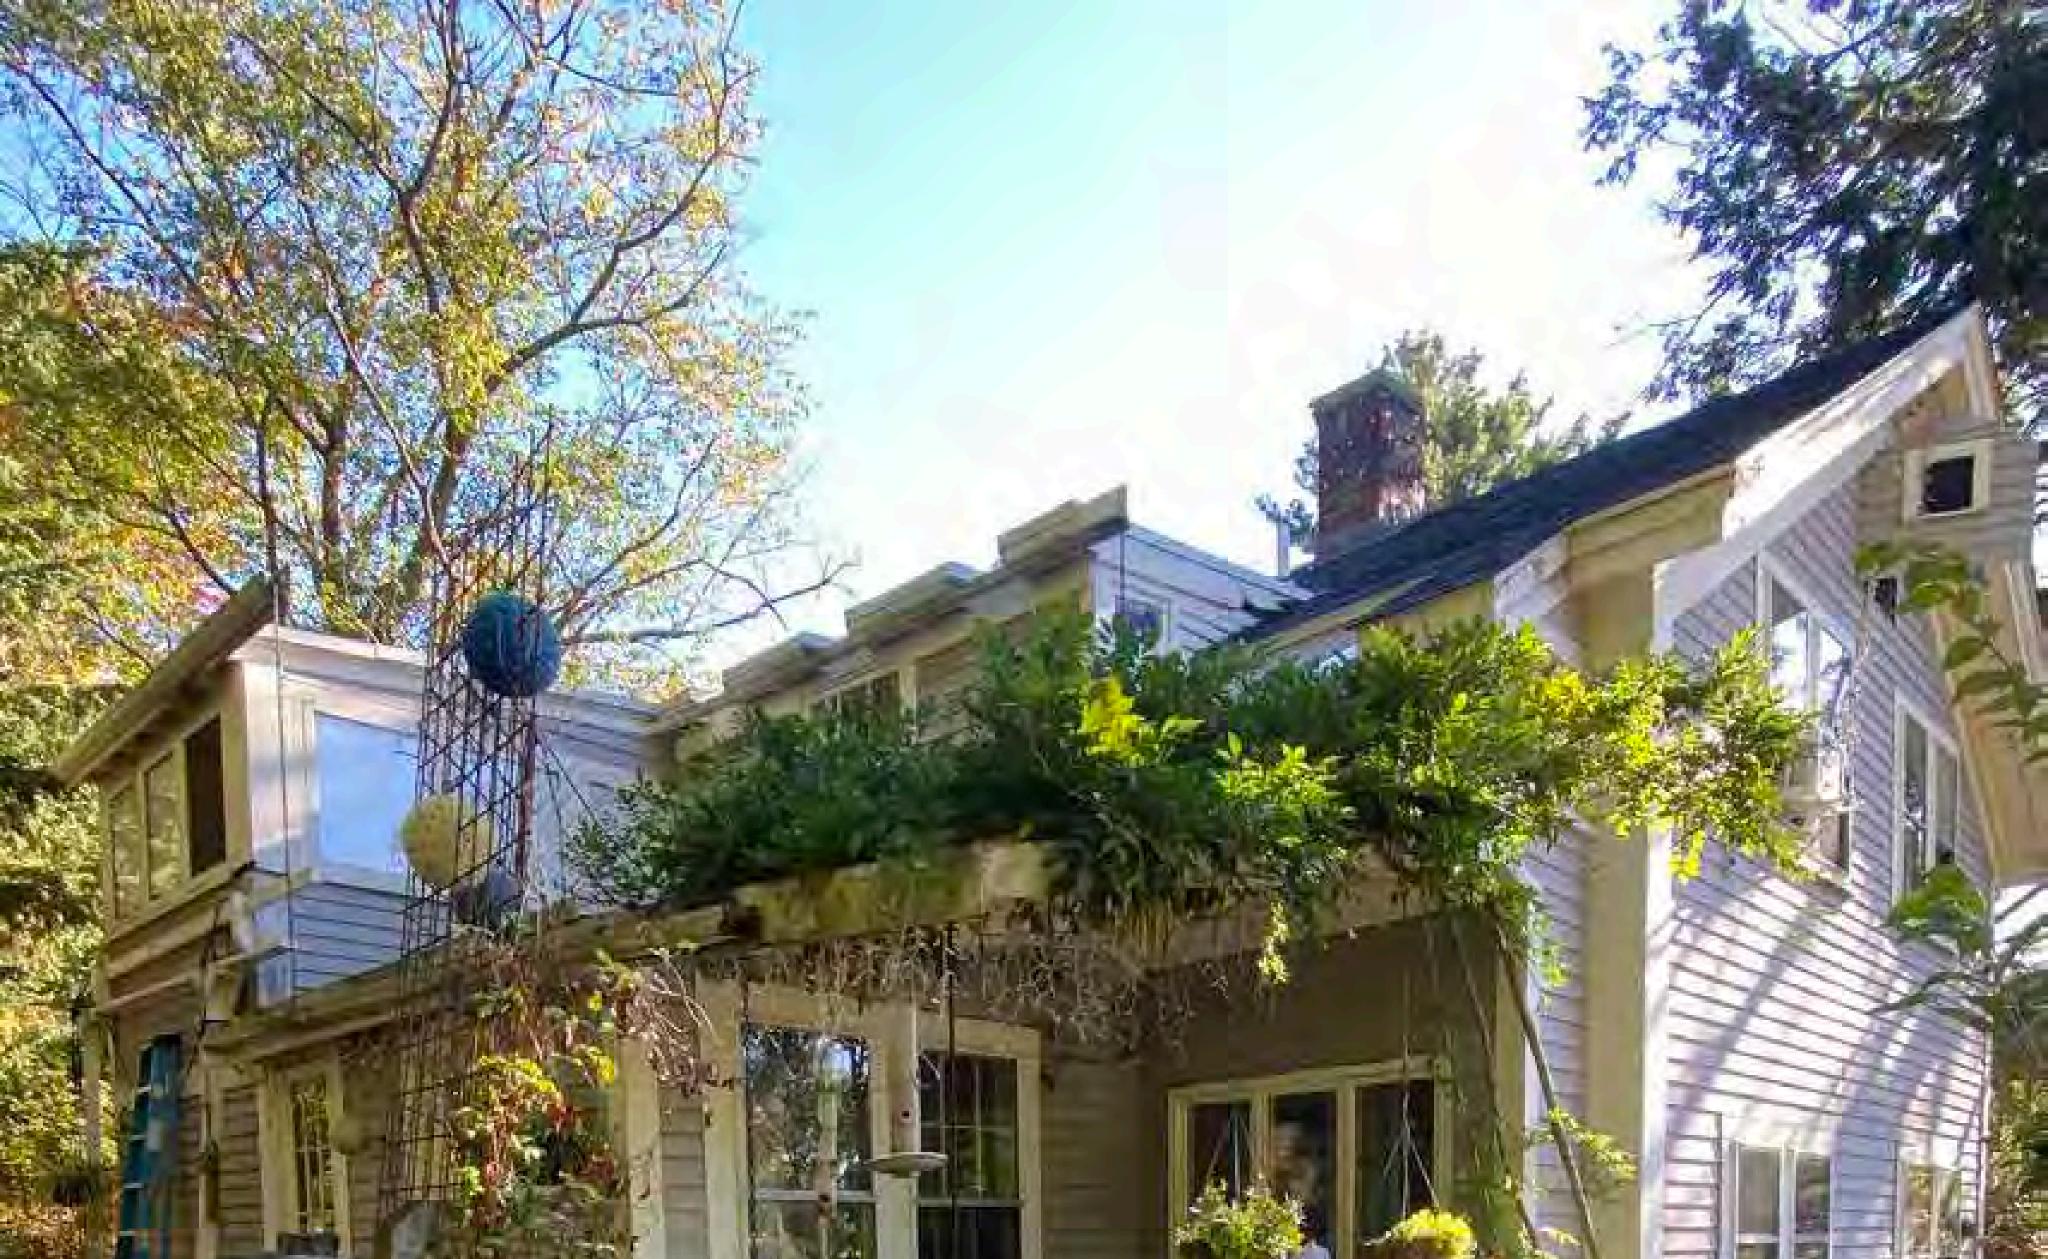
SCOPE 4 REMOVE AND REPLACE IN KIND ONE ROTTED TRIM BOARD AT TRIANGULAR WINDOW IN MASTER BATHROOM ABOVE TRAPEZOIDAL WINDOW.

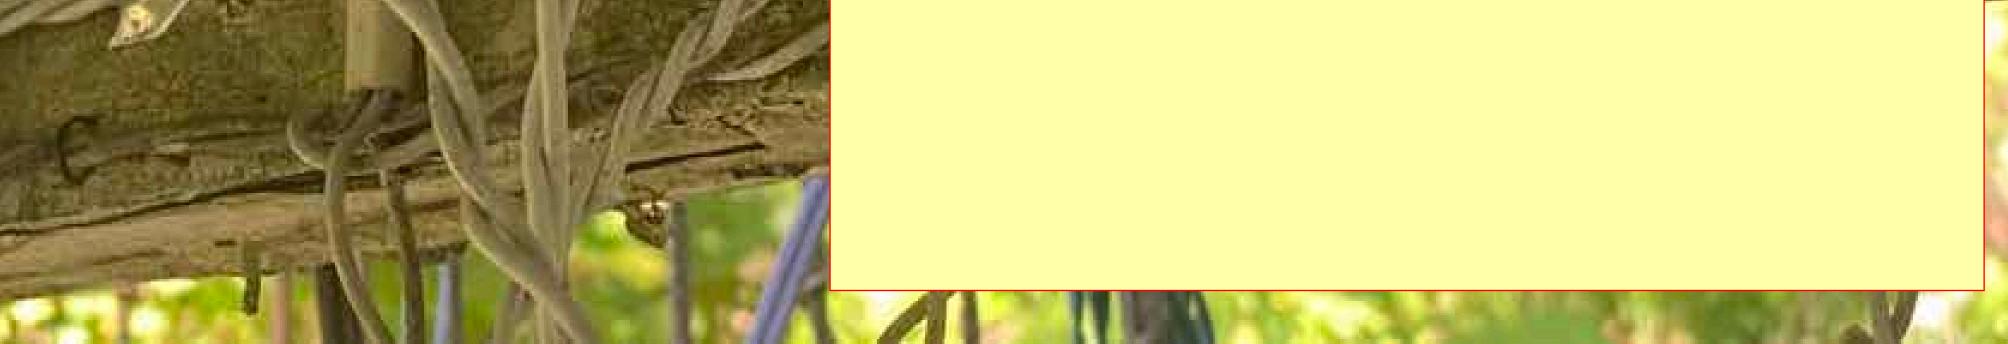
SCOPE 4 REMOVE AND REPLACE EXISTING TRELLIS OVER DECK. PROTECT WISTERIA VINE AND REATTACH TO NEW TRELLIS.

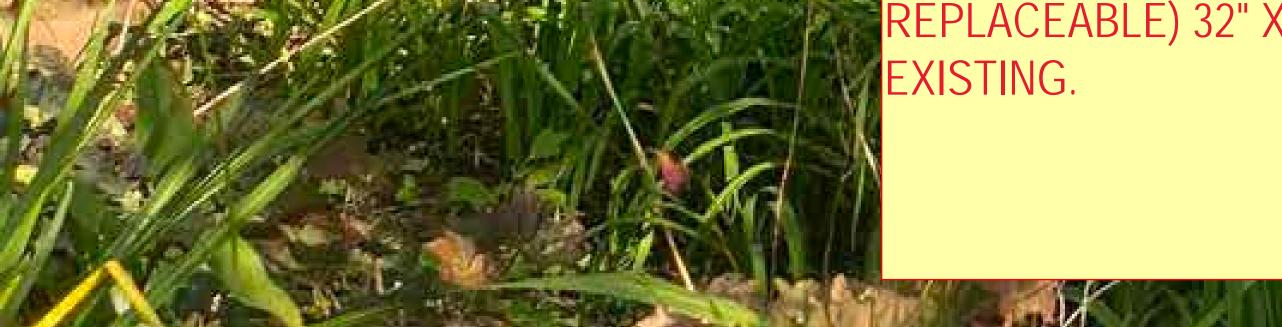
SCOPE 5 REGLAZE LARGE EXISTING THERMOPANE WINDOW TO BASEMENT (OUTER LIGHT BROKEN) 46.5" X 76.5", TO MATCH EXISTING REPLACE THERMOPANE DOOR TO BASEMENT (OUTER LIGHT BROKEN, NOT

REPLACEABLE) 32" X 6'-5", WITH FIR DOOR TO MATCH

- 1. Re-glaze 42" x 78" thermopane window, driveway side.
- 2. Replace full light basement door with a new full light 32" x 80" door. Replace interior and exterior trim.
- 3. Prime and paint all wood.
- 4. Replace existing storm door at rear of house (labor only).
