24 March 2023 Re: 711 Pleasant Street – HDC Application 1 – Façade Restoration

Applicant Statement

Façade restoration project (deferred maintenance). Replace in kind / paint to match various existing rotted wood: front porch (except roof); replace siding and trim (northeast façade, limited area at tool porch first floor); rear wood gutters and trim boards; basement door and window; trellis over deck. See scope photos, plot plan, site section attached.

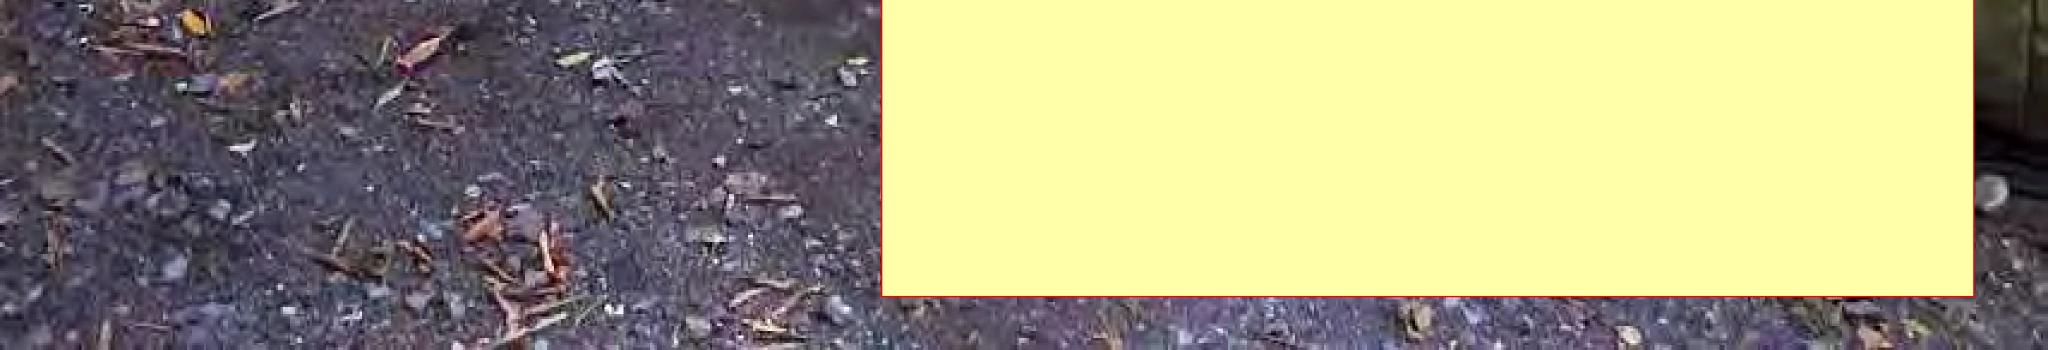
SCOPE 5 REPLACE EXISTING STORM DOOR AT REAR ENTRANCE (ROTTED) WITH NEW TO MATCH EXISTING, WITH STORM AND SCREEN INSERTS.

- 1. Re-glaze 42" x 78" thermopane window, driveway side.
- 2. Replace full light basement door with a new full light 32" x 80" door. Replace interior and exterior trim.
- 3. Prime and paint all wood.
- 4. Replace existing storm door at rear of house (labor only).

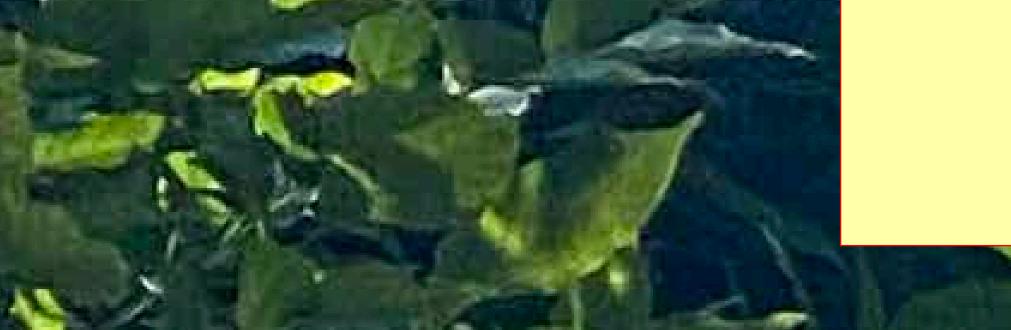
SCOPE 5 REGLAZE EXISTING TRAPEZOIDAL WINDOW IN MASTER BATHROOM (CRACKED).
