# 3.1.4 EVALUATION OF EXISTING CONDITIONS

# 3.1.4 - EVALUATION OF EXISTING CONDITIONS

**RE: Historic Status, Belmont High School**

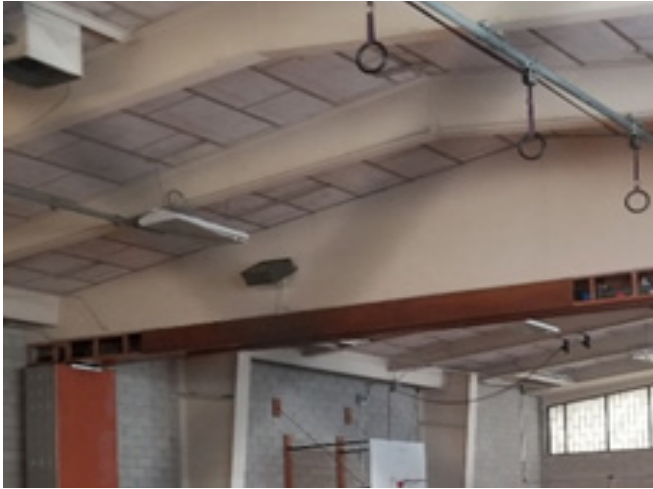
Figure 1-1: Unprotected Steel Construction

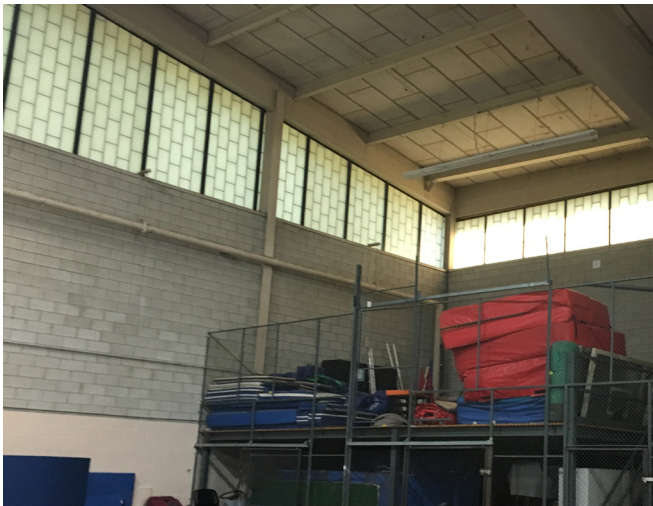
Figure 1-2: Unprotected Steel Construction

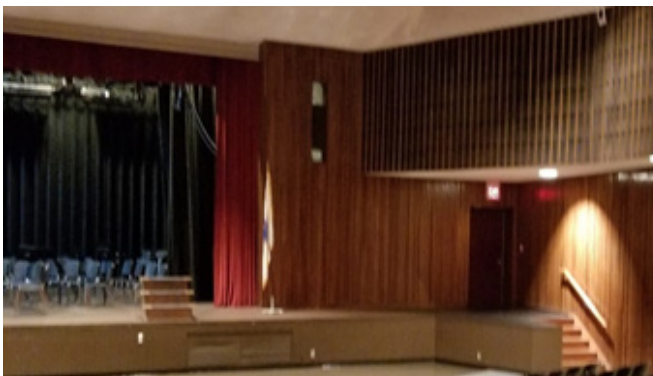
Figure 2: Stage

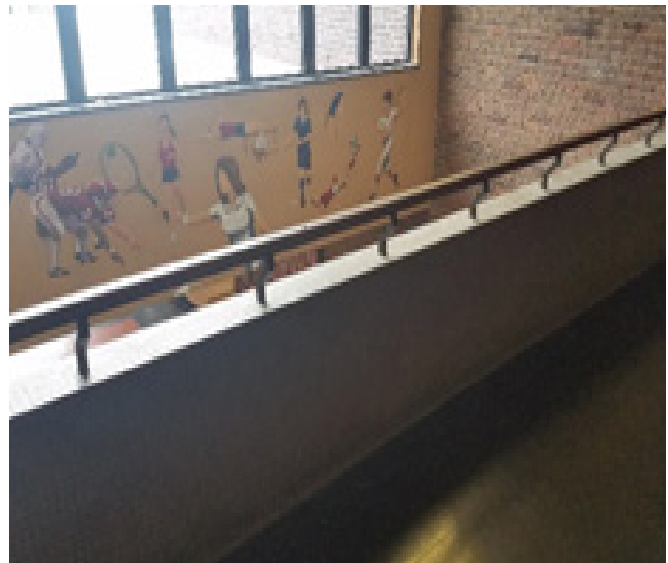
Figure 6: 2-Story Opening with 35.5" Guard

As non-compliant guards are a hazardous condition that may be cited by the AHJ, it is recommended that these guards be addressed regardless of project scope. Where guards or handrails are replaced, they are required to be comply with the requirements for new construction, as outlined below.

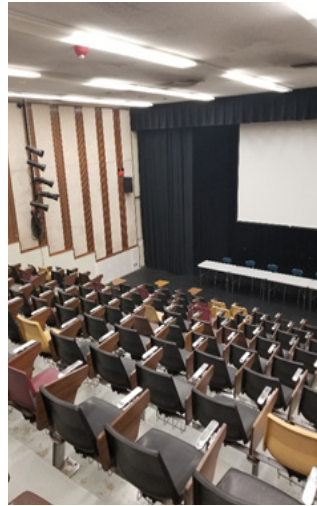
Figure 7: Lecture Seating

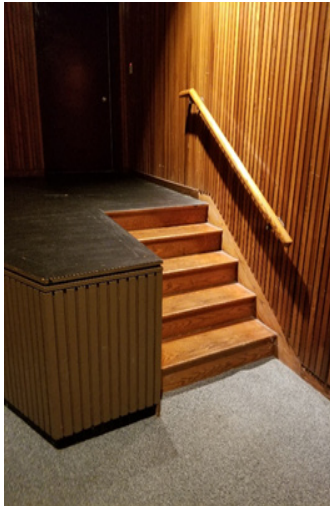
Figure 11: Stage Access

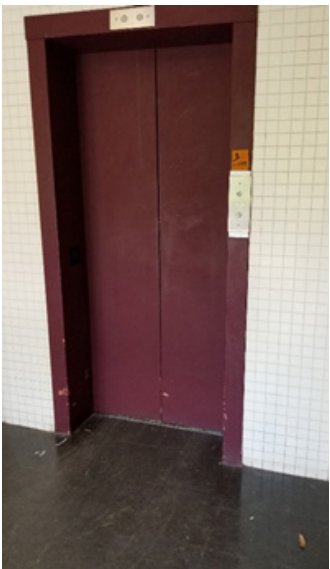
Figure 13: Elevator

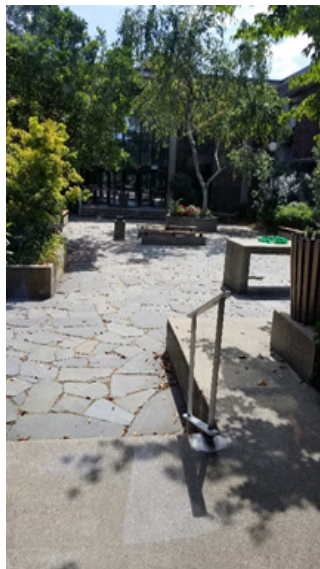
Figure 14: Courtyard

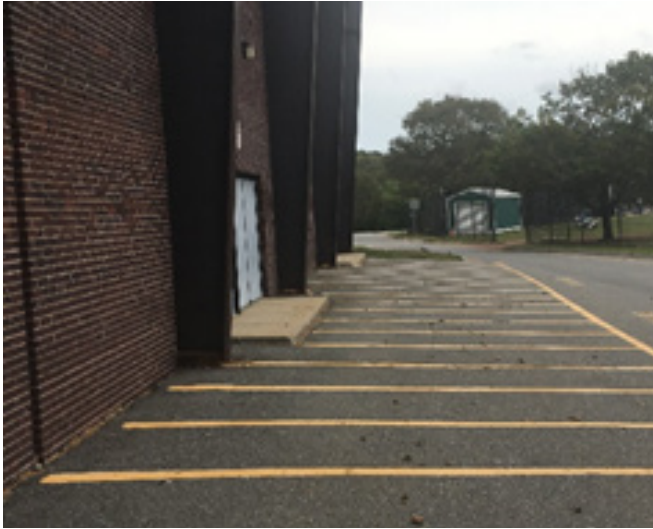
Figure 7: Pavement

Pavement was assessed during the 2017 site visit. Images from google street view suggests that the parking lot was resurfaced in 2013. The asphalt pavement the parking lot, front drive, and walkways adjacent to the school were observed to be in fair condition with some cracking and degradation. The pavement in the driveway to the rear of the school was in poor condition. Curbing on the site is granite, and bituminous concrete in the

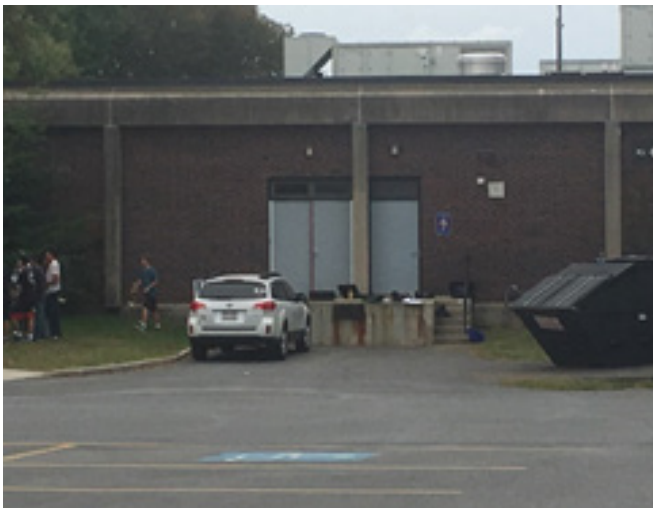
Figure 8-1: Pavement

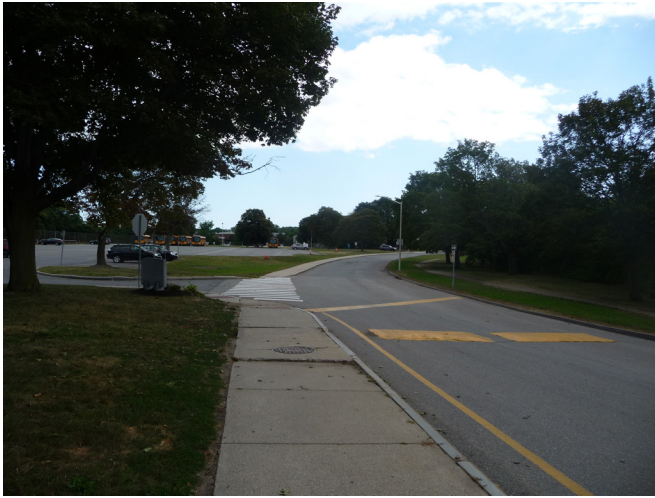
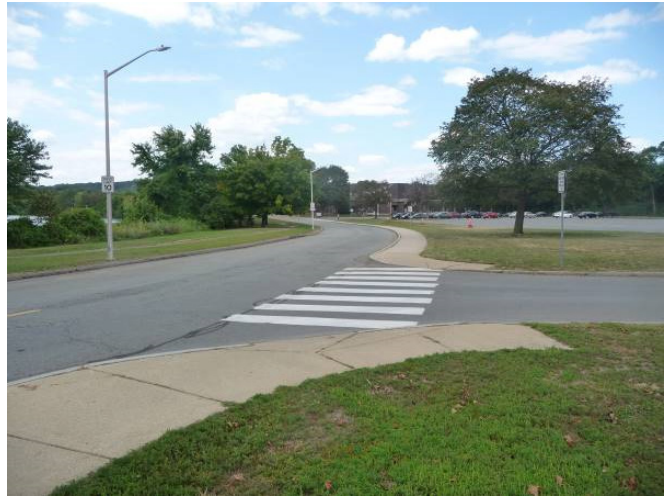
Main Driveway Entrance to the school site looking east toward Hittinger Street (left) and west toward the school building (right)

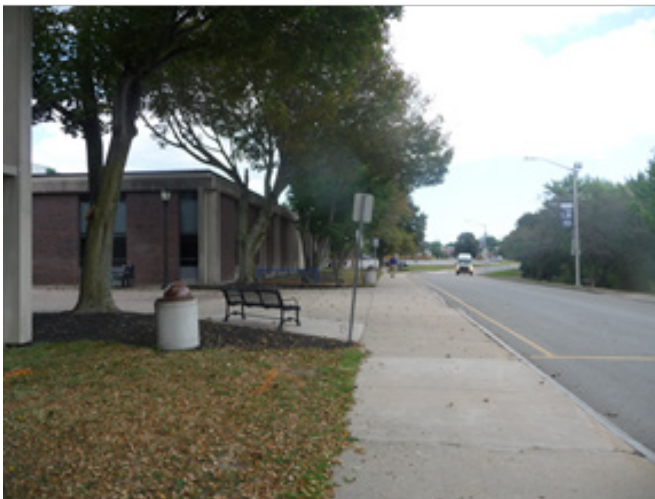
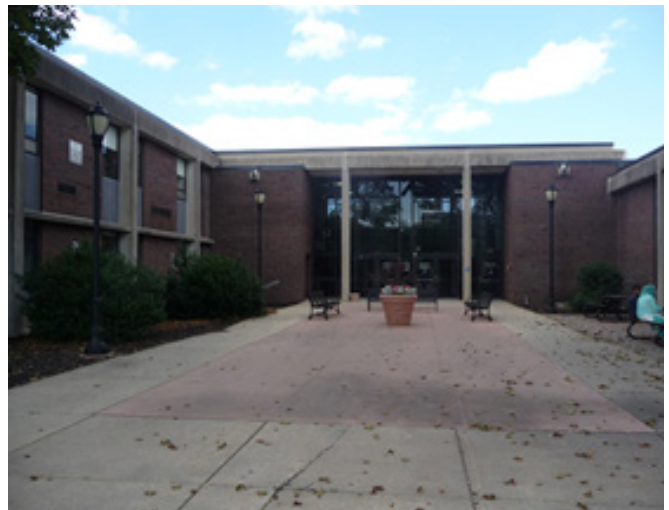
Primary school building entry plaza

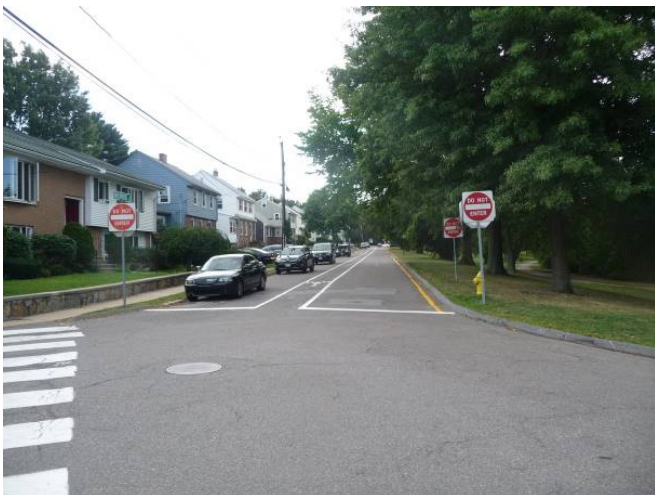
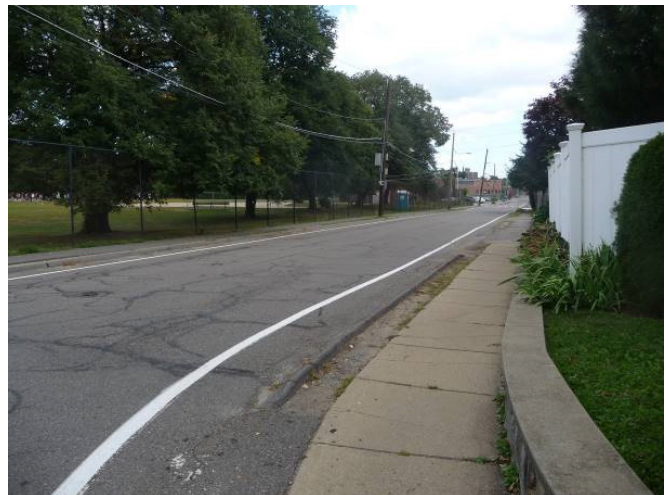
Looking south down Underwood Street (left) and east down Hittinger Street (right)

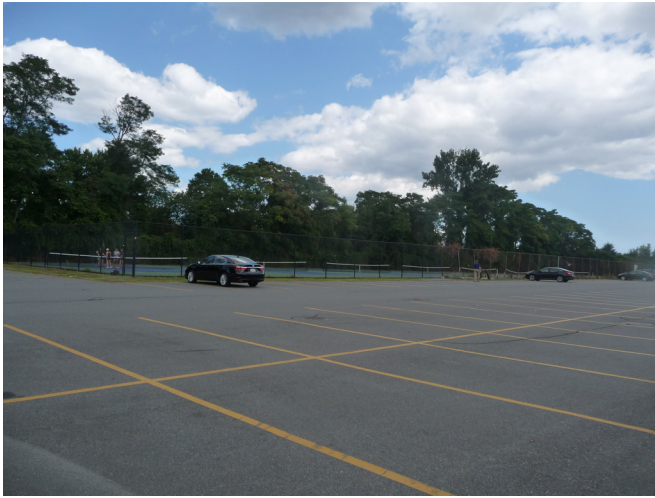
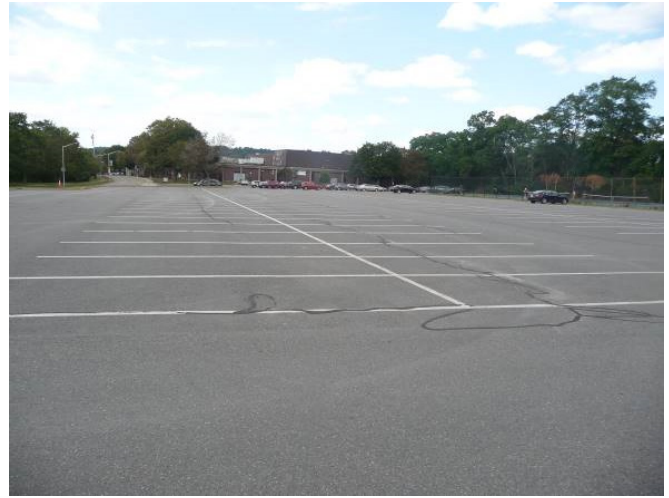
Primary parking lot east of the school building looking northeast to the tennis courts (left) and west to the school building (right)

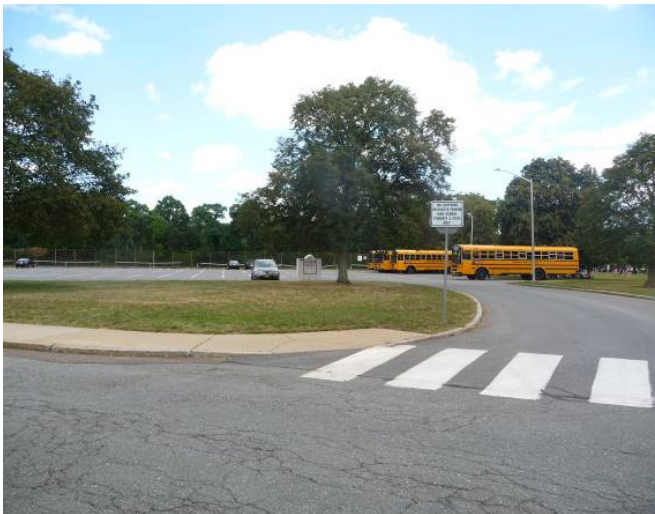
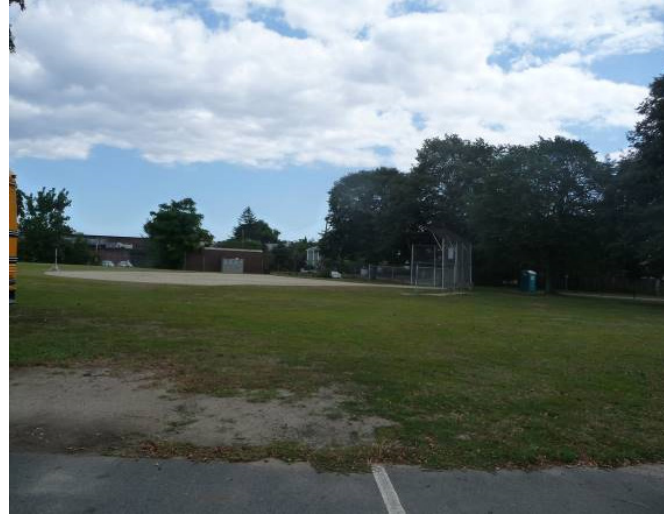
Bus parking (left) and softball field east of the school building (right)

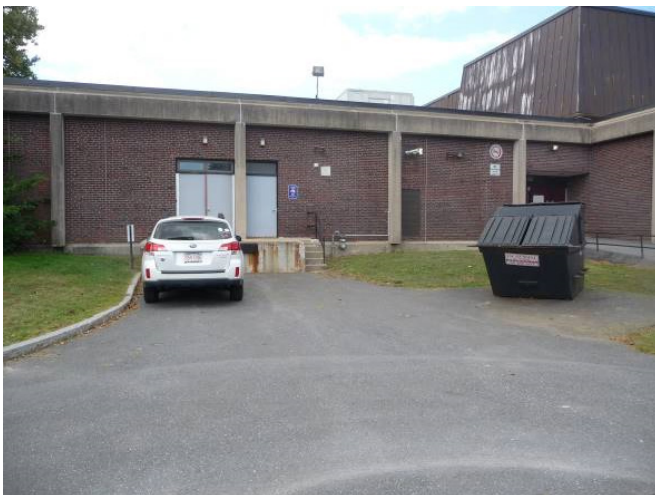
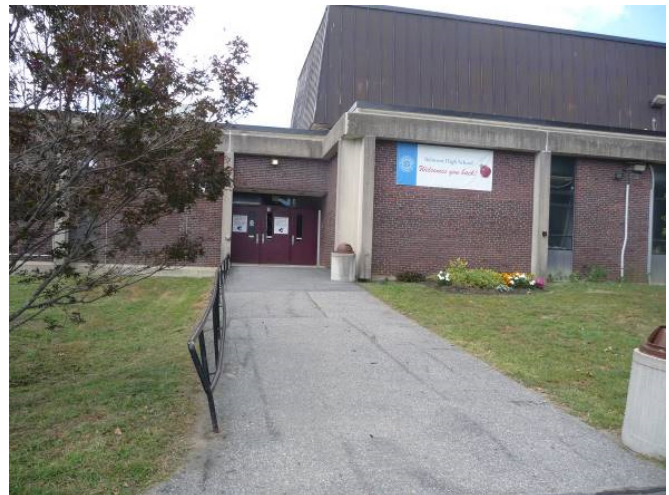
Service area (left) and secondary entrance (right) on east side of school building

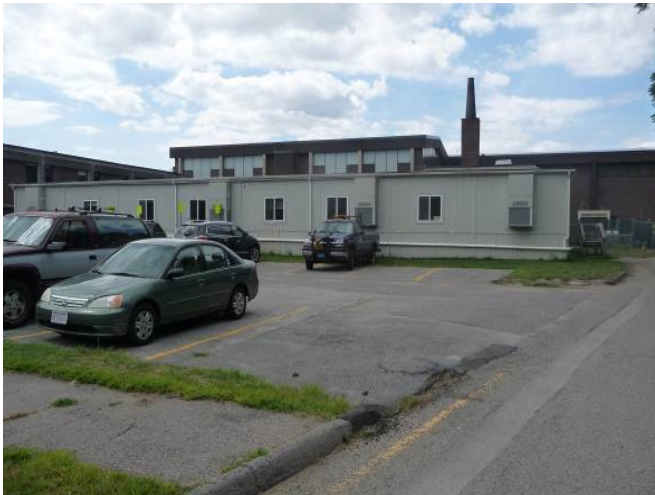
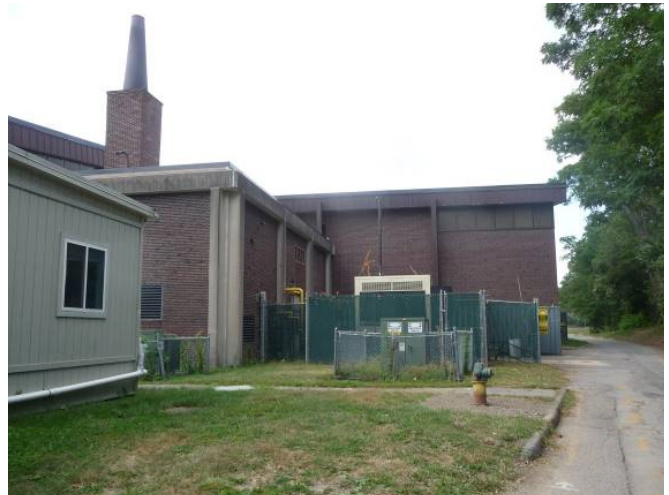
*Modular building on north side of school building (left); electrical transformer on north side of school building with railroad embankment to the right (right)*

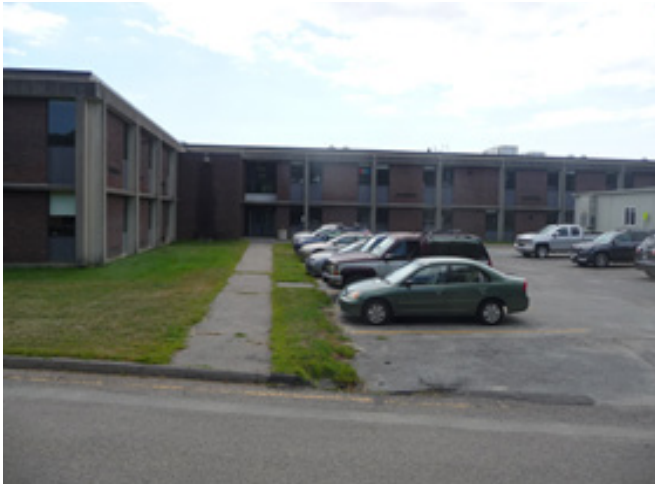
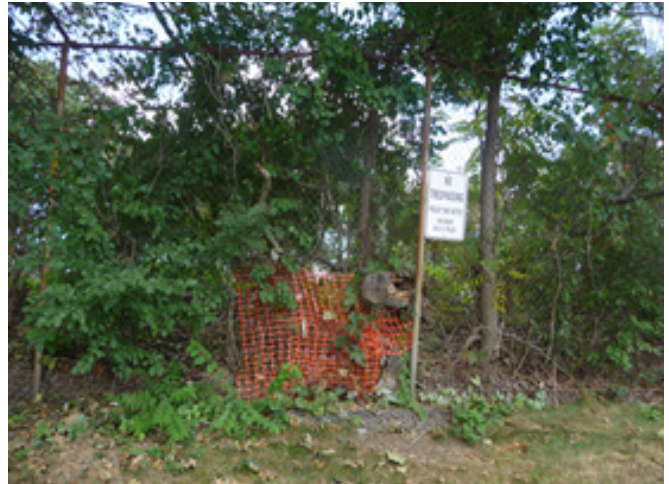
*Parking area on north side of school building (left); patched holes in north boundary fence between school building and MBTA right-of-way (right)*

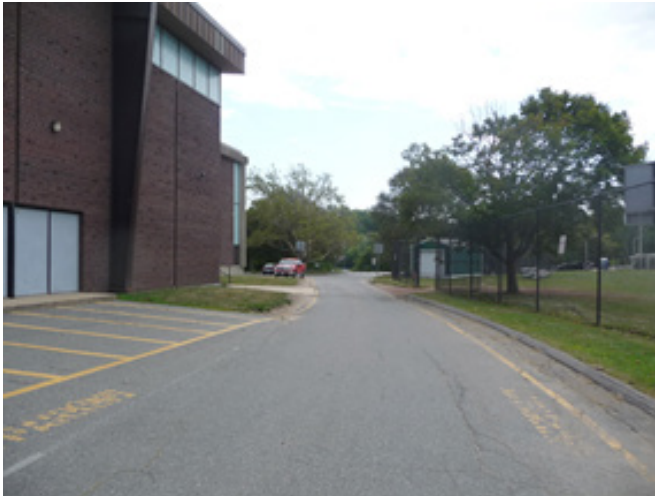
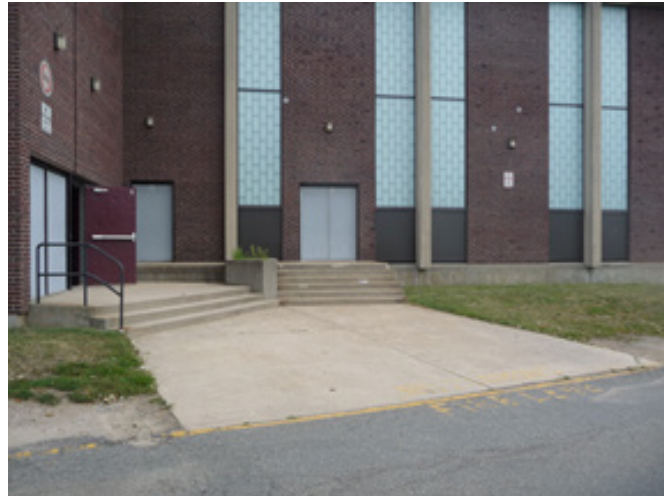
*Drive on west side of building between fieldhouse and athletic fields (left); No exterior accessible entrance to fieldhouse (right)*

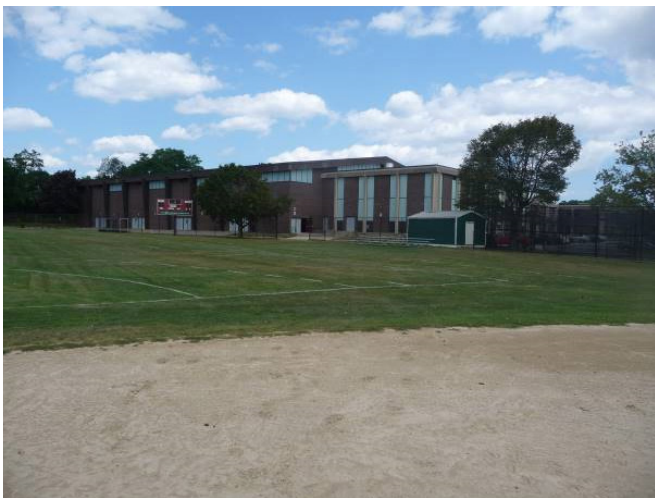
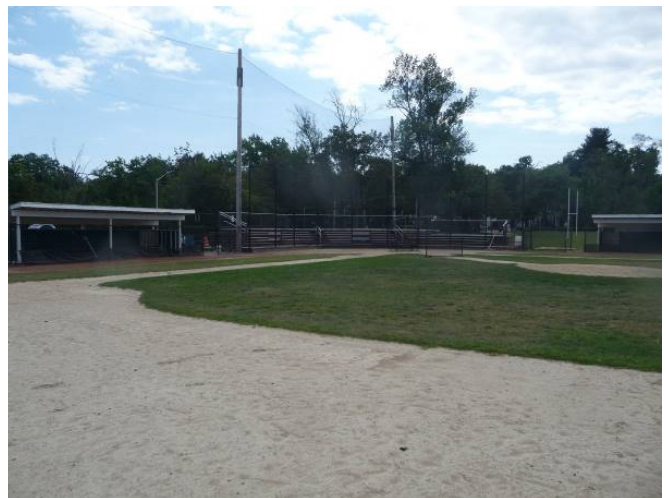
*Looking northeast toward school building from Brendan Grant Memorial Baseball Field (left); bleacher and dugouts at Brendan Grant Memorial Baseball (right)*

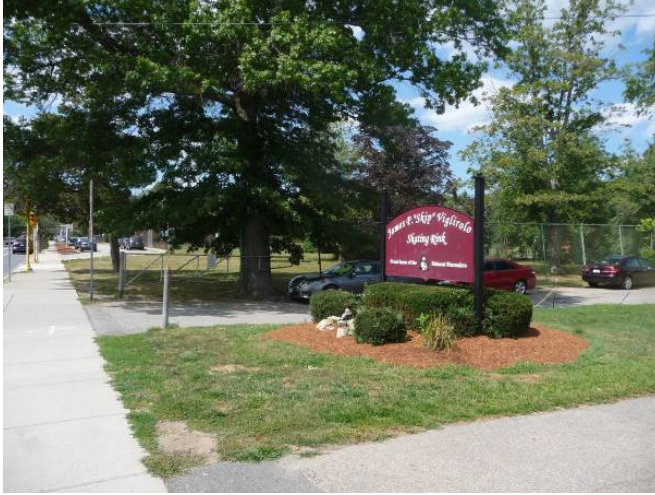
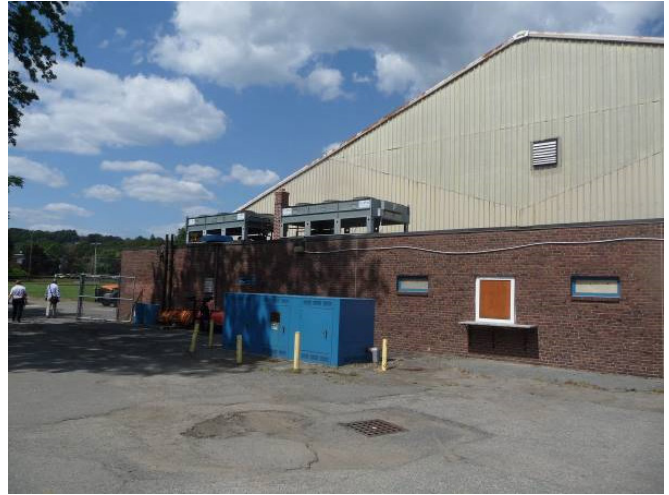
Entrance to skating rink (left); south face of skating rink structure (right)

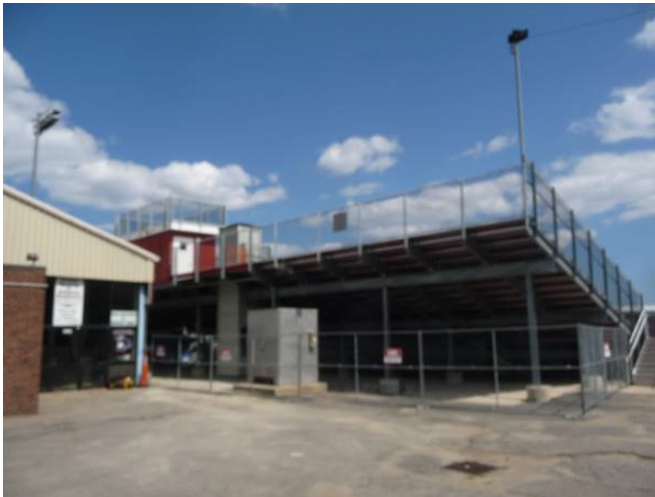
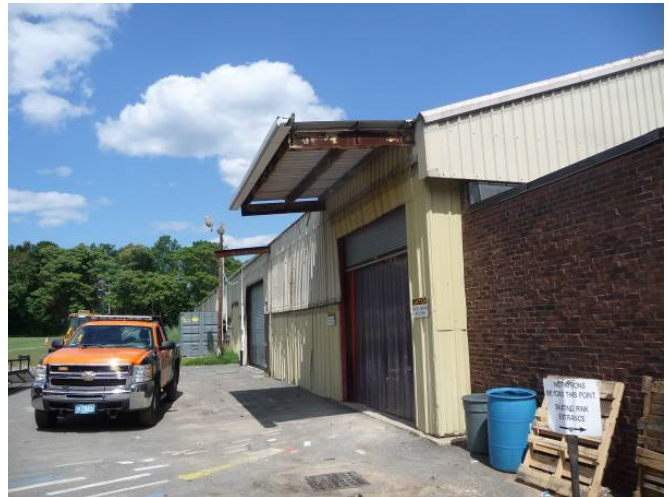
Home bleacher, press box with elevator (to remain) with skating rink to west. There are no public restrooms associated with Harris Field bleachers (left); Skating rink structure in poor condition (right)

Proposals for replacing the failing indoor skating rink show the need for a larger building utilizing a portion of the school site. Planning efforts for the school project will need to consider the space needs for the future rink building, access and supporting facilities.

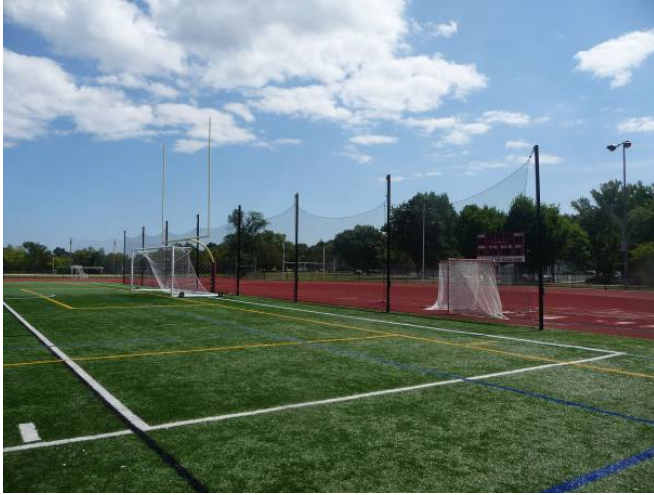
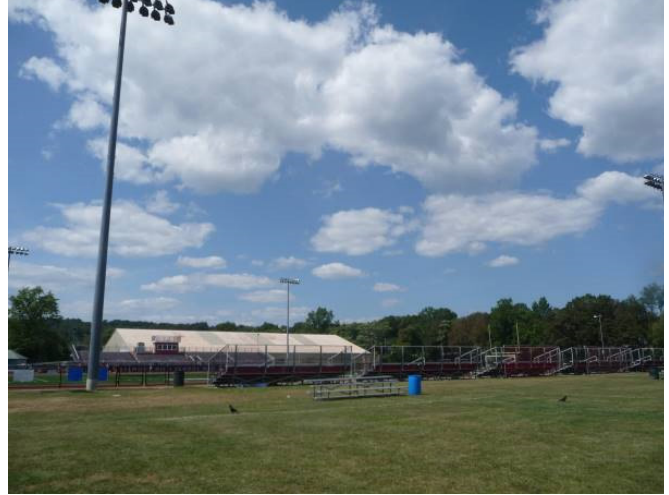
Multi-use synthetic turf field and track (to remain) in good condition (left); Looking west toward visitor bleacher, home bleacher and press box, sports lighting, and skating rink beyond (right)

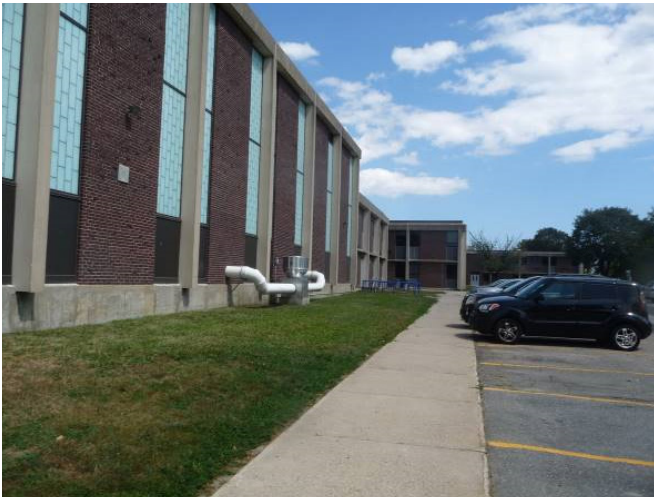
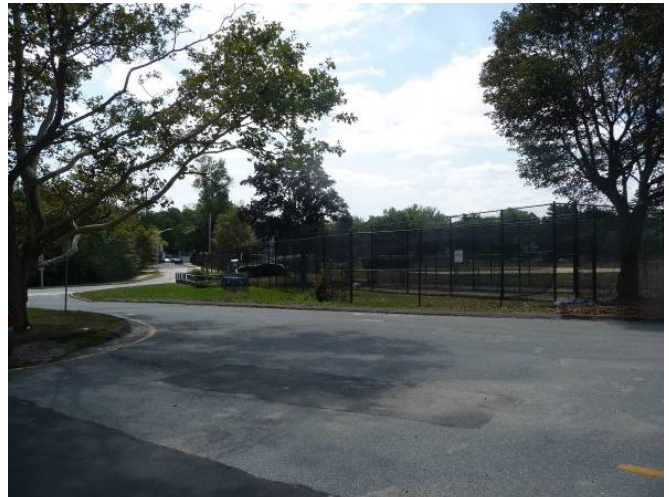
Parking lot at southeast corner of school building, fieldhouse pool dehumidifier (left); Looking south from parking lot toward Concord Avenue exit (right)

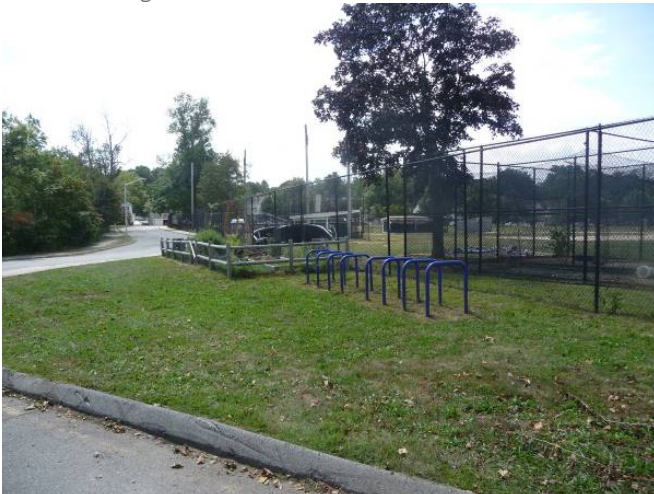
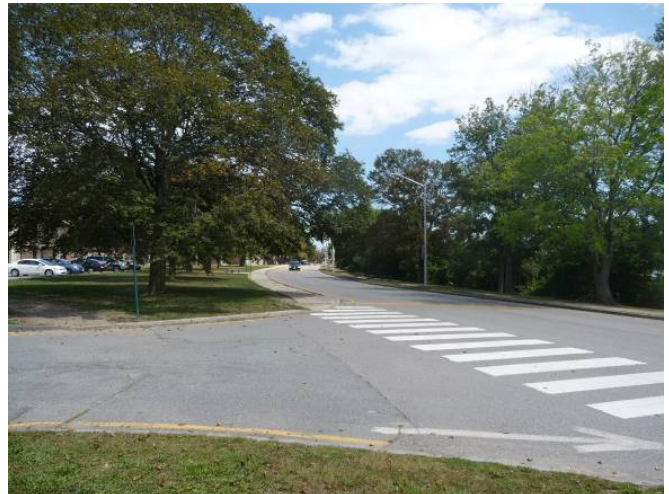
Bicycle parking and planting beds adjacent to batting cages (left); Looking east up drop-off loop, mature maples trees on left and vegetation obscuring views to Claypit Pond on right (right)

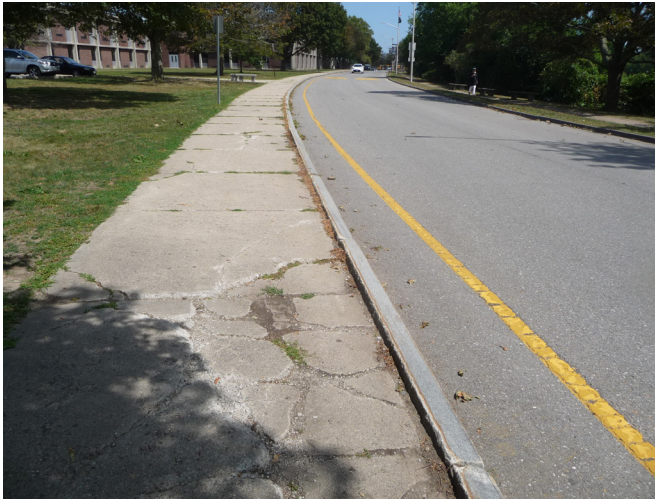
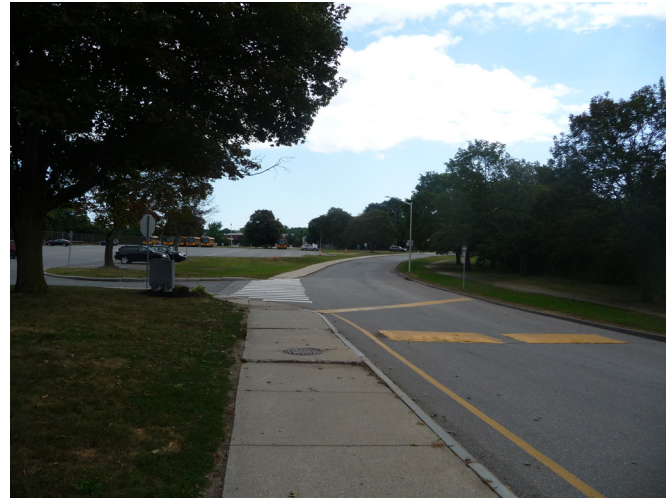
*Sidewalk in poor condition looking east up drop-off loop (left and right); Informal footpath around Claypit Pond (right)*

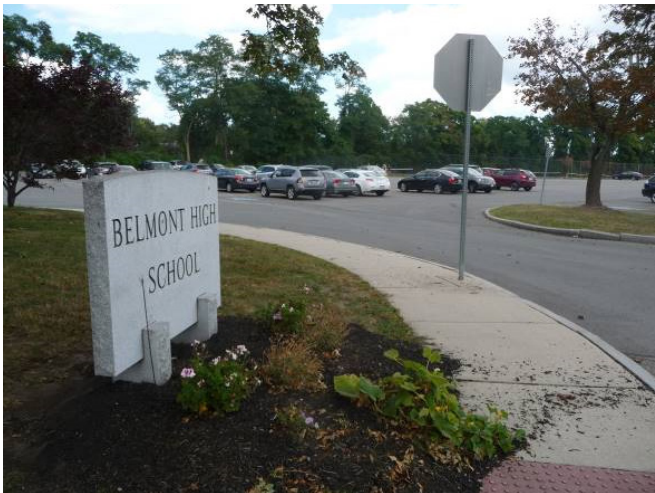
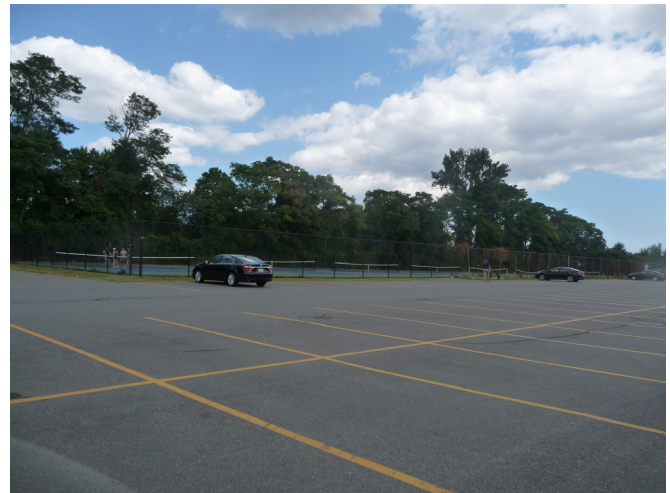
*Granite school entry sign at east parking lot (left); 10 tennis courts on north property line adjacent to east parking lot, lights removed/not working (right)*

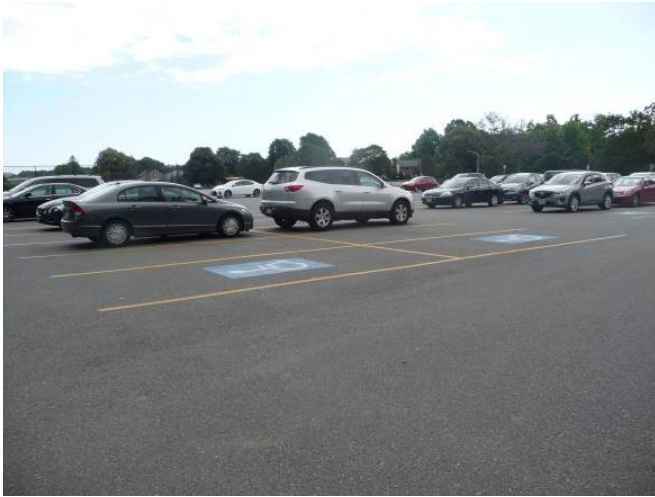
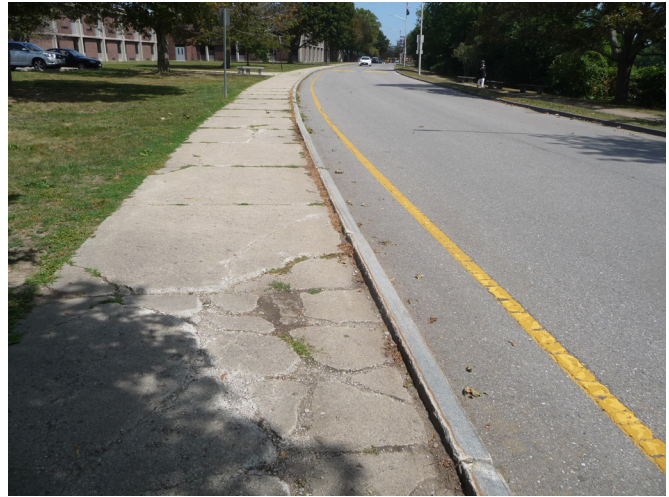
With the exception of the new multi-sport synthetic turf field and track, there are limited or incomplete accessible routes to existing athletic facilities. Brendan Grant Memorial Field has an accessible route to the bleacher from an accessible parking space on Concord Avenue, but there is no accessible route to the dugouts.

Accessible parking in east parking lot (left); Sidewalk condition is not accessible (right)

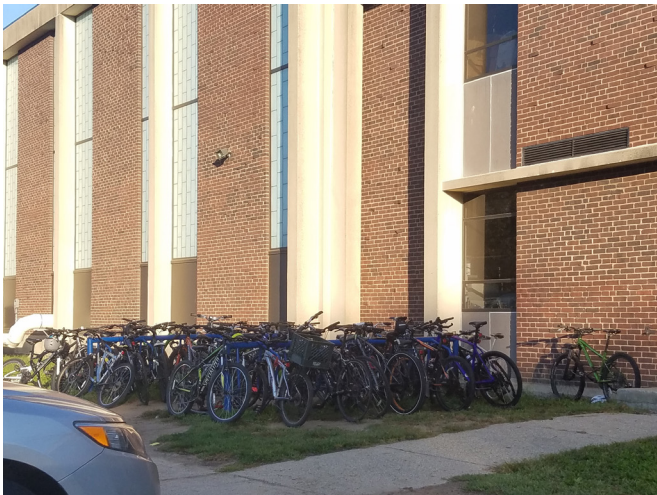
Figure 12 Full Bike Racks at Belmont High School

Bike racks in and around campus had high utilization during the site observation period described above (Figure 12). The high demand for bike parking on campus is evidence of the need for additional bike parking and enhanced biking access and safety improvements.

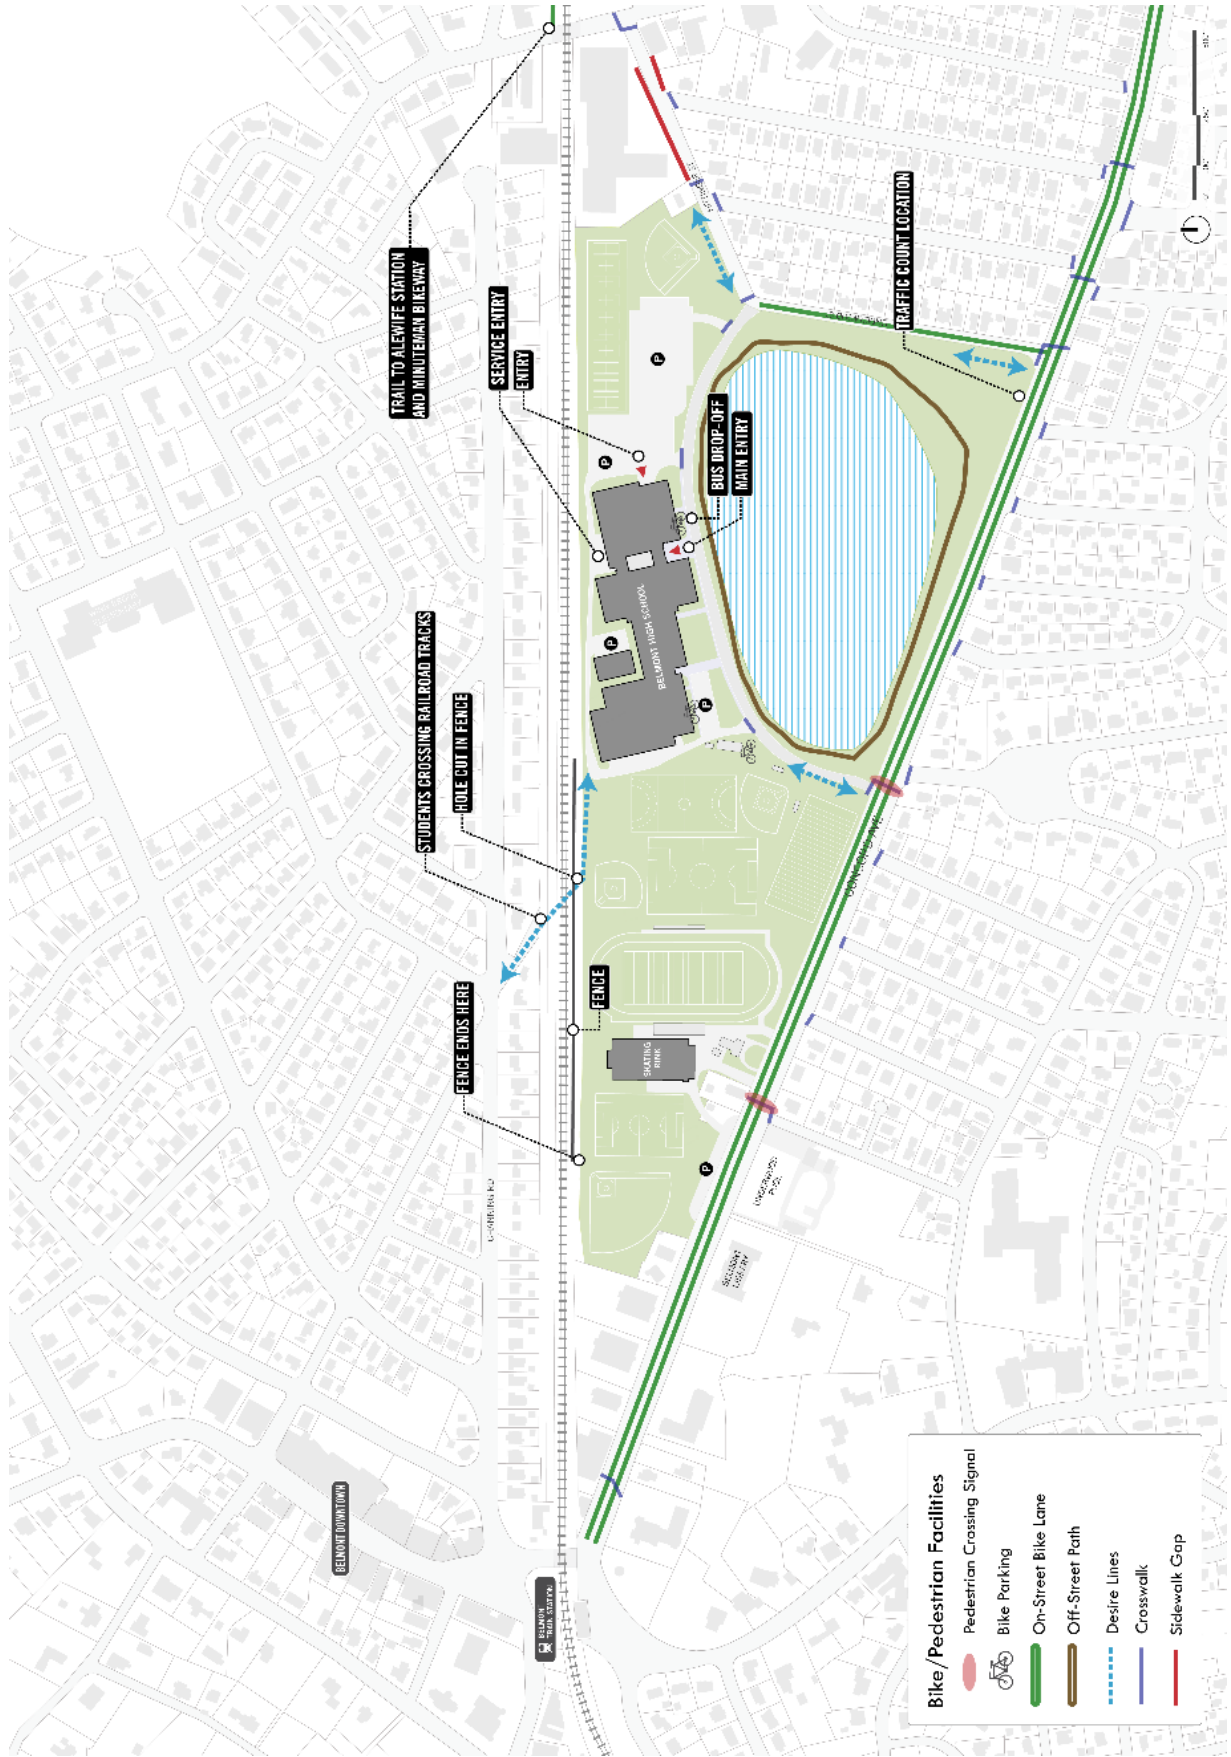
FIGURE 13: CAMPUS BIKE AND PEDESTRIAN ACCESS

In discussions with campus stakeholders, the most commonly cited walking access issue was that students frequently cross the MBTA tracks at a location immediately north of the baseball field, indicated on Figure 13, to connect with Alexander Avenue, Sherman Street, and other destinations in northern Belmont. Stakeholders noted that affiliates had previously cut a hole in

the chain-link fence between the campus and the railroad tracks so that baseball players could retrieve foul balls. In addition to presenting a serious safety issue in which students are exposed to the risk of fatal collisions with oncoming rail traffic while crossing the tracks, this problem highlights the need for enhanced walking connections between the High School and neighborhoods in northern Belmont. Under existing conditions, there are no points of access between Concord Avenue and northern Belmont neighborhoods between Leonard Street and Brighton Street, a distance of over three-quarters of a mile.

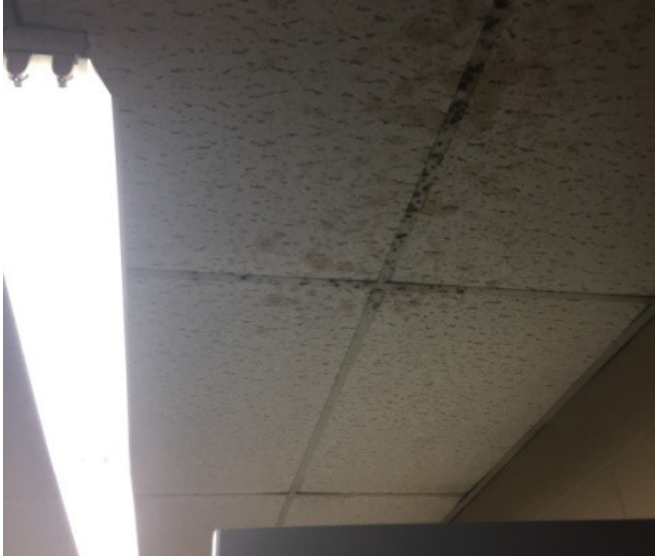
*The picture shows mold growing on the ceiling panels in the kitchen. All ceiling panels should be smooth, water resistant and easy to clean to prevent the growth of mold.*

*The light fixtures shown here do not meet the board of health code. All lights are required to have shatterproof lens and coated bulbs.*

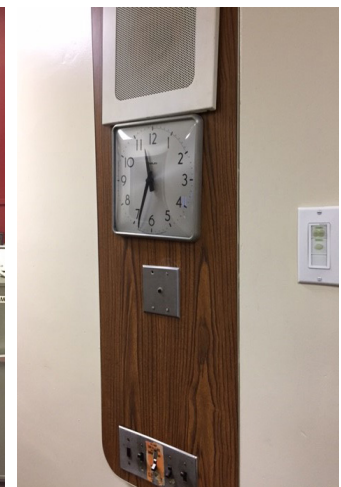
Typical Speaker, Clock, Call Button Location

Classrooms are equipped with two-way speakers, secondary clocks and call buttons. Some of the equipment is no longer functional and have reached the end of their serviceable life. Many spaces are using battery operated clocks that are not synchronized. Bell system in not functional. Any future project should provide new components based on current technology.

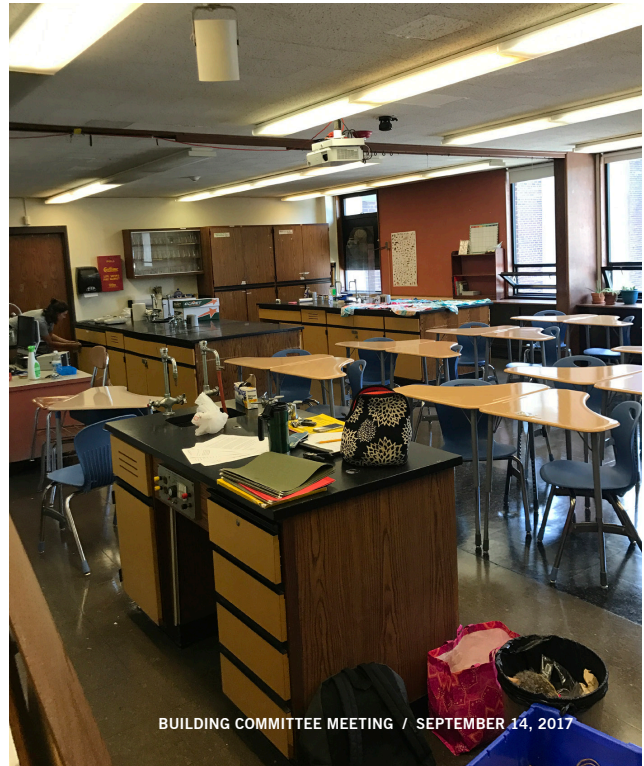
**CONTROLS:** are original to the building consisting of local line voltage switching vs. current low voltage dimming, vacancy sensors and day lighting controls

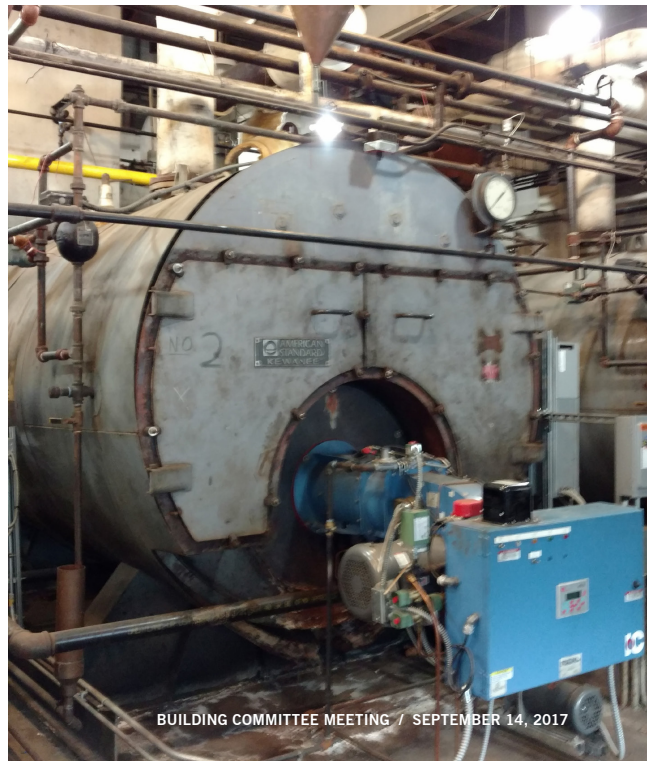
**DUEL FUEL:** burners can burn gas or fuel oil.

**STEAM SYSTEM:** requires maintenance of steam traps, condensate pumps, receiver tanks, control valves, anti-corrosion chemicals.

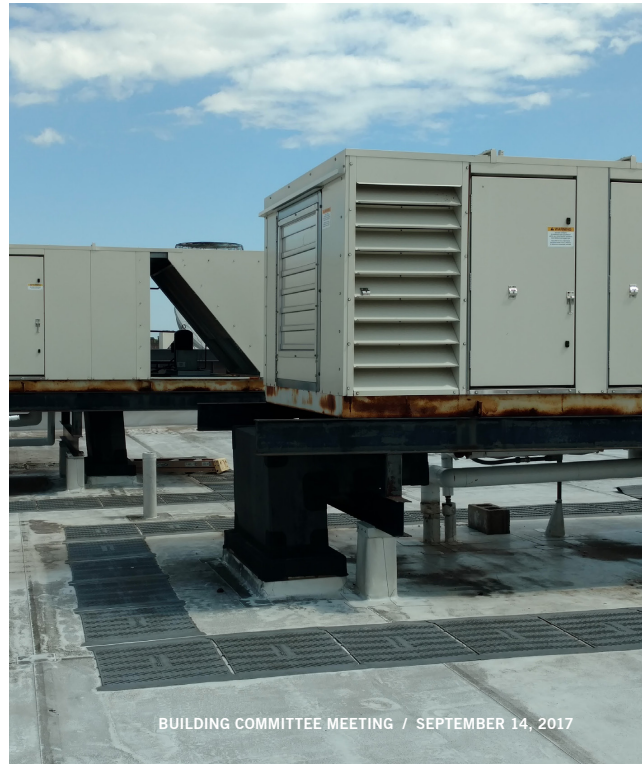
- Casings are in good condition. Corrosion around the unit base.
- There are two vintages of units. Same manufacturer, but with differences in technology. Five units have web interfaces.
- All have steam heating coils.
- Some have DX cooling.

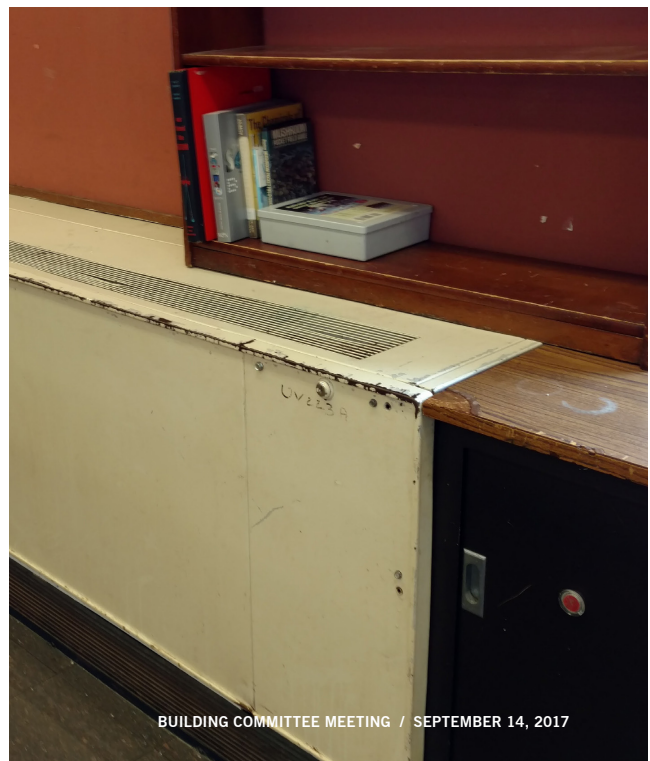
- Provides heating with hot water and outdoor air ventilation through an exterior louver.
- Heavy gauge casings are in good condition, but some with dents and deformations. Chipped paint typical.
- Pneumatically controlled dampers and valves require a high level of maintenance.

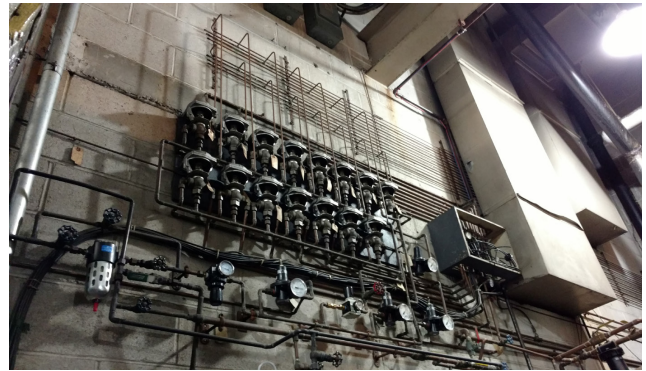
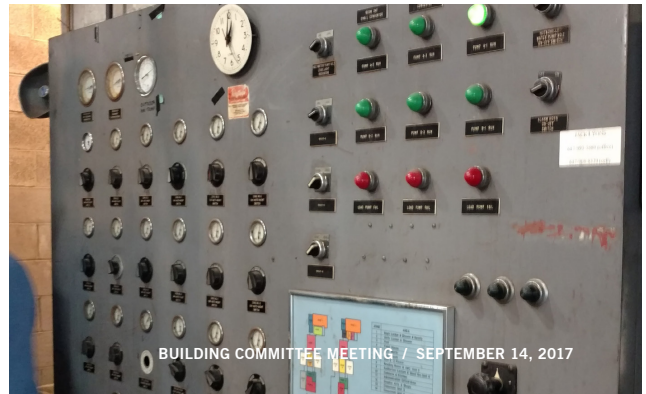
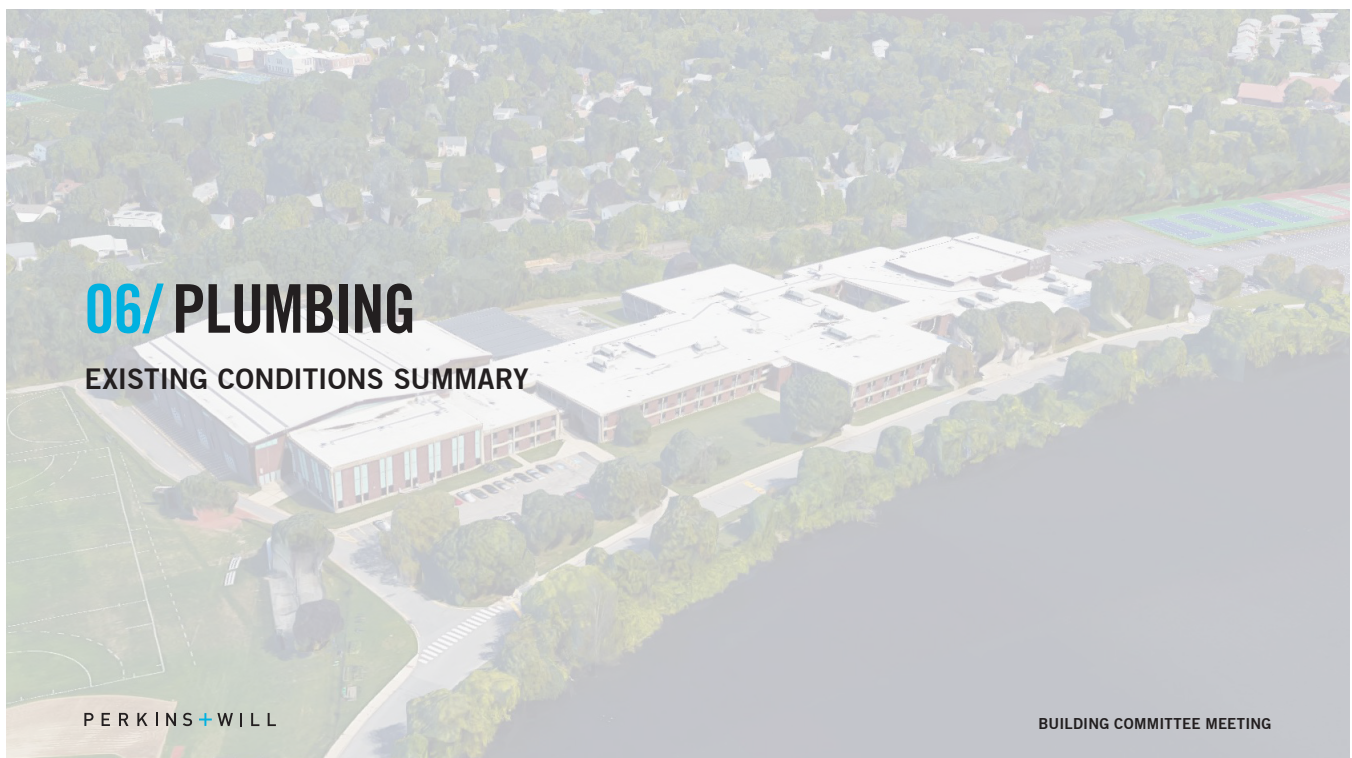
#### PNEUMATIC TEMPERATURE CONTROLS

- Master control panel and pressure control actuators (see photo)
- Original copper tubing with soldered fittings with some plastic tubing.
- Repairing of leaks is difficult. Some tubing is covered with fire proofing.
- Little to no monitoring capability.
- Pneumatic technicians harder to find.
