# 3.1.4 EVALUATION OF EXISTING CONDITIONS

# 3.1.4 - EVALUATION OF EXISTING CONDITIONS

**RE: Historic Status, Belmont High School**

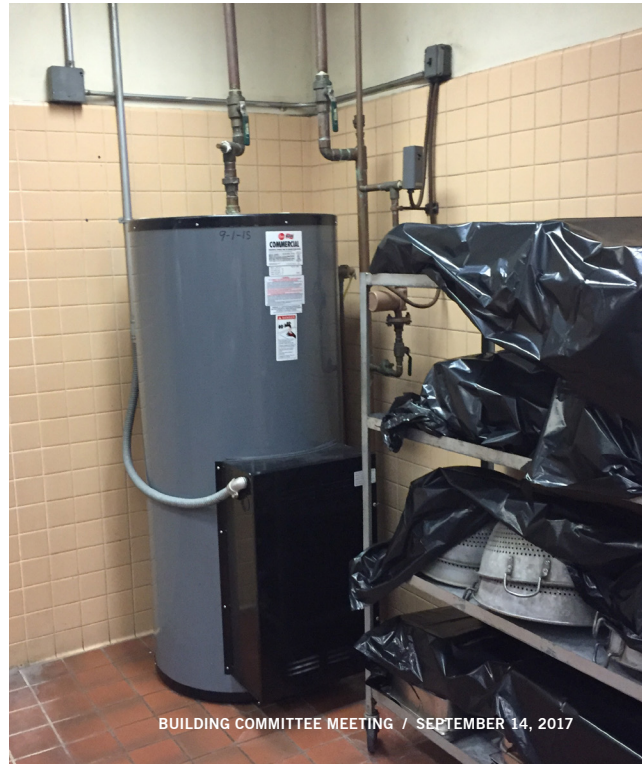
**HOT WATER SYSTEM:** Combination of steam-fired and electric water heaters. A more centralized approach should produce energy savings in future.

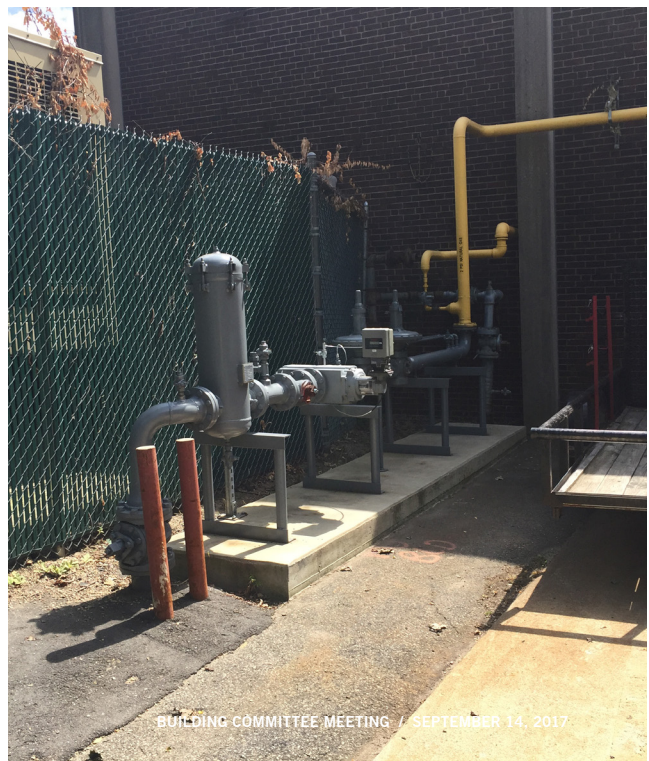
**SANITARY SYSTEM:** Piping system is visibly in fair condition, but piping serving science lab is not acid-resistant per code.

**STORM SYSTEM:** Existing roof drains and visible piping systems appear in good condition.

**NATURAL GAS SYSTEM:** Existing gas service is more than adequate to meet current needs of school and visible piping systems appear to be in good condition.

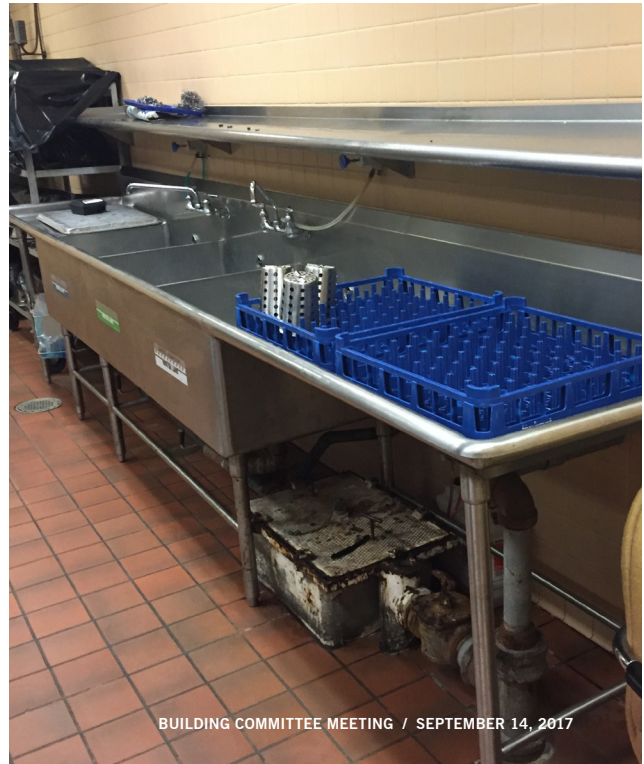
- Currently, all electric equipment/ no gas connections.
- No dish washing on site at this time all disposable plates and utensils.
- Three-compartment sink and associated grease trap not used.
- No exterior grease trap on site.

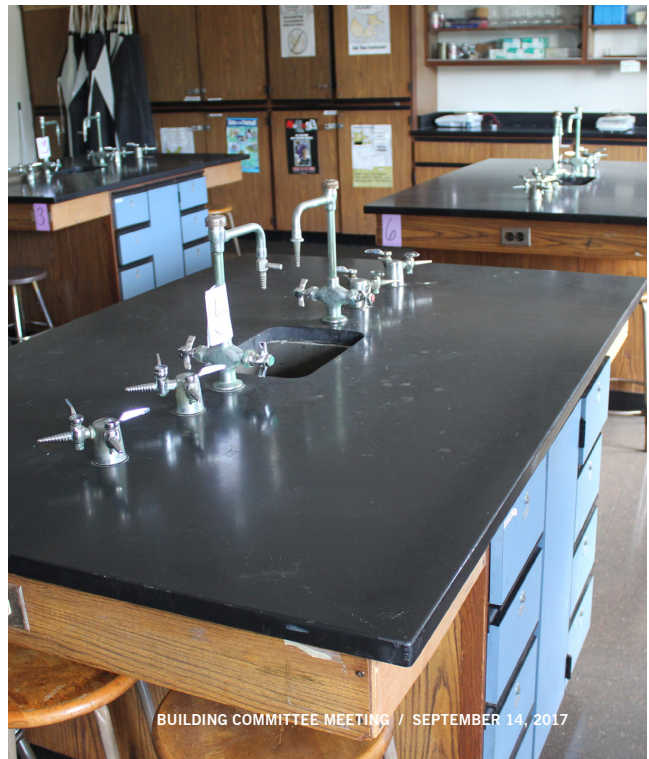
- No gas connections to counter top turrets.
- Main gas shut-off valve to wing is in ceiling and not code compliant.
- Lab sink waste piping is on its own system, but does not have acid resistant piping and treated before connecting to the building's main waste system.
- Water service to the lab is from the main domestic system.
- Lab water should be its own protected system.

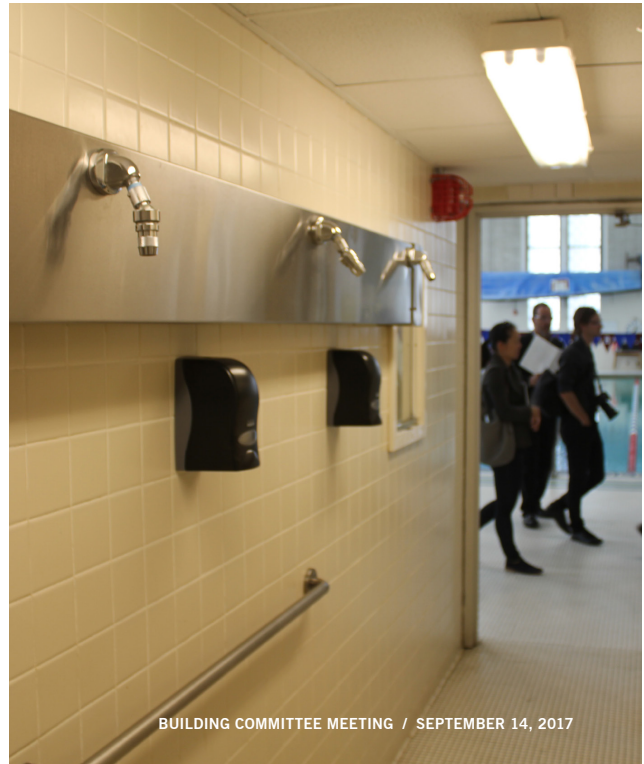
- Existing locker rooms and shower rooms in fair condition.
- Single floor drain in shower areas.
- Water from one shower should not drain into other shower areas.

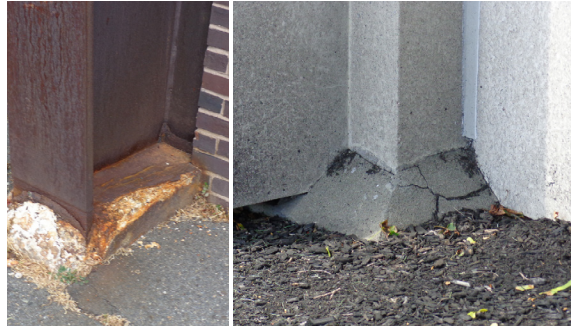
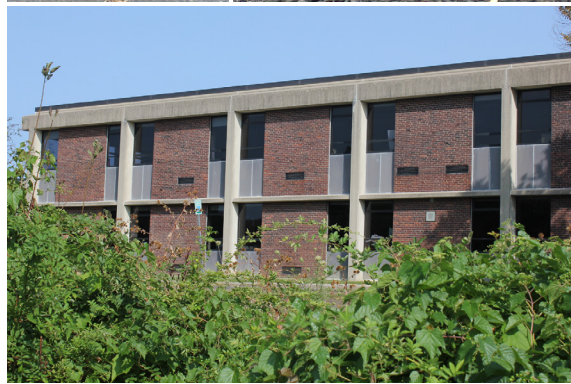
**Vertical additions may not be feasible, due to limited capacity of foundations, columns, and roof structure.**

- The existing structure is performing well - Minor cracks in the interior/exterior masonry walls were observed.
- No signs of foundation settlement and no undue vibration from footfall were observed
- Majority of walls do not appear to be structural in nature

- Compliance with International Existing Building Code
- Proposed renovations will trigger an analysis of the existing building and will require the addition of shear walls or braced frames - probably requiring additional piles within the building.
- Grade beams and piles will be required for phased and partial demolition to support the new exterior walls.
- Renovations will require trenching of existing slabs - not easy to trench under supported structural slabs
- Proposed additions should be horizontal, separated from the existing structure by expansion joints.

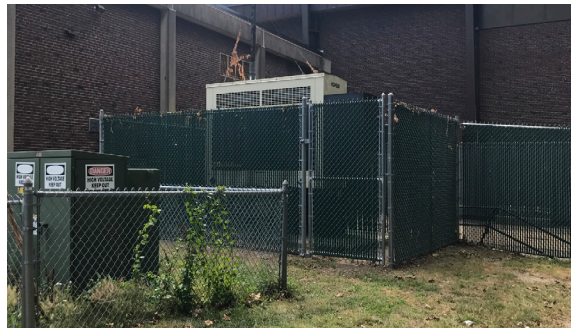
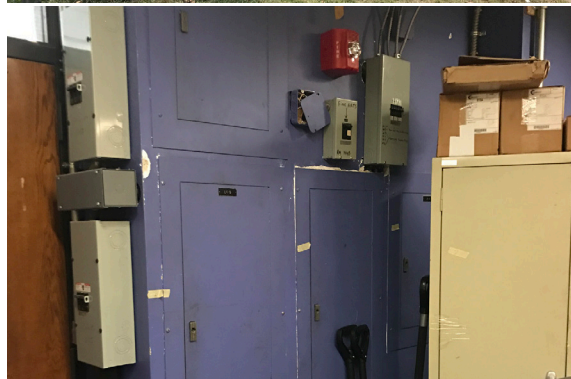
- **Main Electric Room:** There are current space limitations.
- **Science Room Lighting/Controls:** Original fluorescent lighting and controls (local line voltage switching) are typical for most of the classrooms throughout the building.

- **Electrical Closets:** For new/renovated designs, all electrical equipment would be in dedicated electric closets. No equipment in storage closets or other non-dedicated areas.

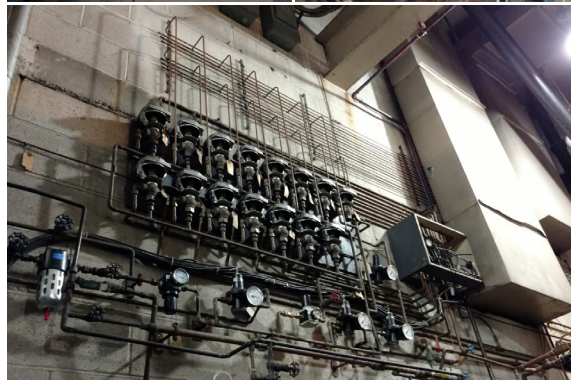
Current mechanical systems are reaching end of life, difficult to repair, and are not positioned to be energy efficient.

- **Steam Boilers:** 47+ year old steam boilers in building.
- **Duel Fuel:** The current burners can burn gas or fuel oil.
- **Boilers:** All boilers have been partially or completely re-tubed several times.

- **Steam System:** Requires maintenance of steam traps, condensate pumps, receiver tanks, control valves.
- **Roof Top Units:** Casings are in good condition, but corrosion around the unit base. There are two vintages of units (same manufacturer), but with differences in technology. Five units have web interfaces. All have steam heating coils.

- **Unit Ventilators:** Provides heating with hot water and outdoor air ventilation through exterior louvers. The casings are in good/fair condition (dented). Pneumatically controlled dampers and valves require a high level of maintenance.

- **Pneumatic Temperature Controls:** Has original copper tubing, some covered in fireproofing - repairing of leaks is difficult. Little to no monitoring capability.

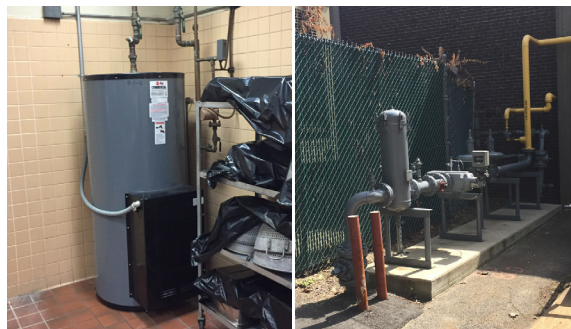
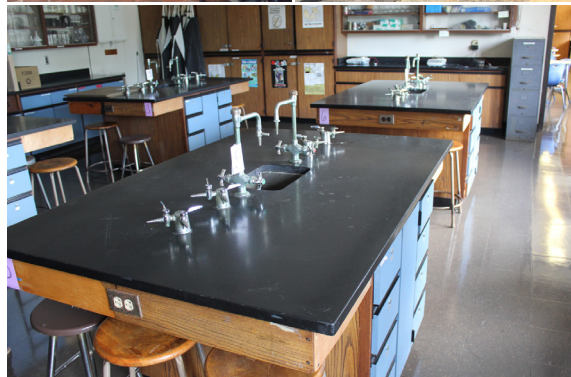
- **Plumbing Fixtures:** Most fixtures are older models and are not compliant with current codes / does not meet ADA req.
- **Cold Water System:** More than adequate to meet existing / future demands.
- **Hot Water System:** Combination of steam-fired and electric water heaters. A more centralized approach should produce a more energy efficient solution.
- **Sanitary System:** Piping system is visibly in fair condition, but piping serving science labs is not acid-resistant per code. Lab water should be on its own protected system.
- **Storm System:** Existing roof drains and visible piping systems appear in good condition.
- **Natural Gas System:** Existing gas service is more than adequate to meet current needs of school and visible piping systems appear to be in good condition.
- **Kitchen:** Three-compartment sink / associated grease trap not used. No exterior grease trap on site.
